1.0 INTRODUCTION

This annual inspection report has been prepared to meet the requirements of 40 CFR 257.84(b).

CALEDONIA LANDFILL - WEEKLY INSPECTION & CONDITION SUMMARY

11/17/2017 Caledonia Landfill Inspection

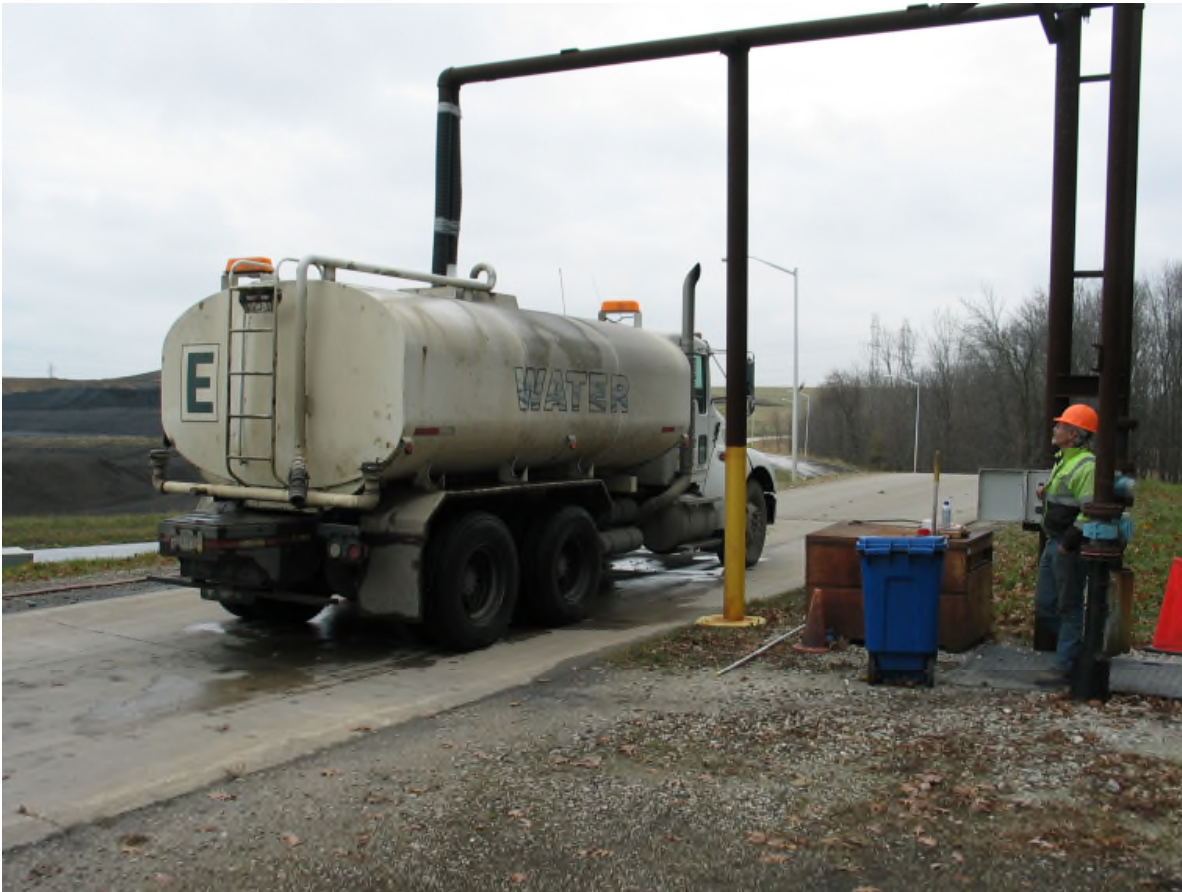
Leachate Load-Out (looking south)

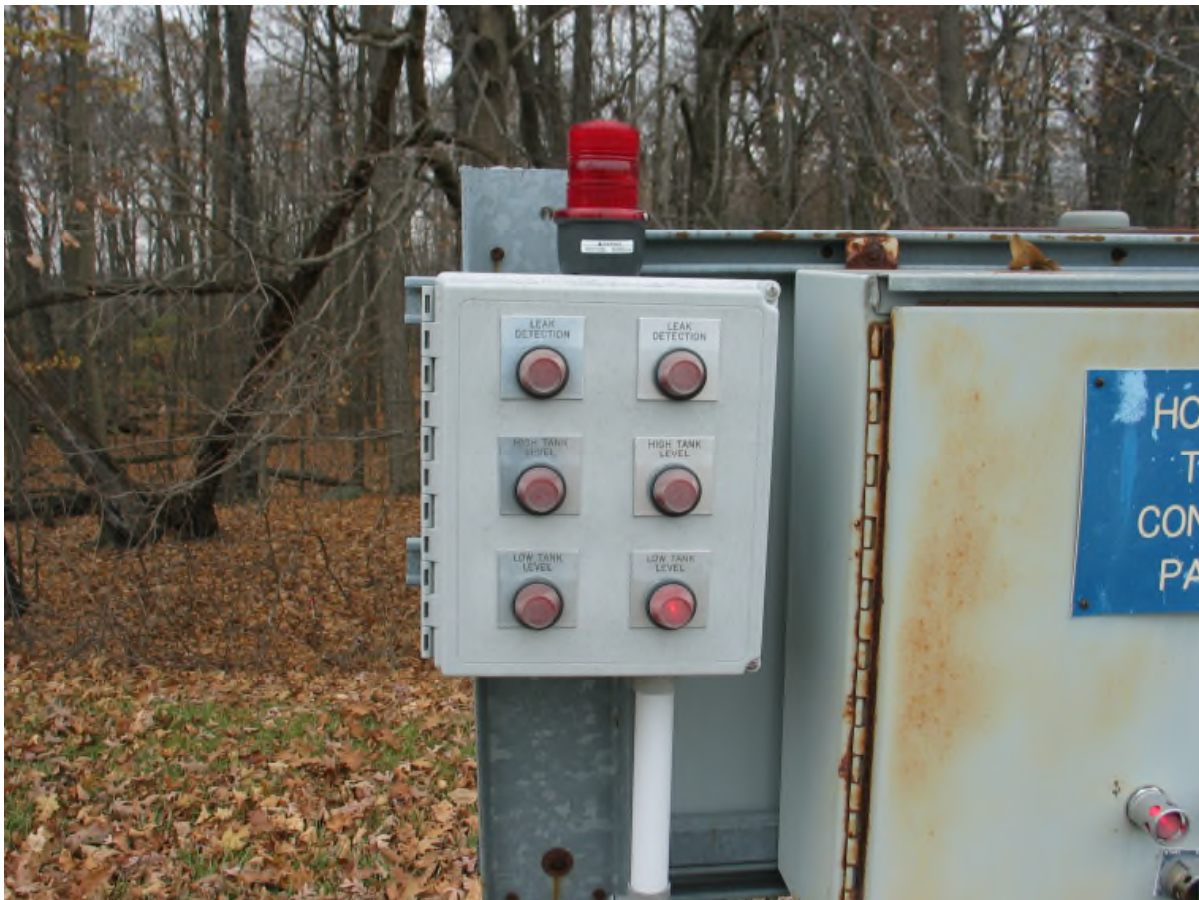
Leachate Load-Out Alarm Panel

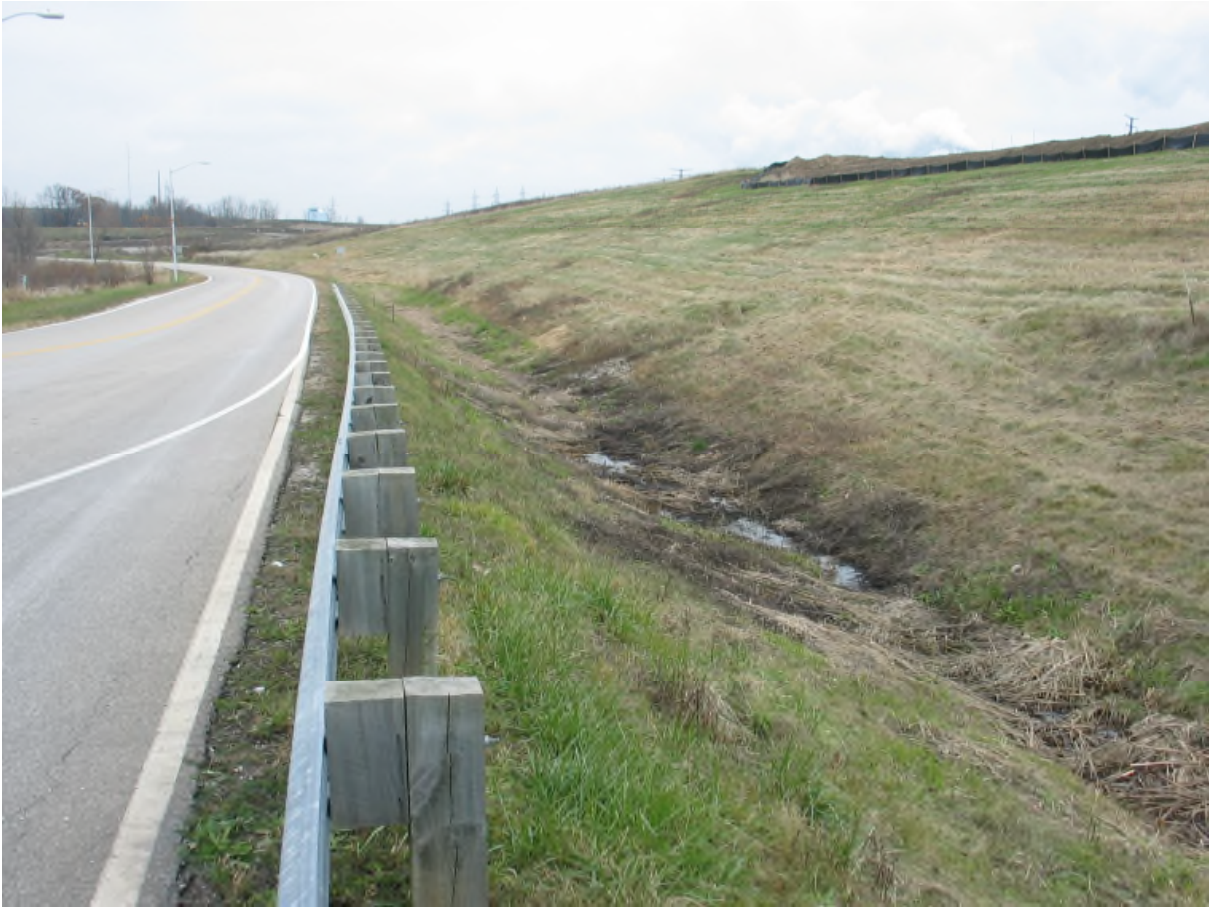
West Side Final Covers & Surface Water Ditch (looking north)

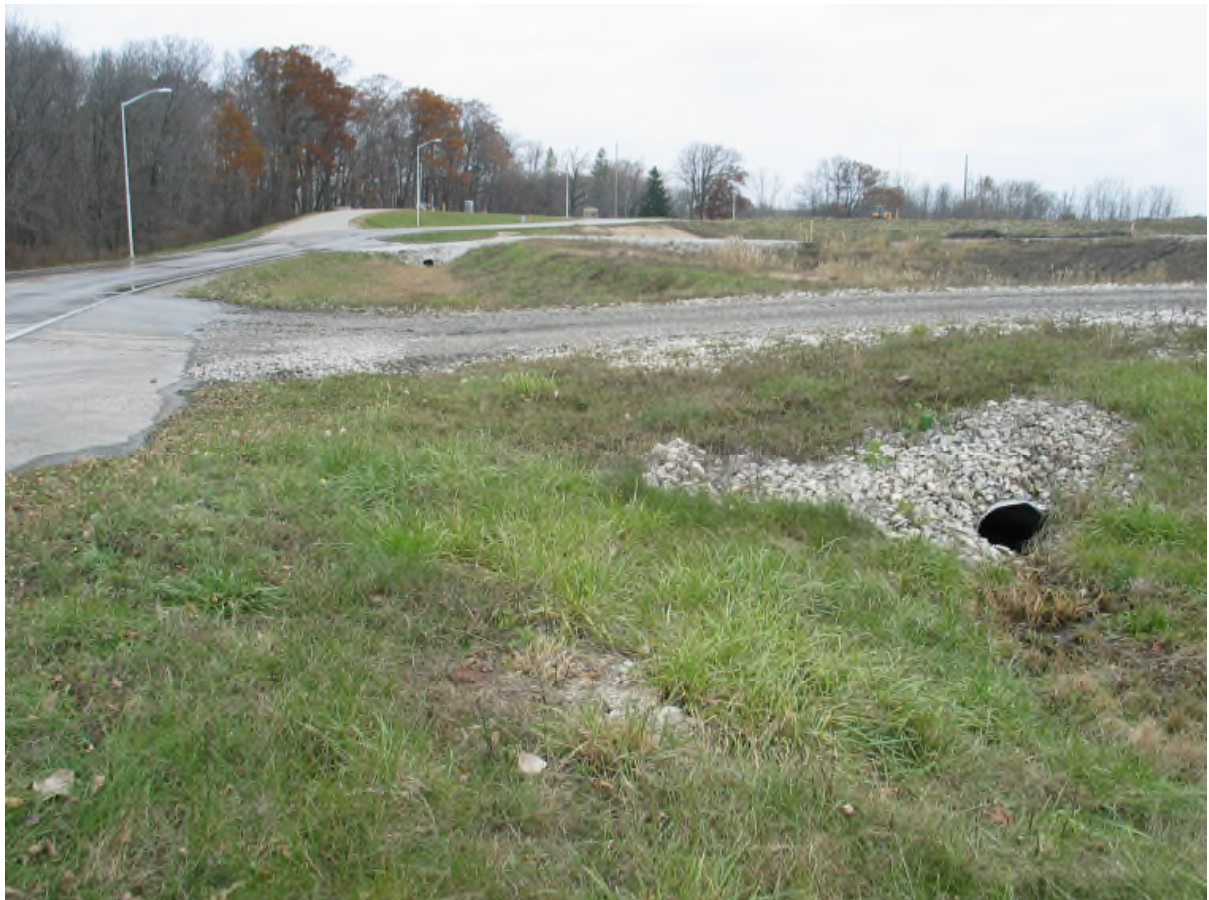
West Berm (looking north)

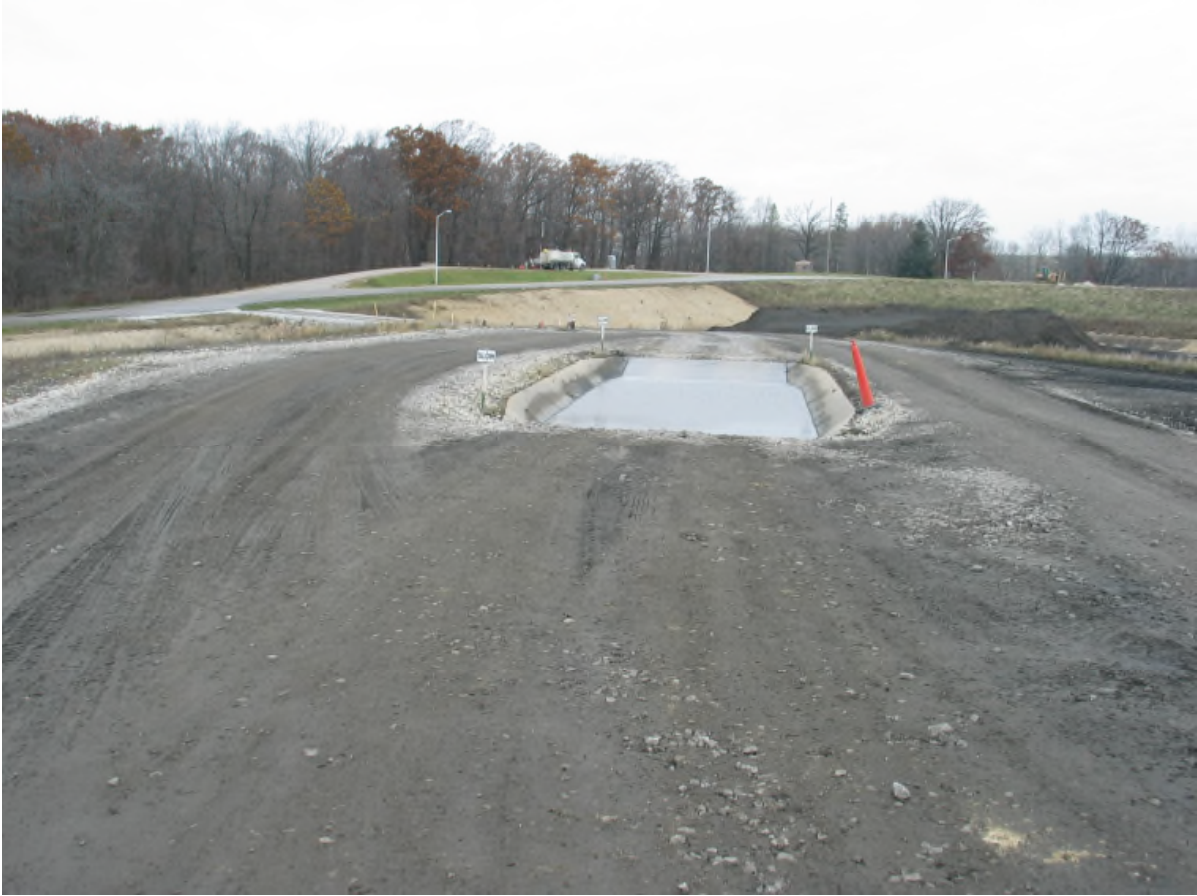
Tire Wash (looking north)

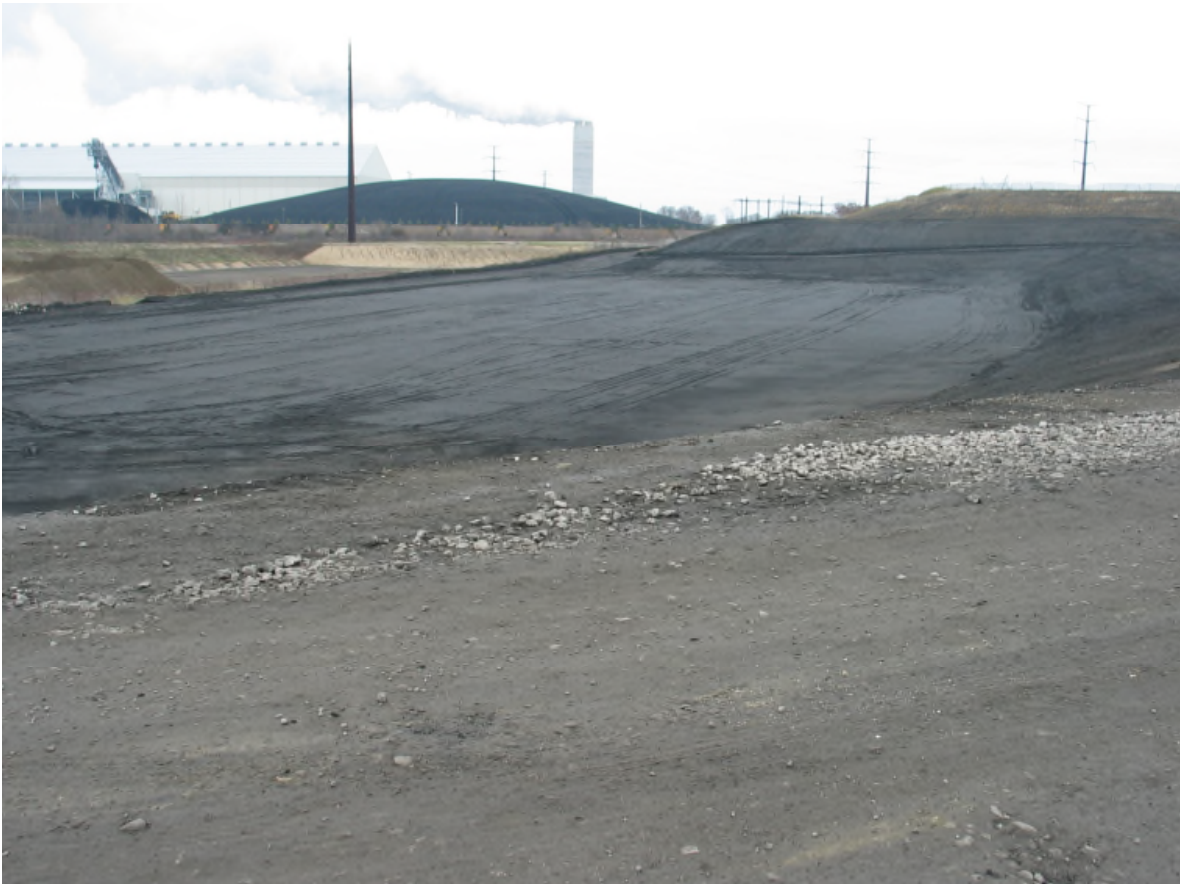
Groomed Waste Surface Cell 8 (looking east)

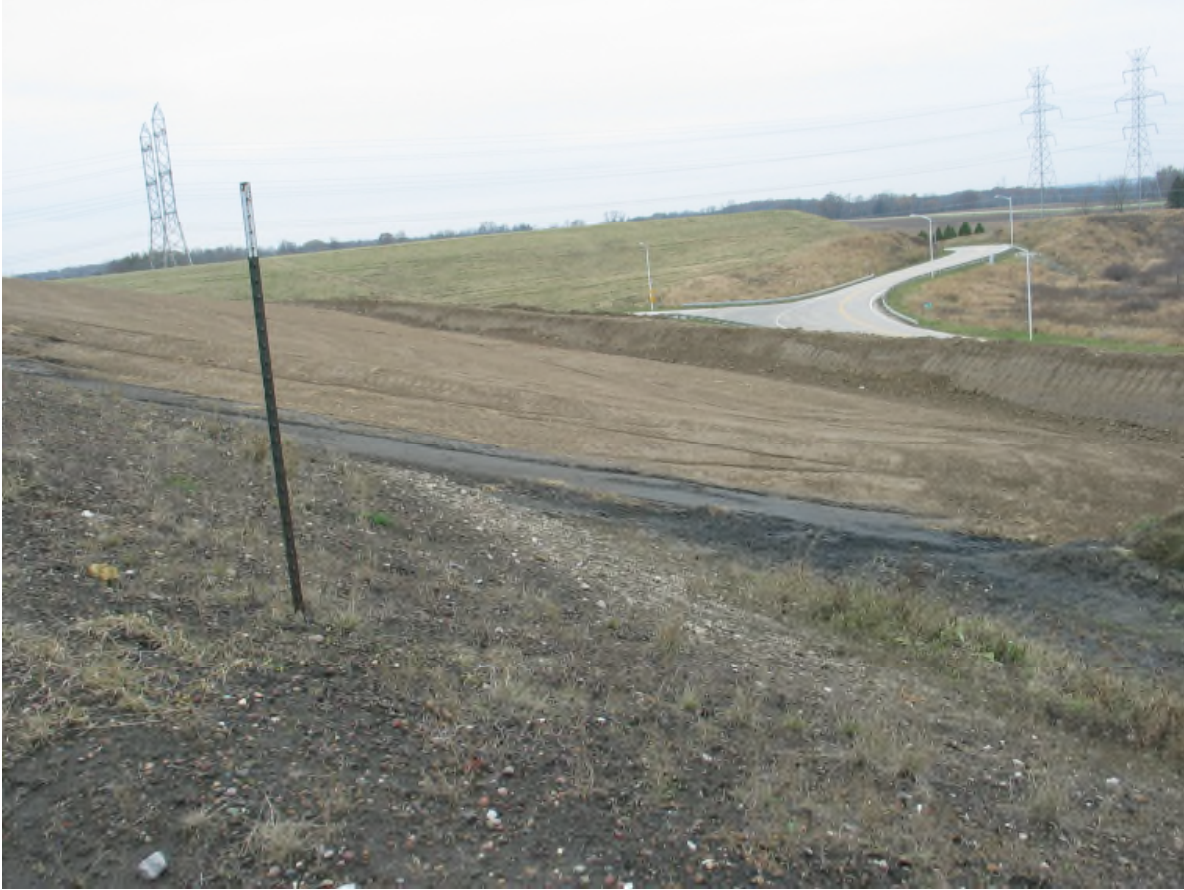
Northwest End Upper Cells & New Cover Construction (looking south)

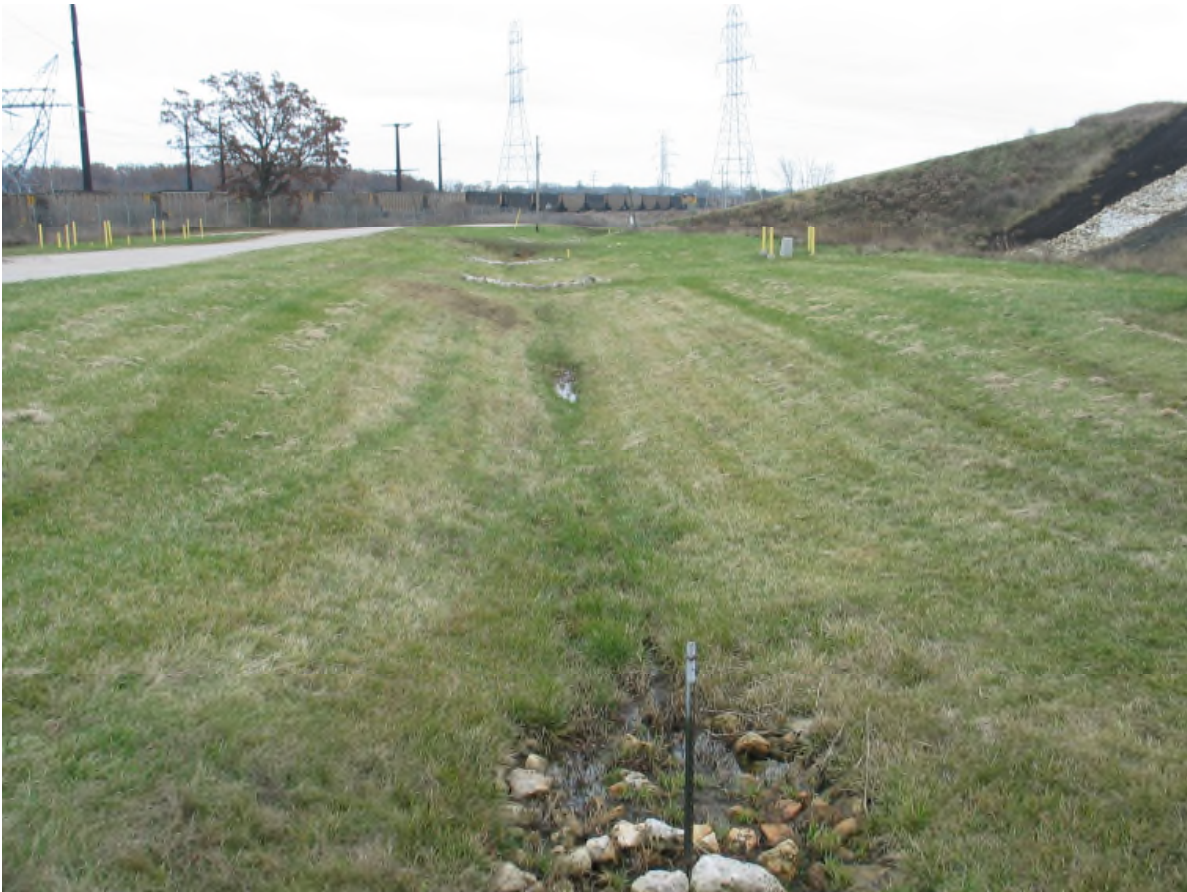
East Side Surface Water Ditch (looking south)

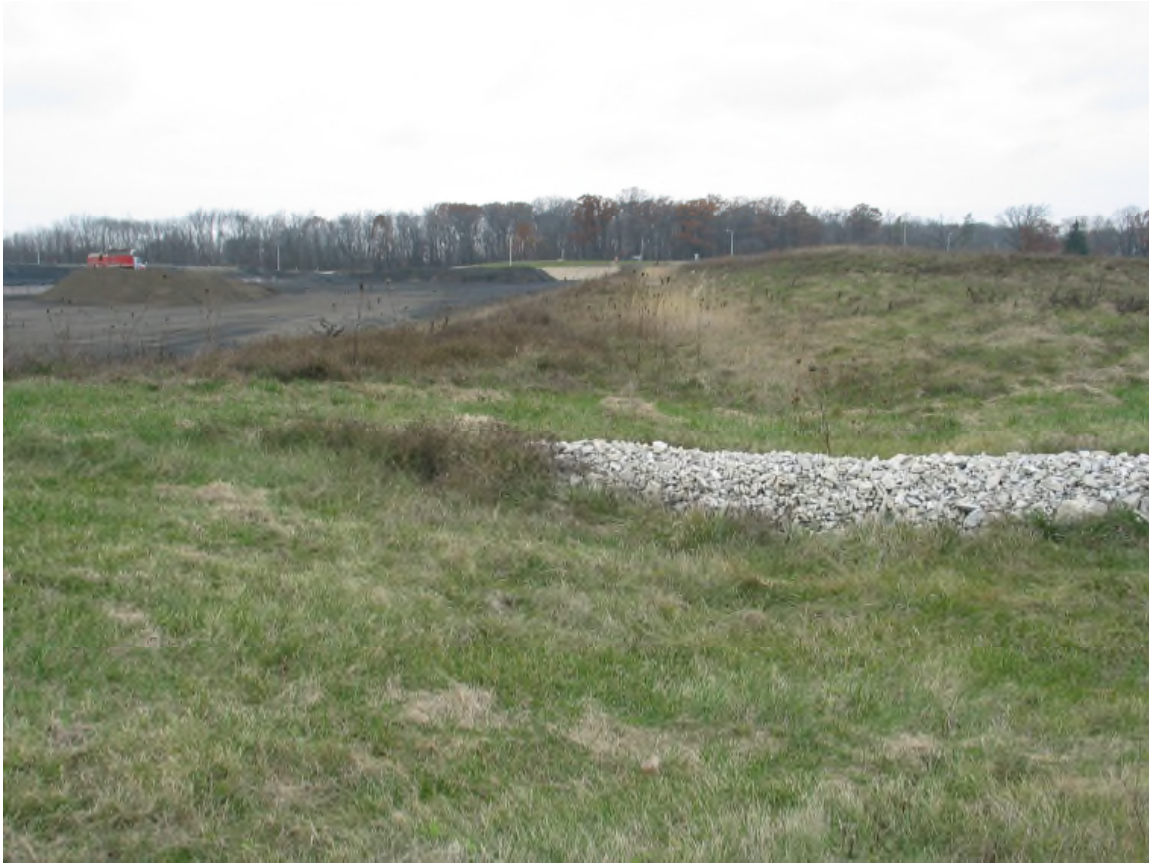
North Intercell Berm (looking west)

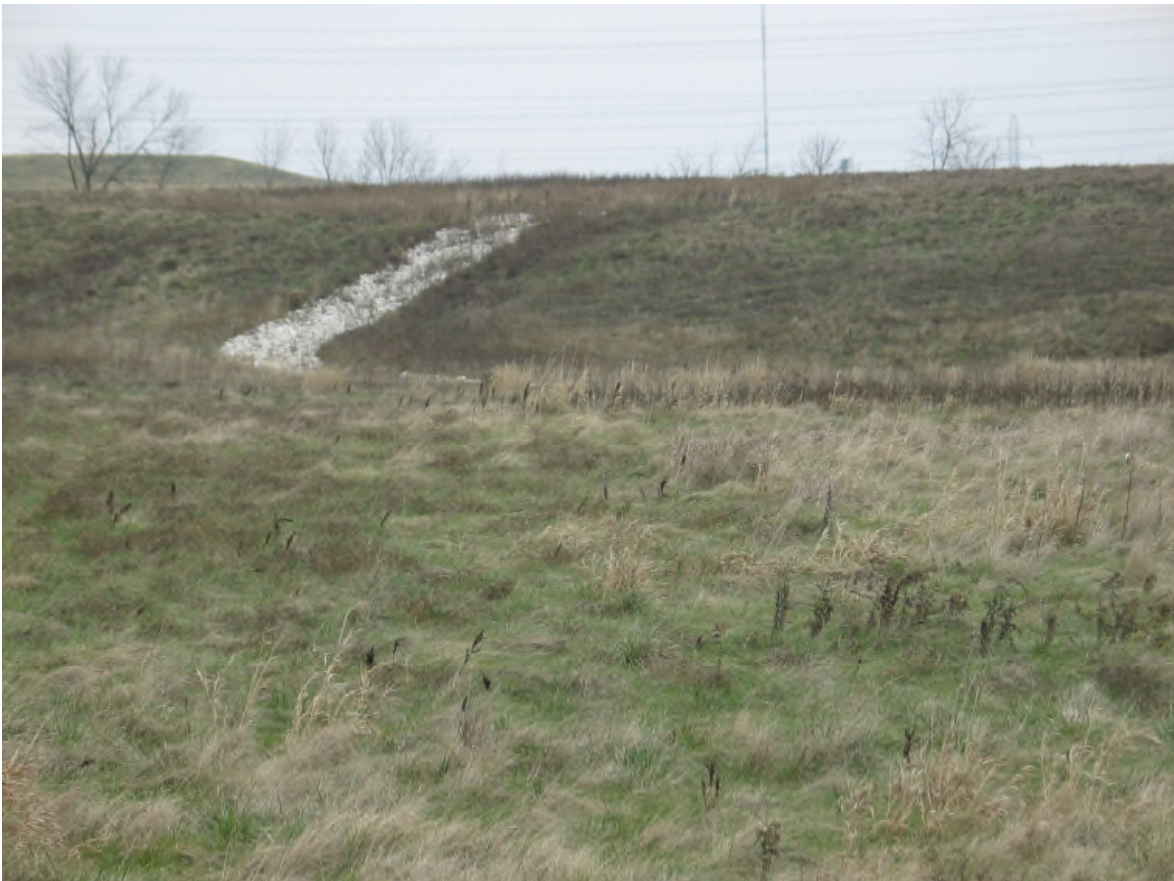
General Fill Stockpile (looking north)

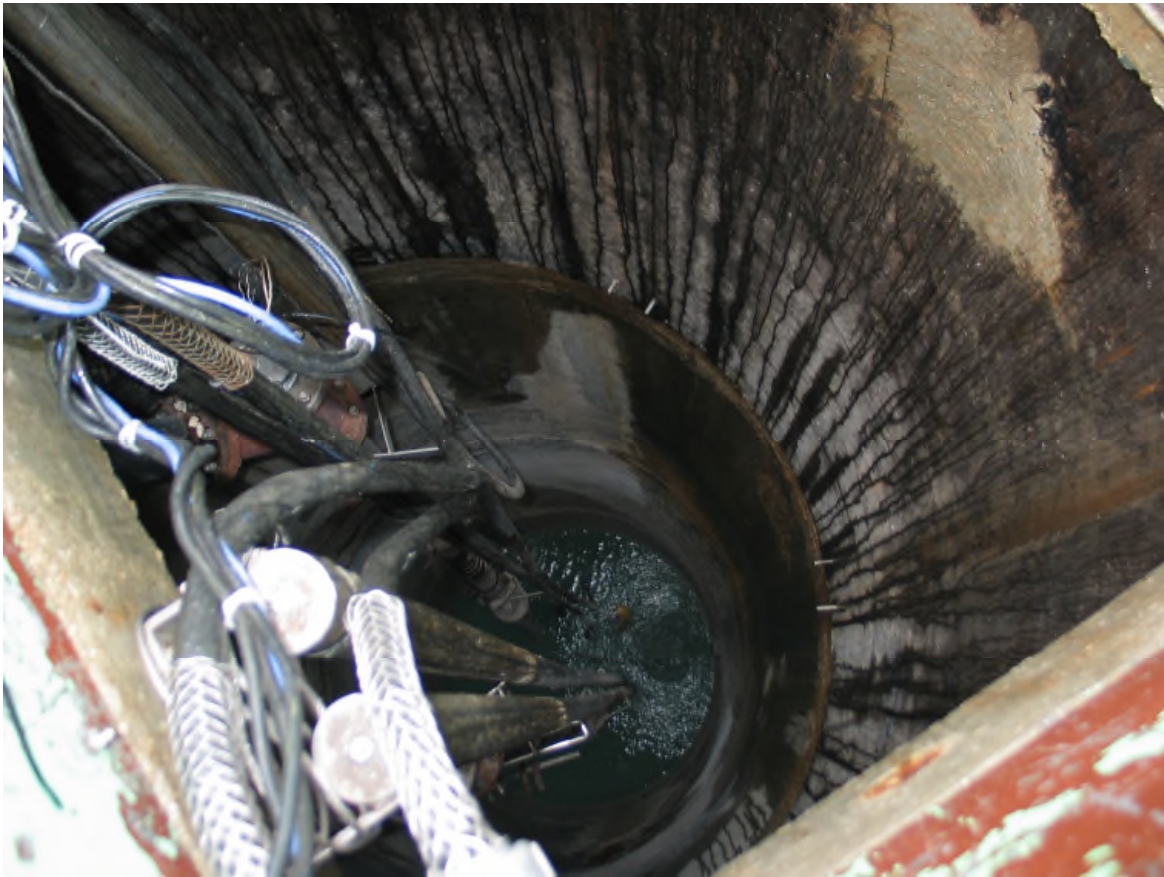
Lift Station (looking down)

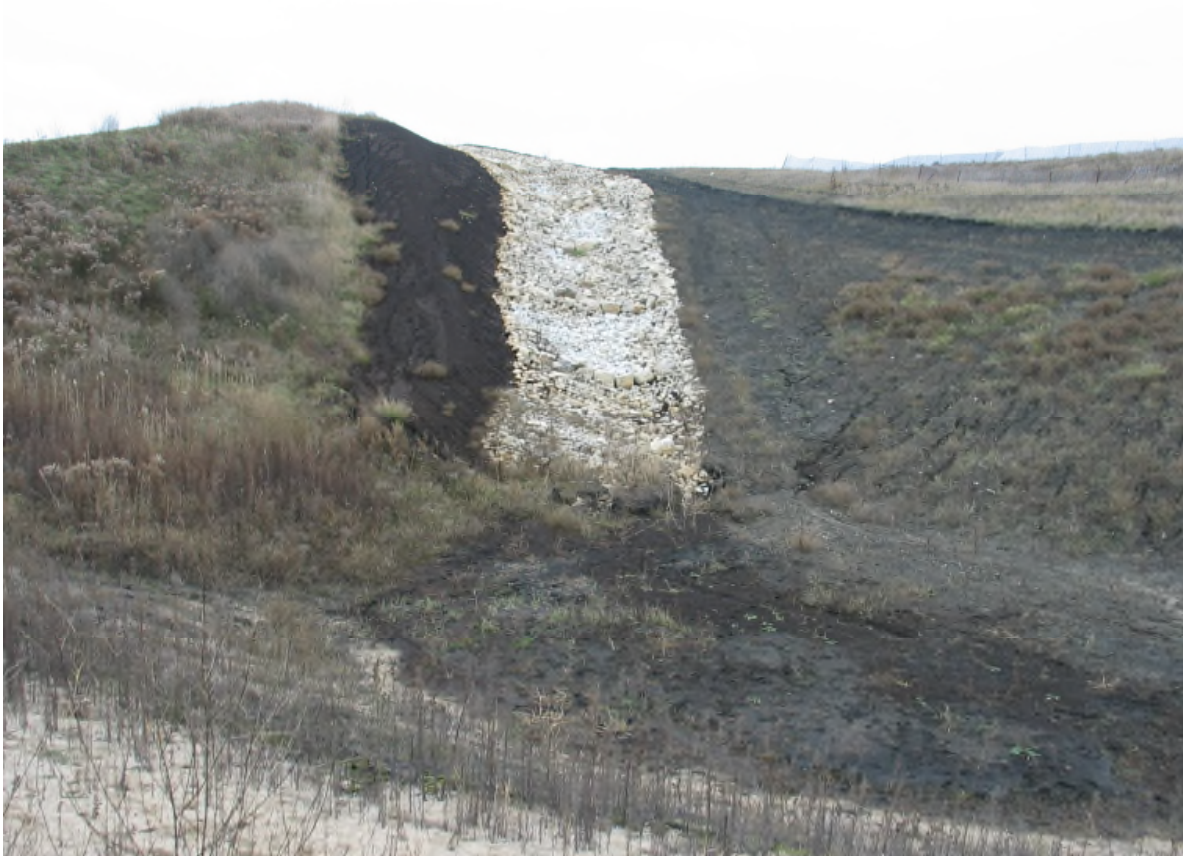
Down Flume from Upper Cells (looking southwest)
