1.0 INTRODUCTION

This annual inspection report has been prepared to meet the requirements of 40 CFR 257.84(b).

Caledonia Landfill Annual Inspection & Condition Summary

11/18/2019 Caledonia Landfill Inspection

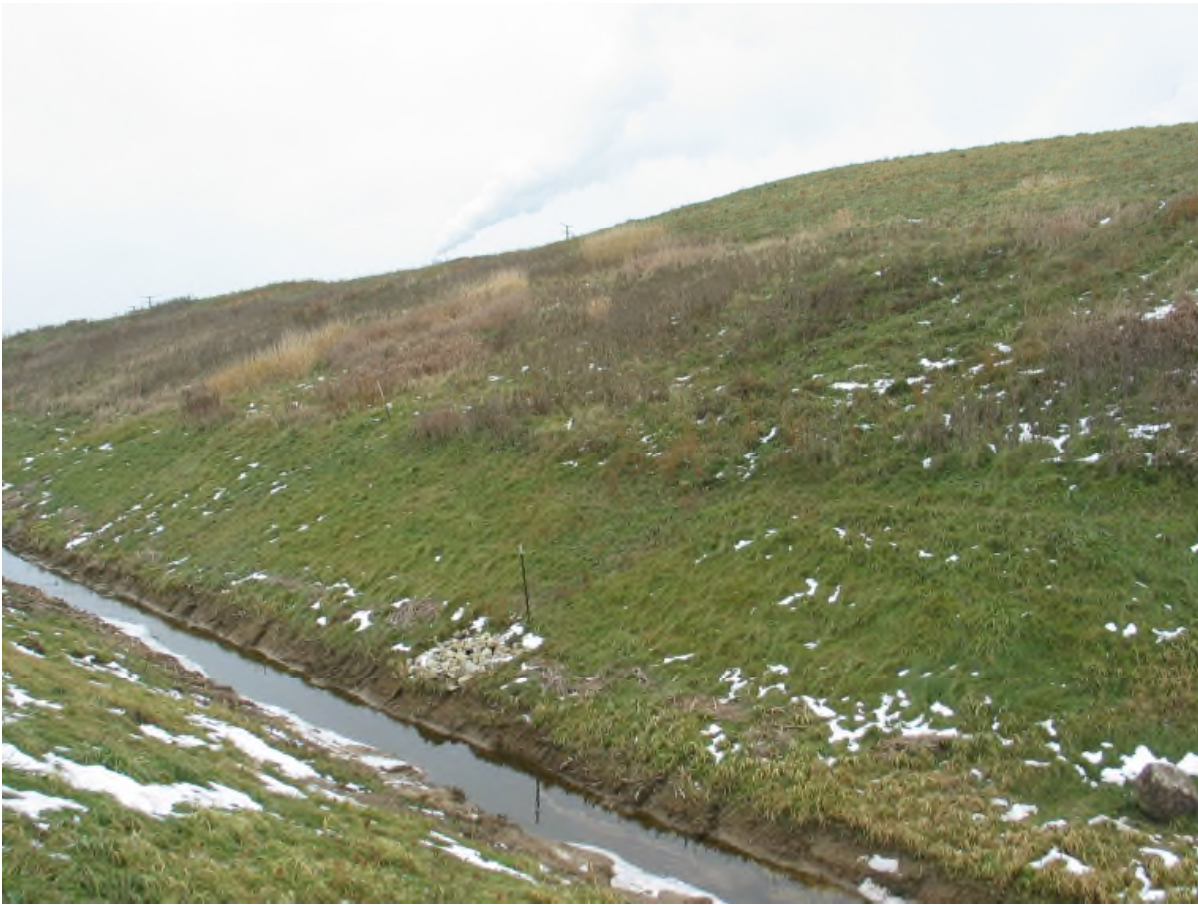
Final cover & perimeter ditch (west side)

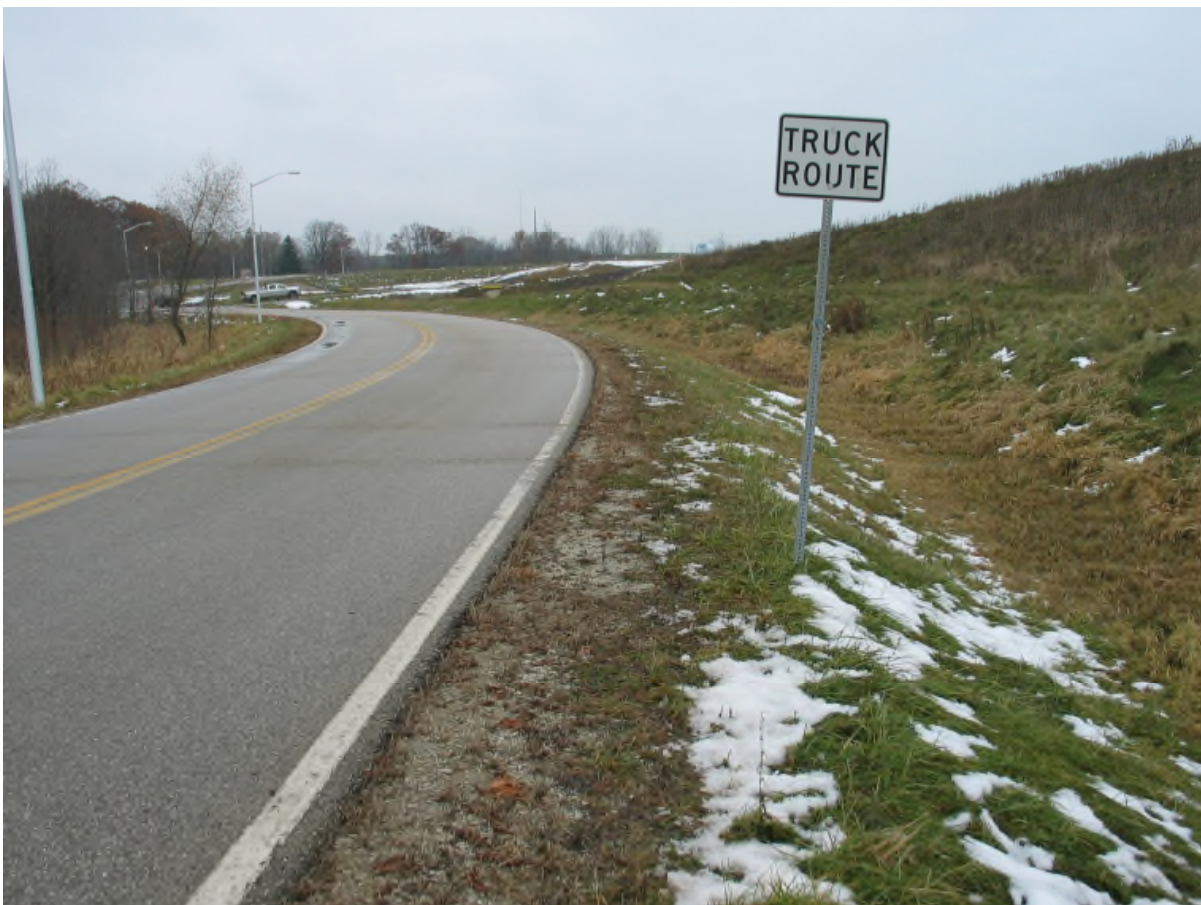
Access Road (looking north)

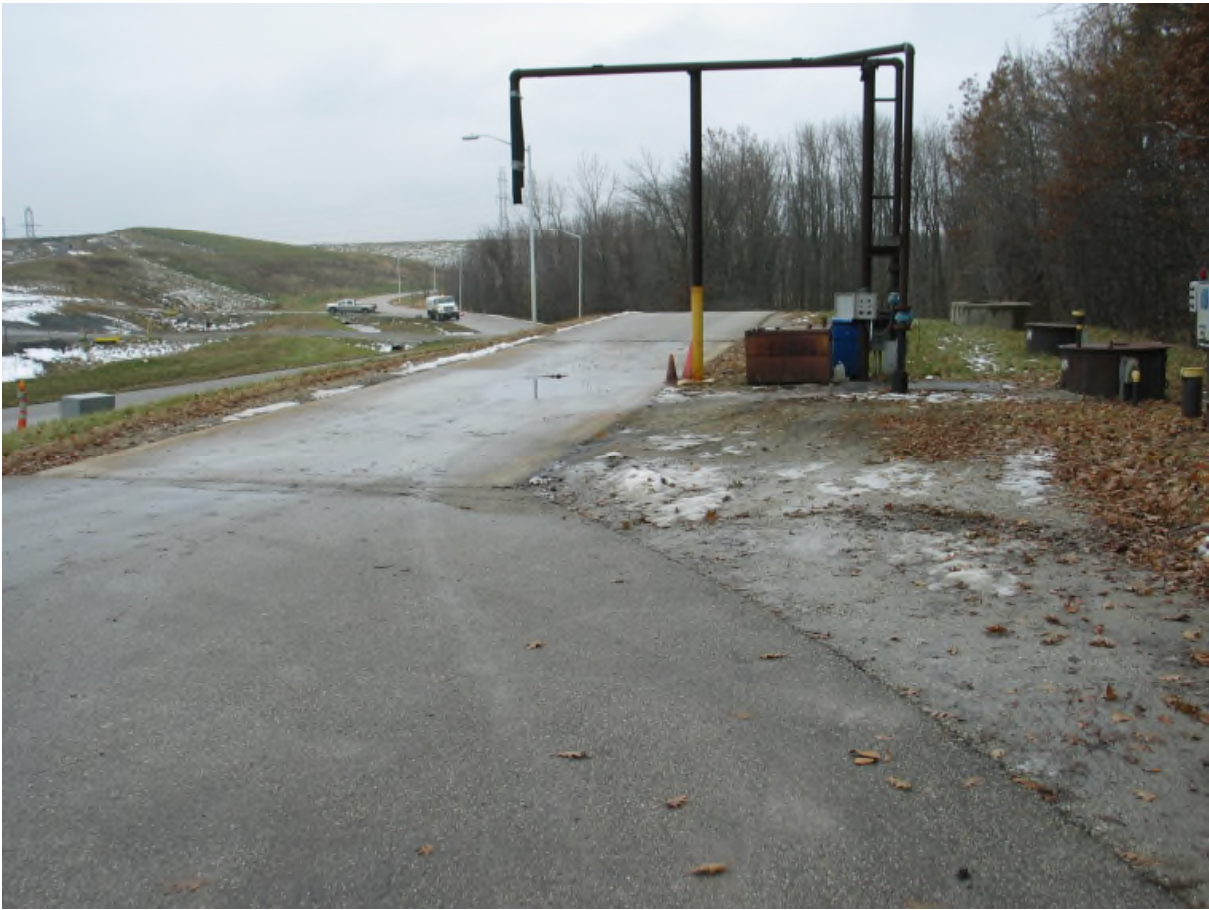
Leachate load-out (looking south)

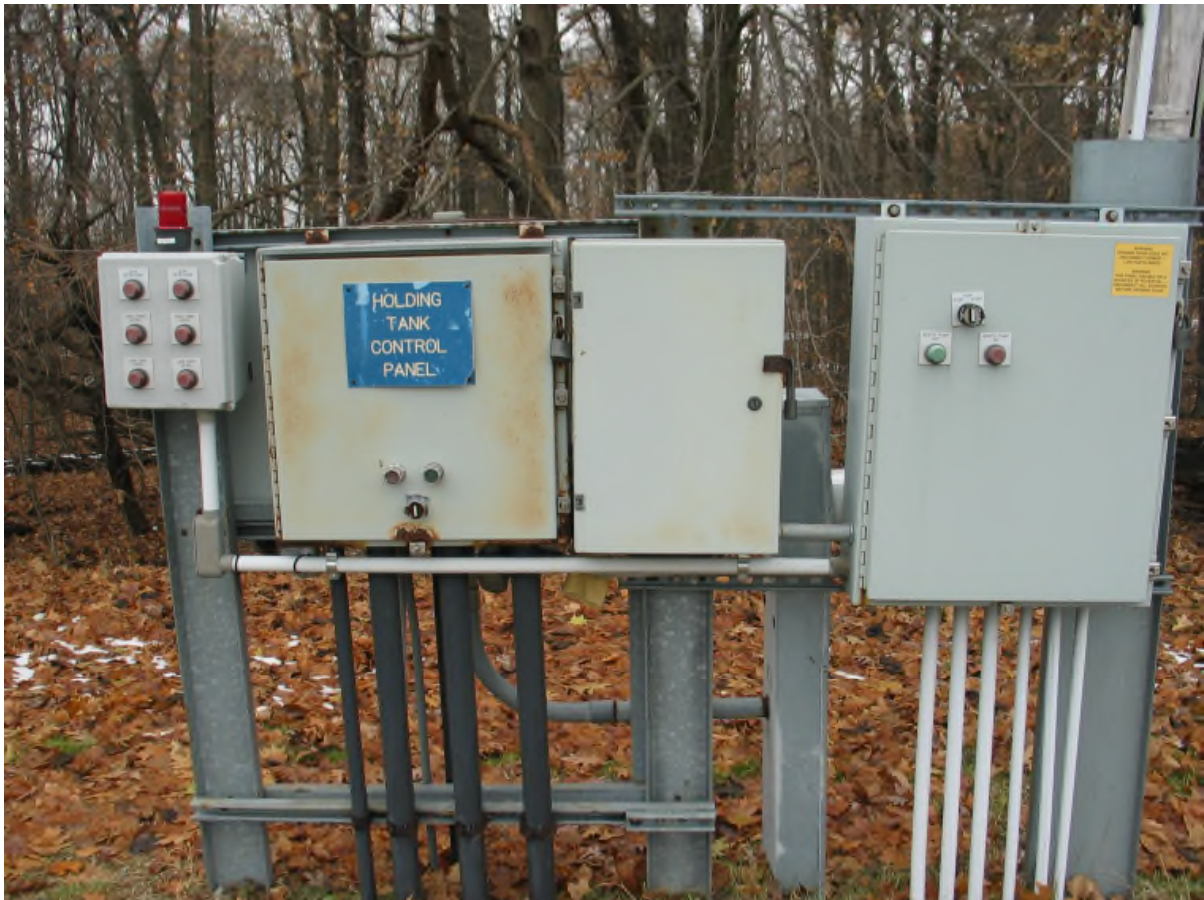
Leachate load-out controls

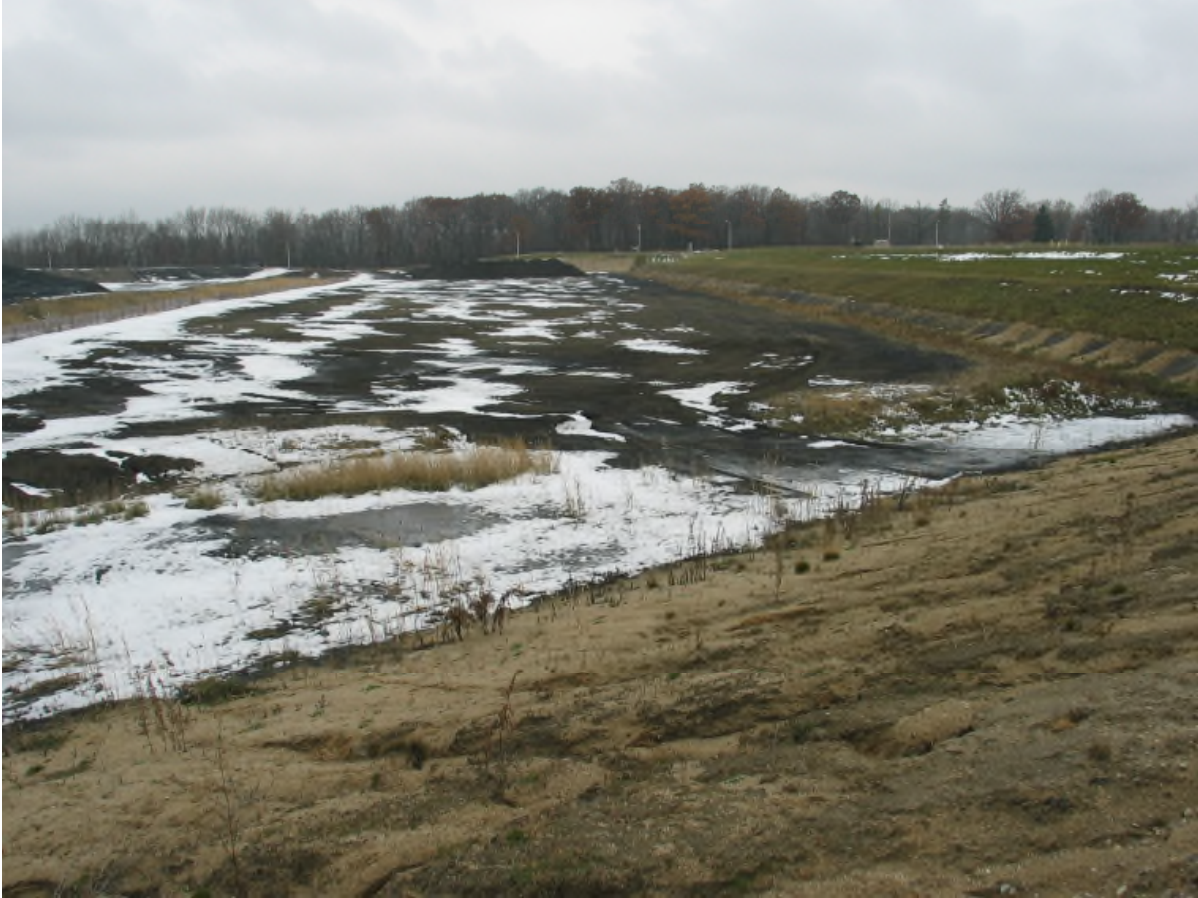
Bottom ash storage area Cell 10 (looking west)

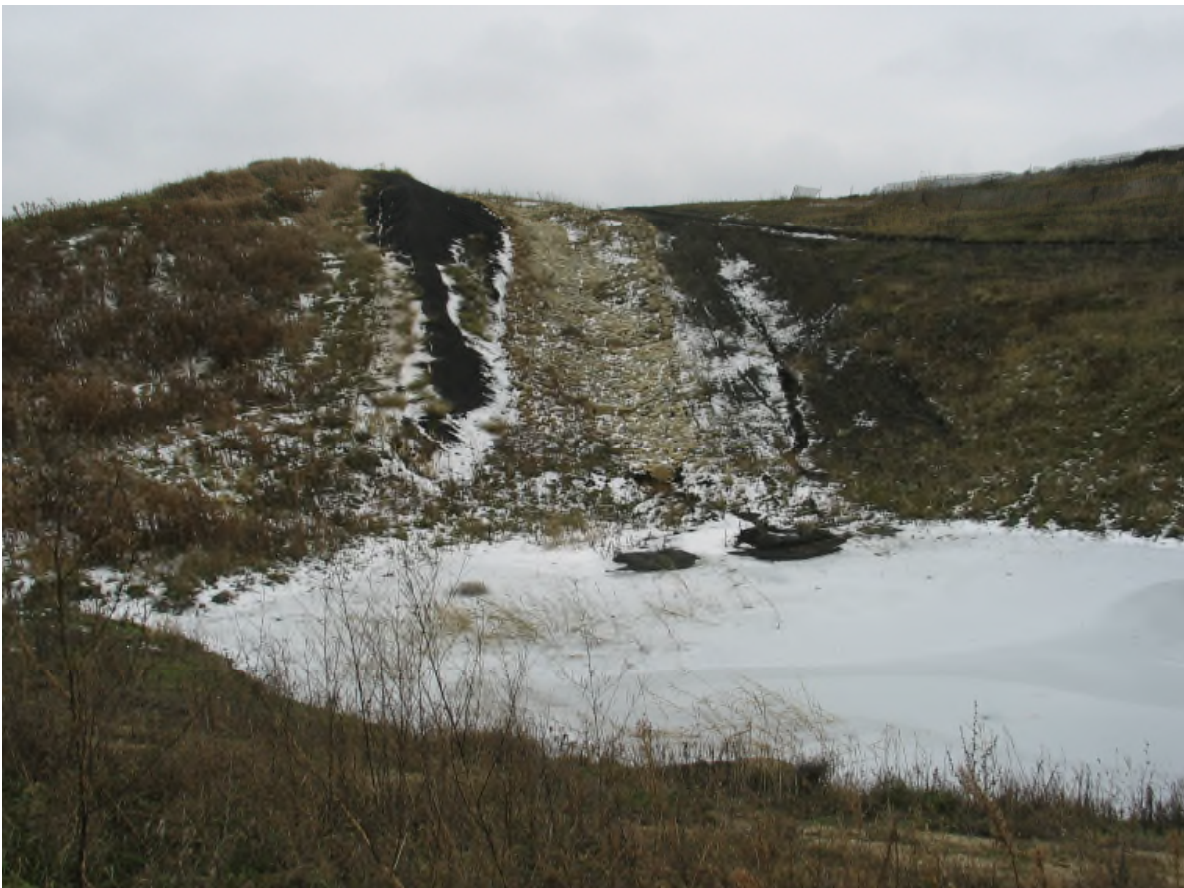
Upper area letdown flume (looking south)

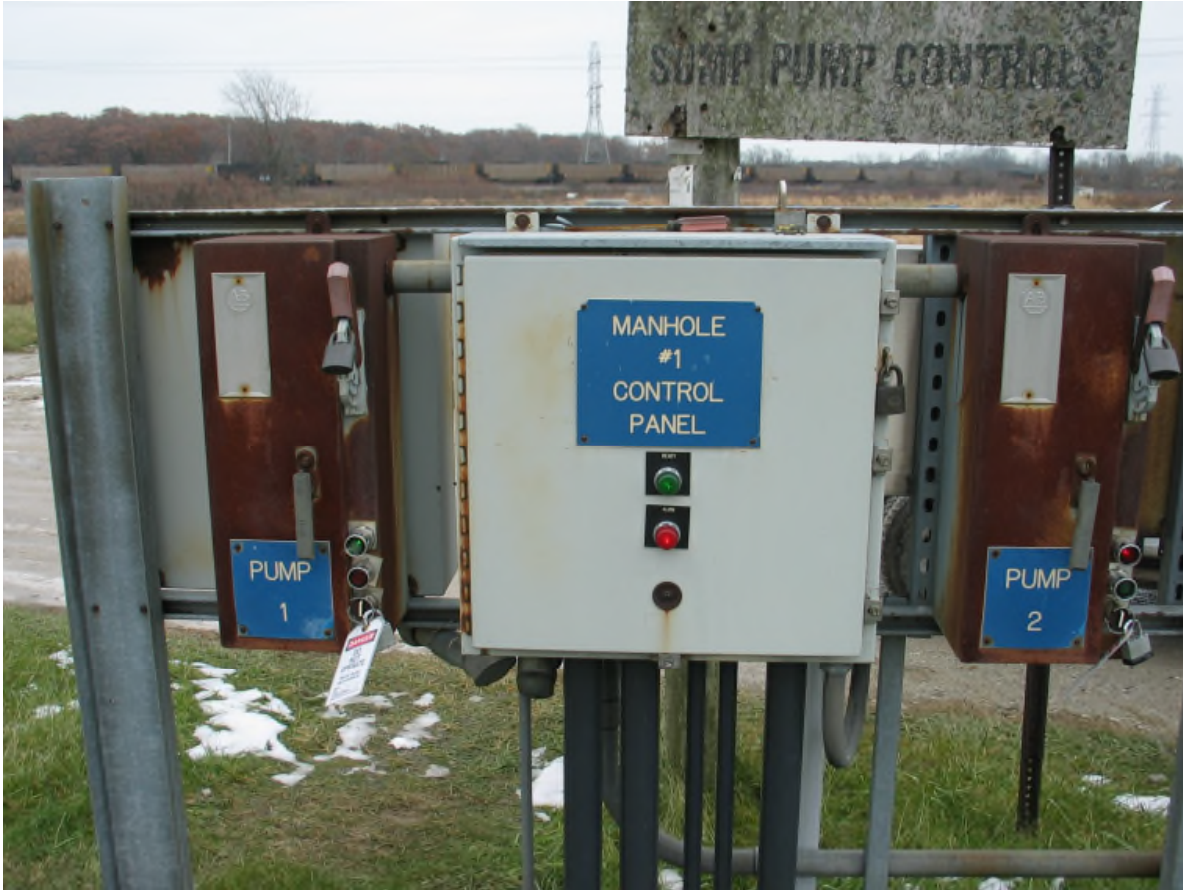
Lift station controls

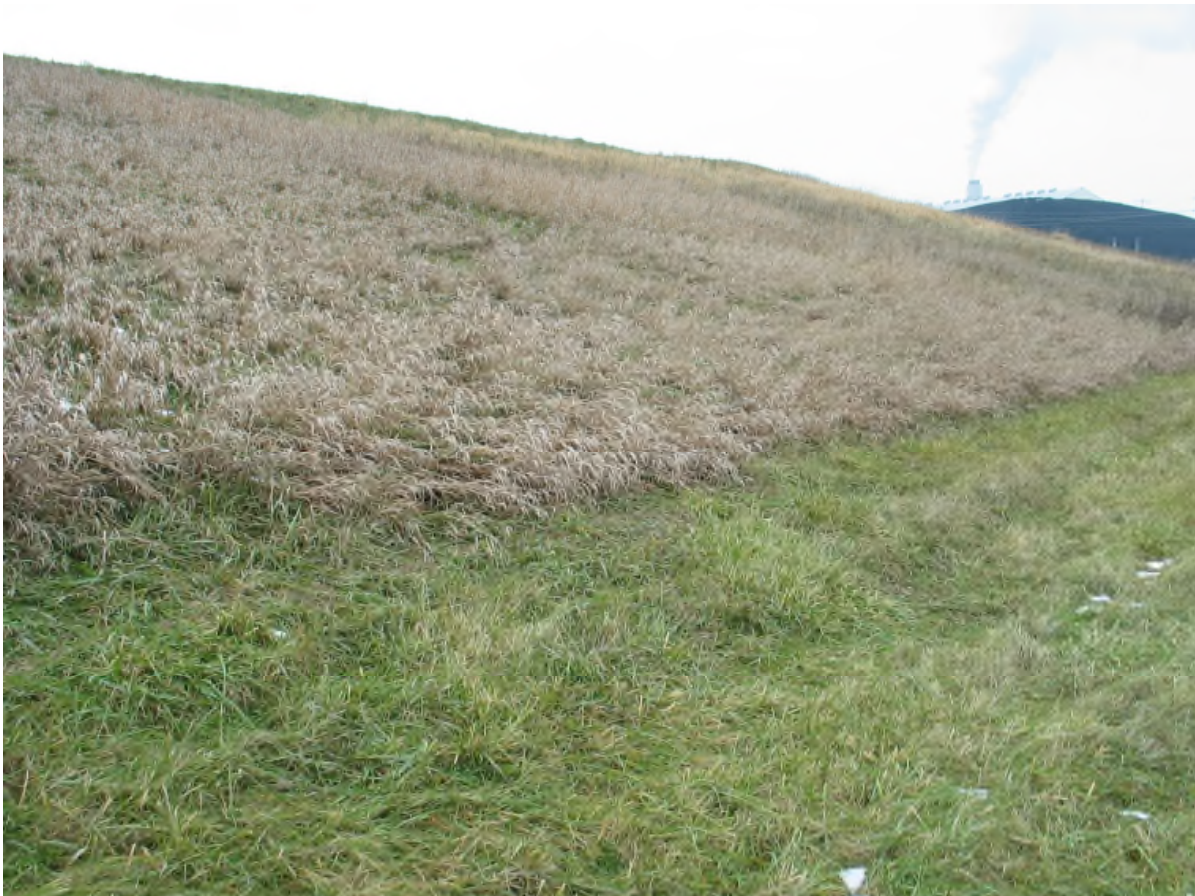
East side final cover (looking northeast)

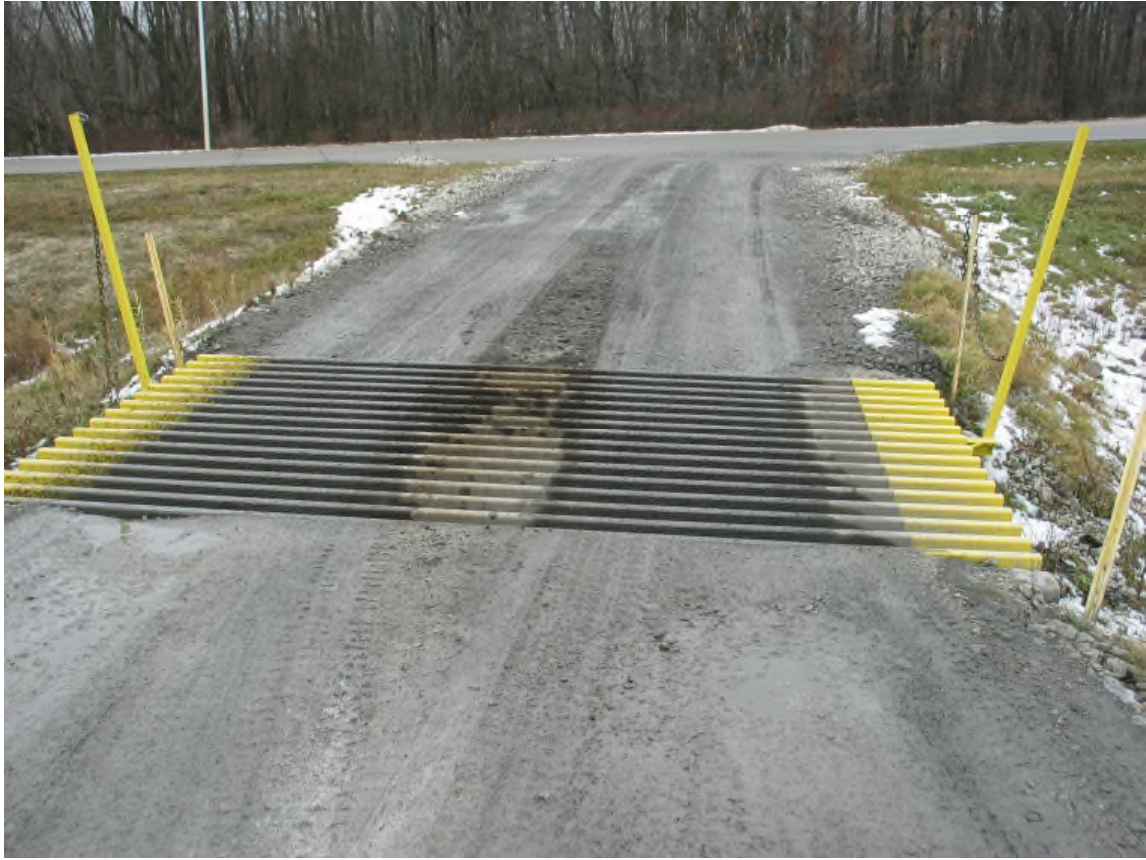
Cell entrance/exit (looking west)

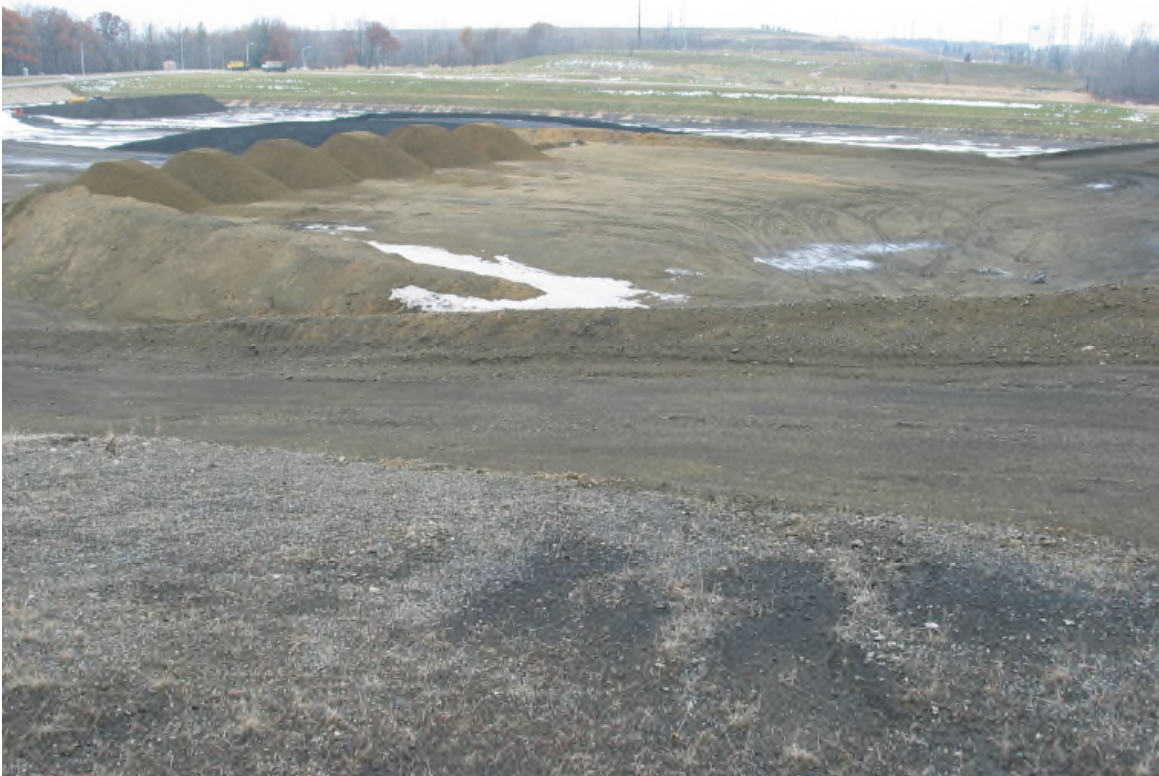
OCPP bottom ash storage area Cell 8 (looking north)
