December 19, 2021
Project 2103691

**Re: Caledonia Ash Landfill Inspection Report
We Energies
Town of Caledonia, Racine County Wisconsin**

CALEDONIA LANDFILL - ANNUAL INSPECTION & CONDITION SUMMARY

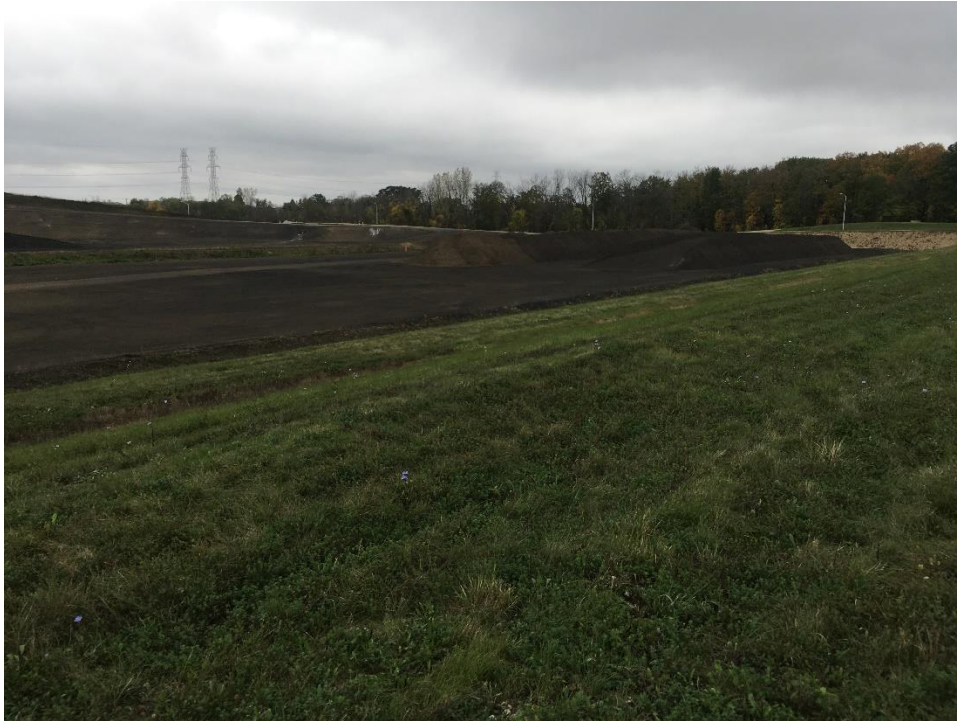
Photo No. 1: North perimeter limit of Cell 10 looking southwest on 10/12/2021

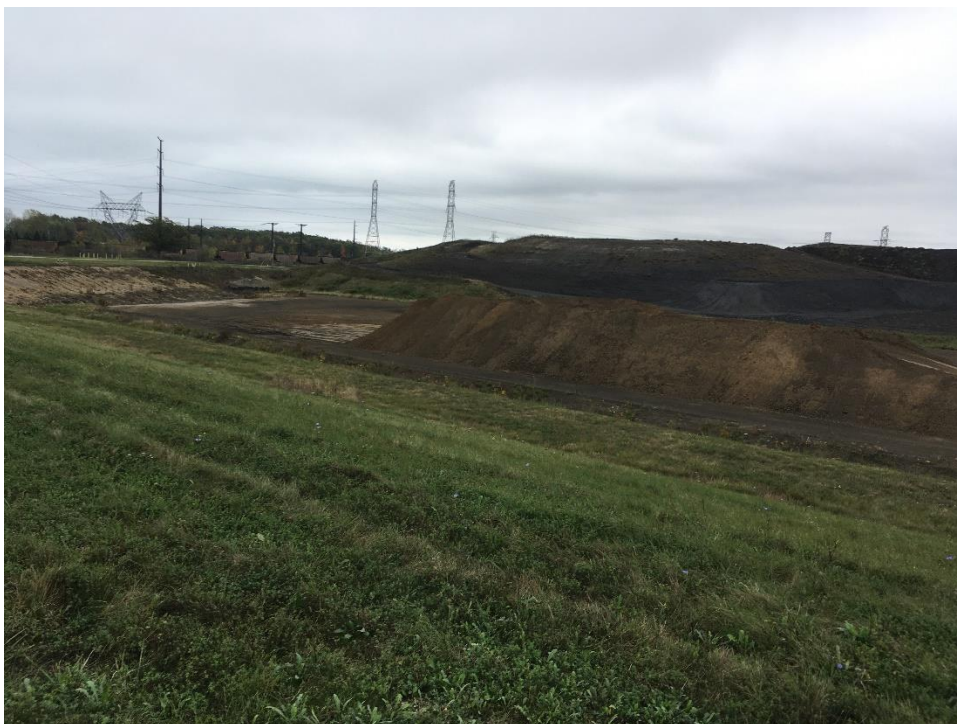
Photo No. 2: North perimeter limit of Cell 10 looking southeast on 10/12/2021

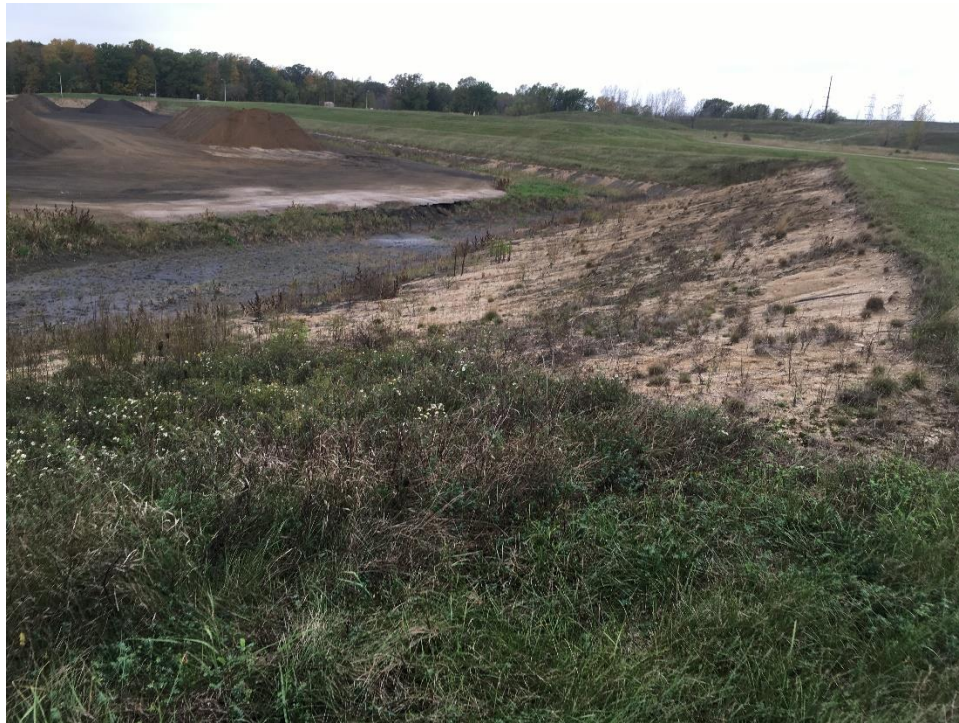
Photo No. 3: East perimeter berm looking north 10/12/2021

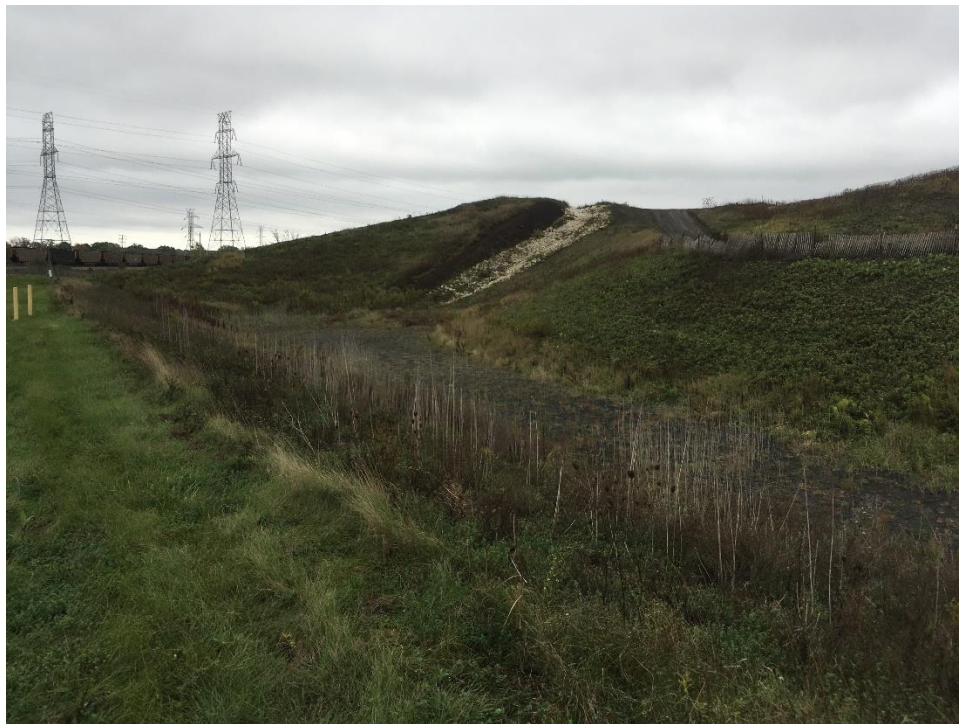
Photo No. 4: East perimeter berm looking south 10/12/2021

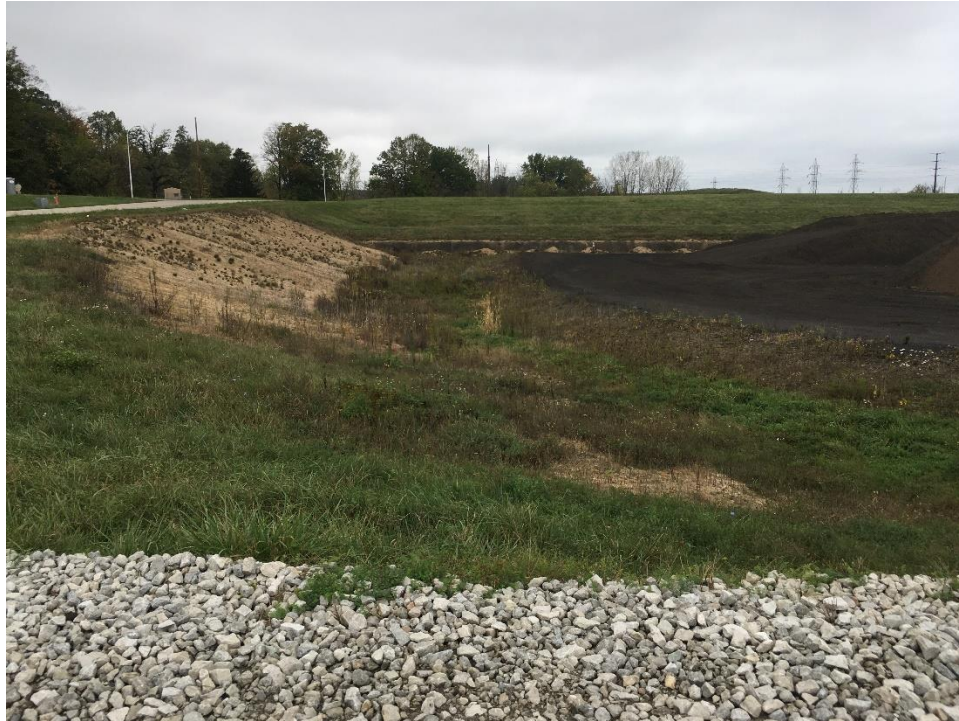
Photo No. 5: West interior slope of Cell 10 looking north on 10/12/2021

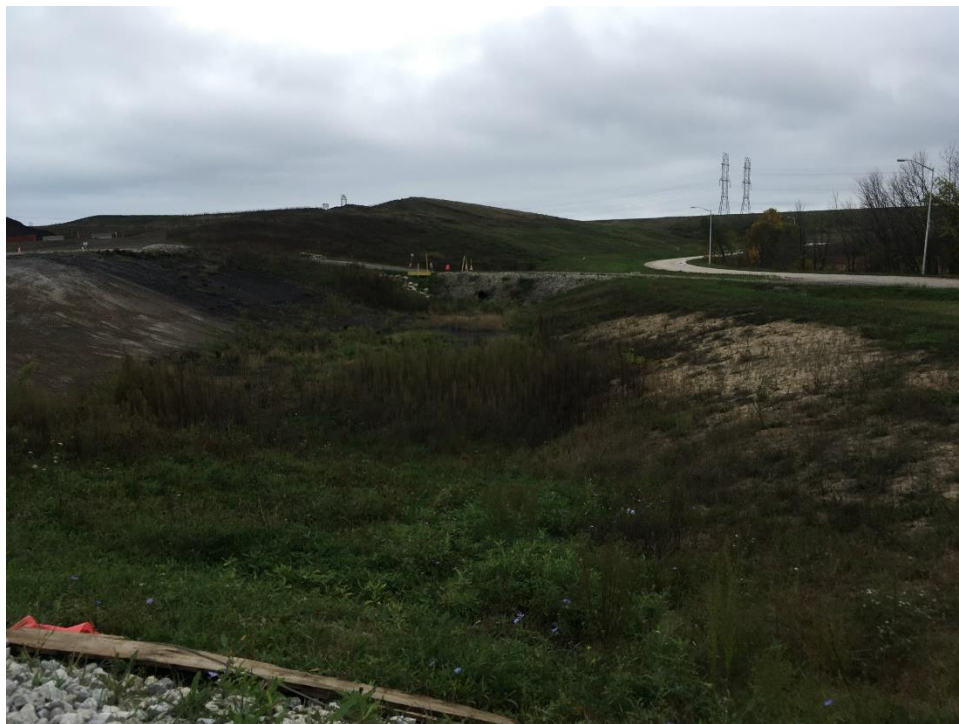
Photo No. 6: West interior slope looking south 10/12/2021

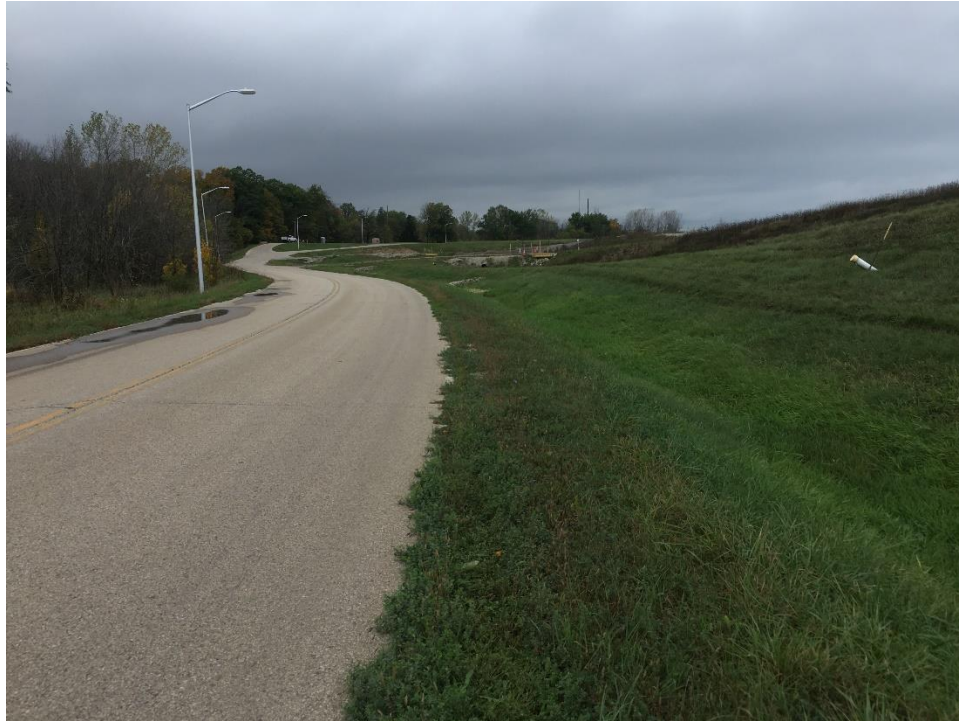
Photo No. 7: West perimeter slope and stormwater ditch looking north 10/12/2021

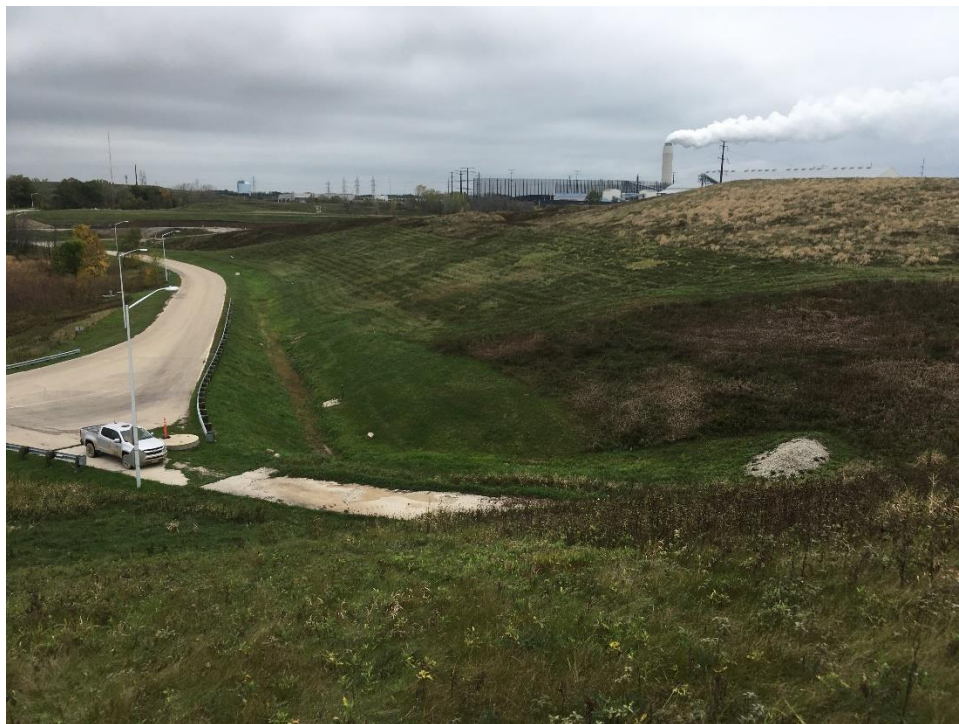
Photo No. 8: West perimeter slope looking north 10/12/2021

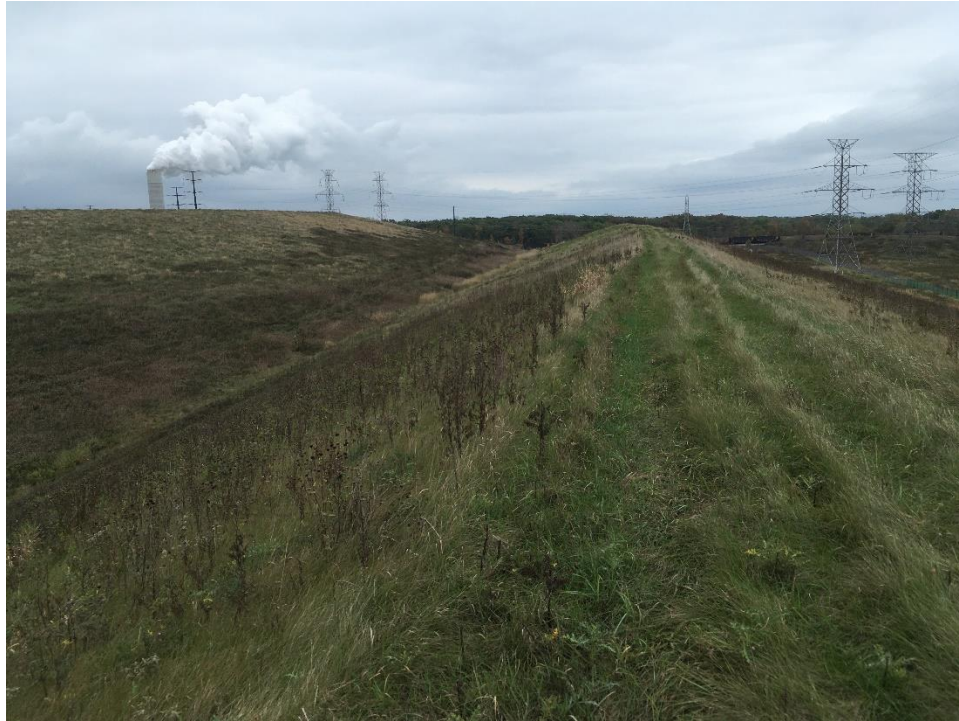
Photo No. 9: South slope of the Caledonia Landfill looking east 10/12/2021

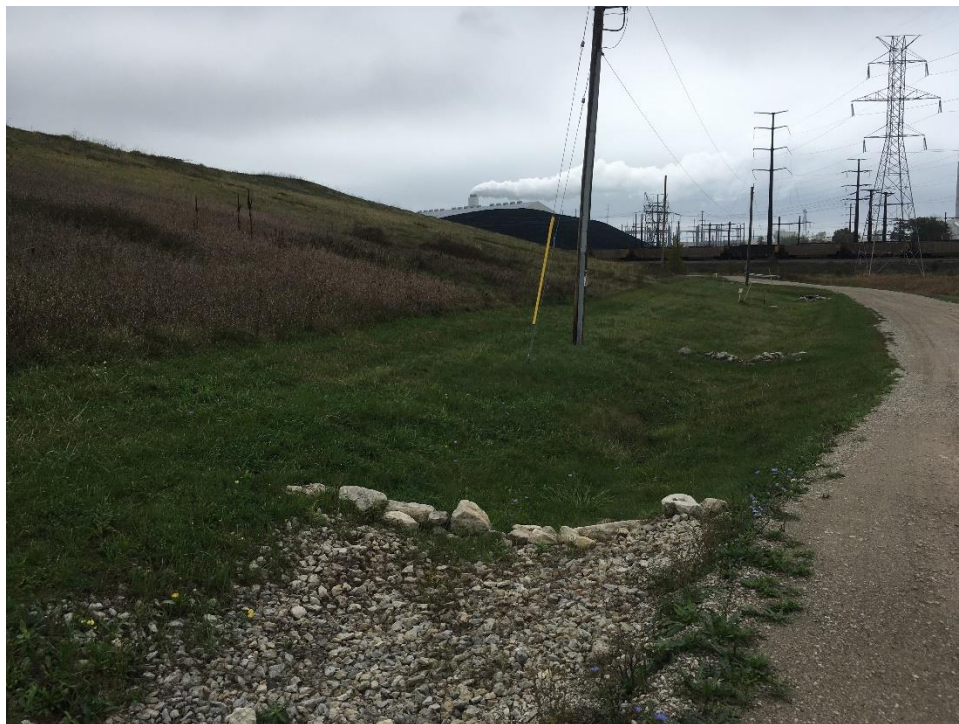
Photo No. 10: East slope of the Caledonia Landfill looking north-northeast 10/12/2021

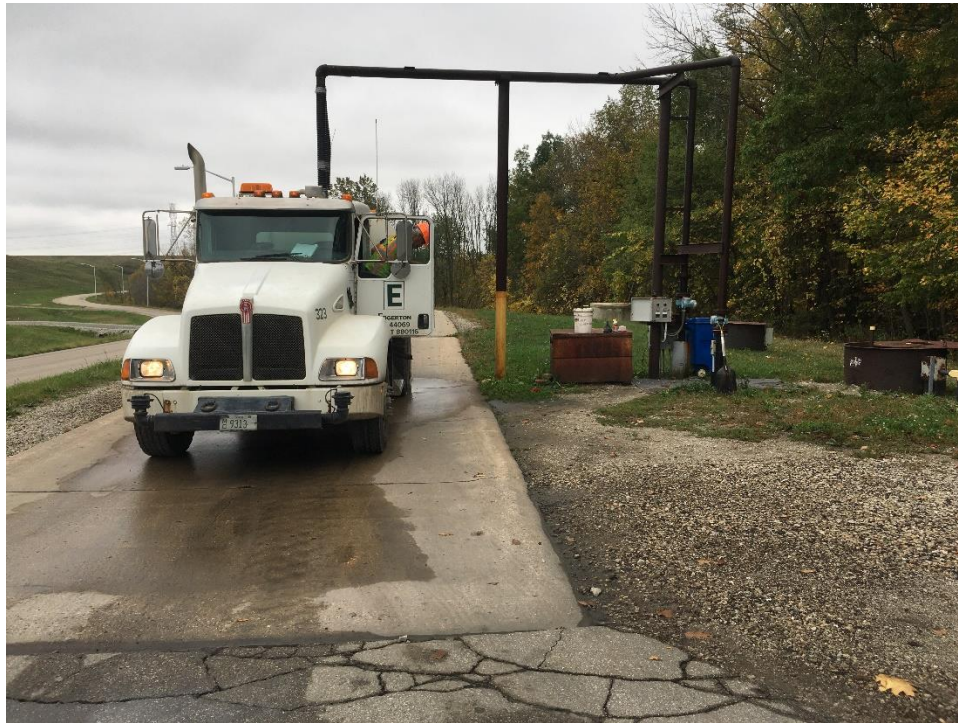
Photo No. 11: Leachate loadout facility looking south 10/12/2021

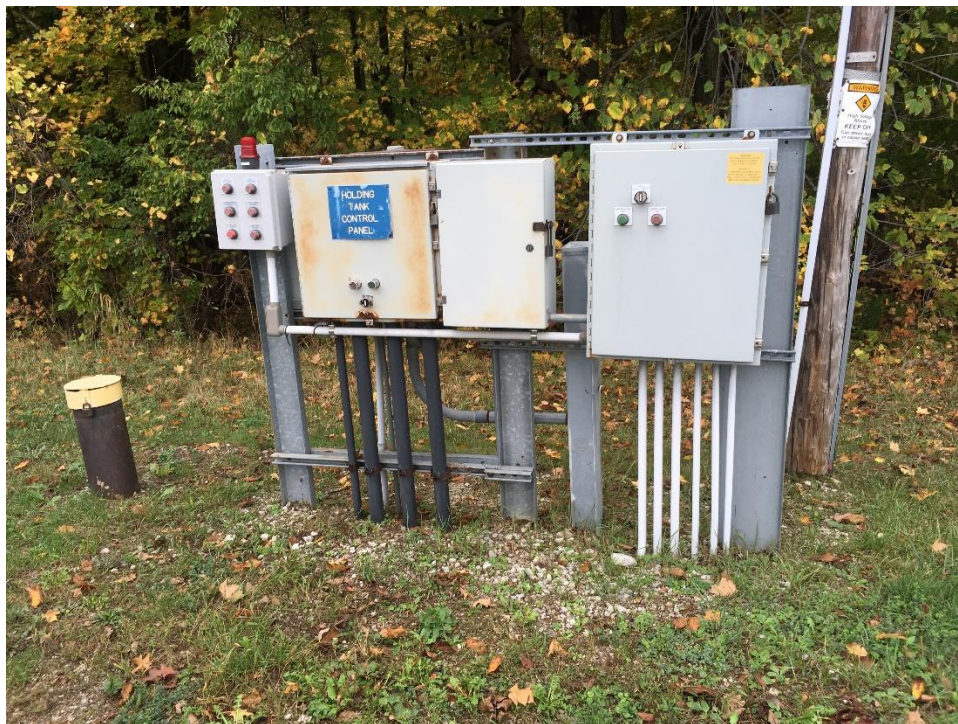
Photo No. 12: Holding tank control panel for leachate loadout facility 10/12/2021
