December 19, 2022
Project 2103691

**Re: Caledonia Ash Landfill Inspection Report
We Energies
Town of Caledonia, Racine County Wisconsin**

WEC Caledonia Landfill CCR Inspection

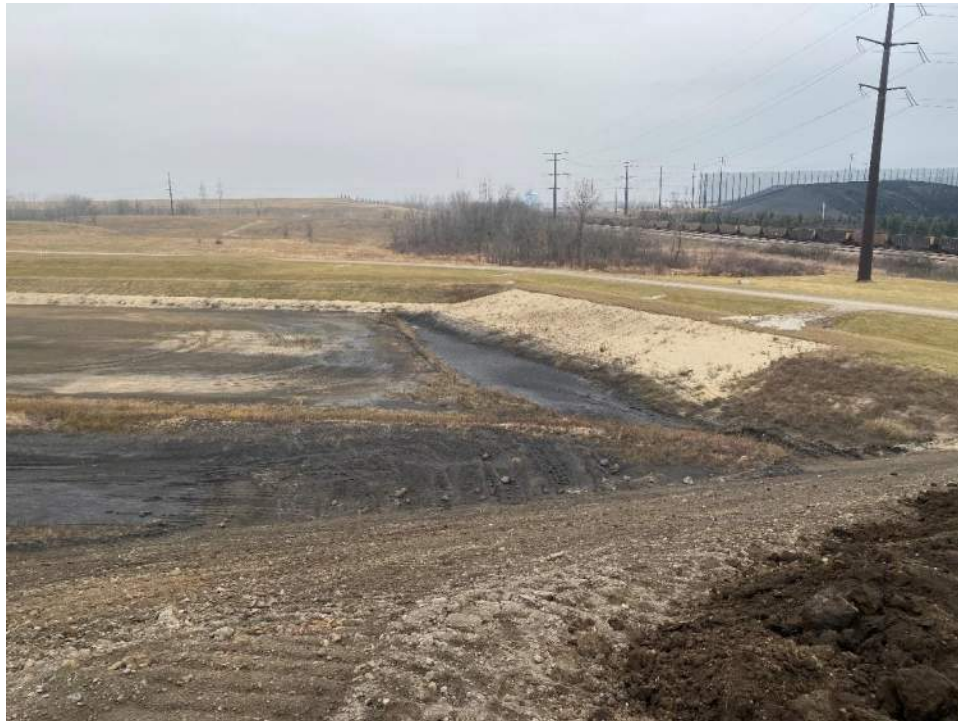
Photo No. 1: East interior berm of Cell 10 looking north 12/07/2022

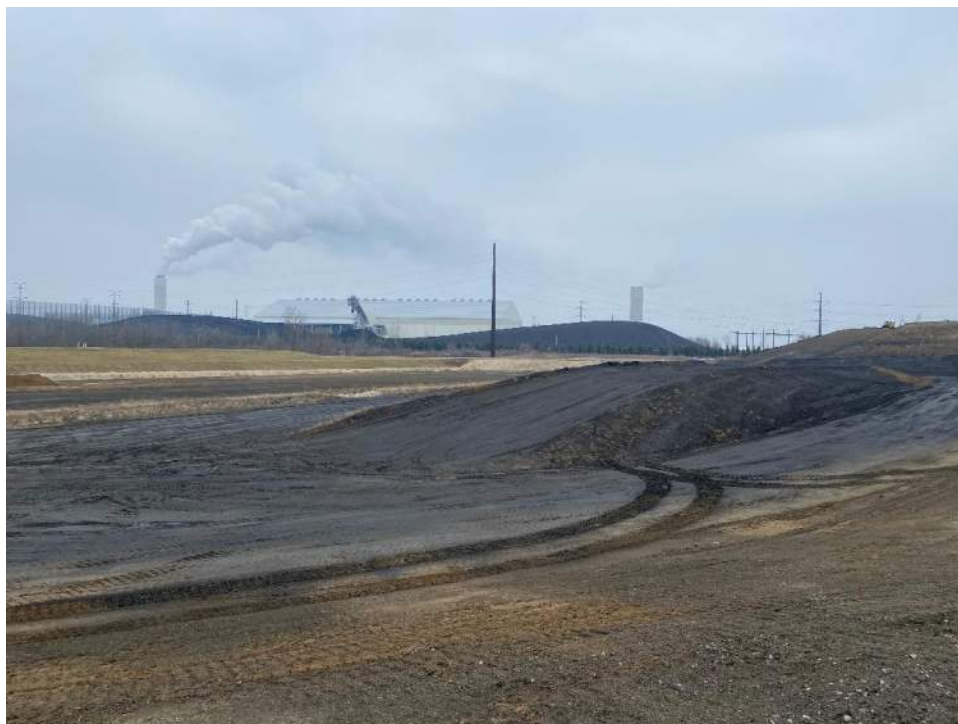
Photo No. 2: Bottom ash stockpiled for beneficial use inside Cell 10 looking west on 12/07/2022

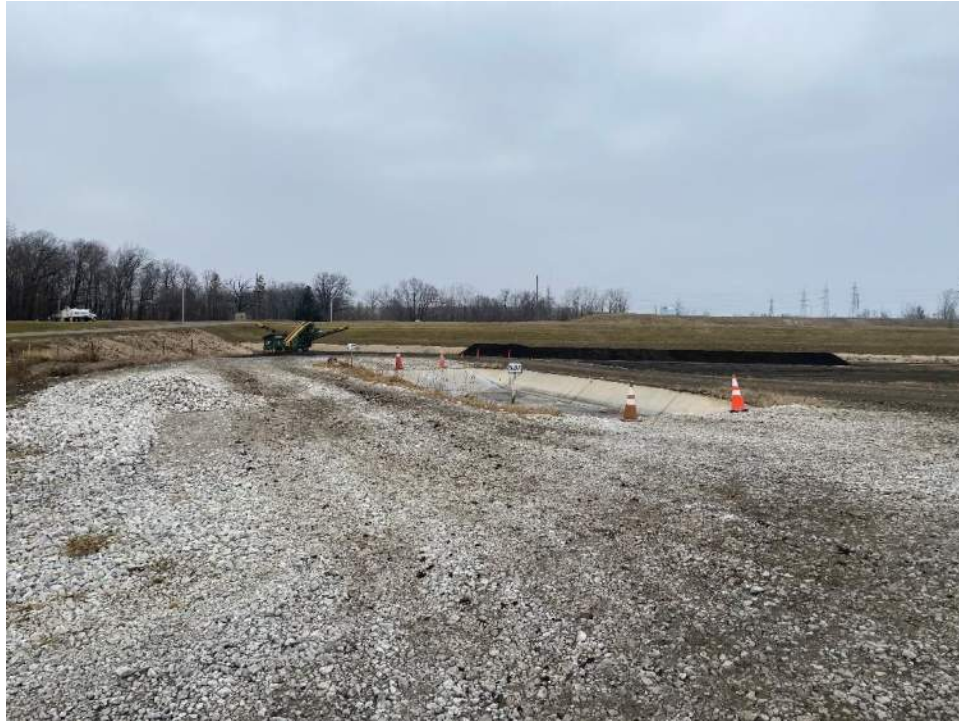
Photo No. 3: Tire wash in Cell 8 looking north on 12/07/2022

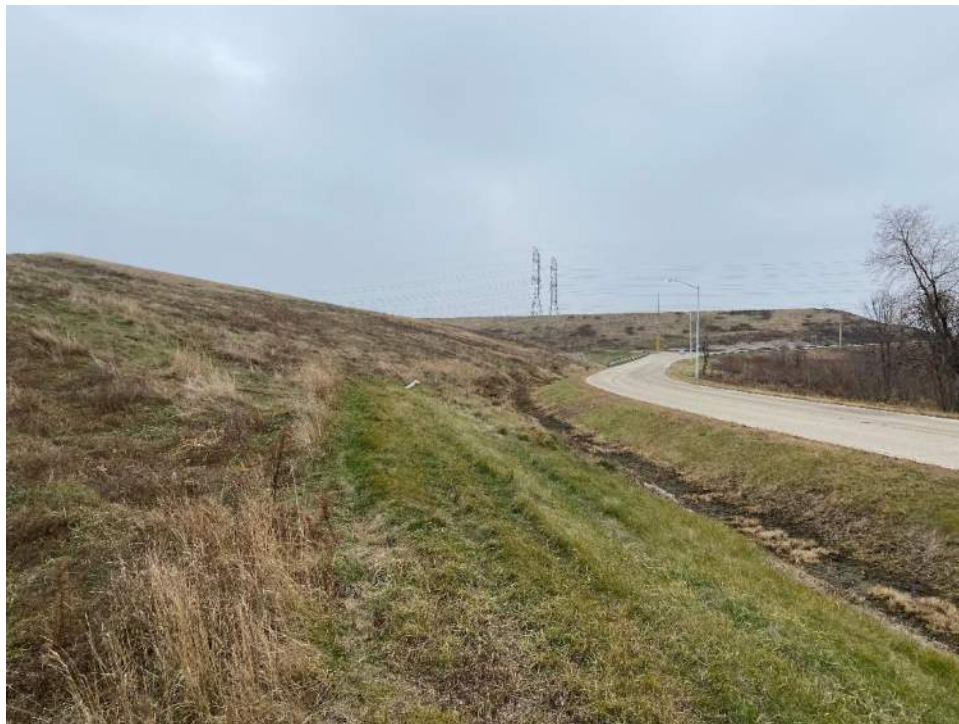
Photo No. 4: West perimeter berm looking south 12/07/2022

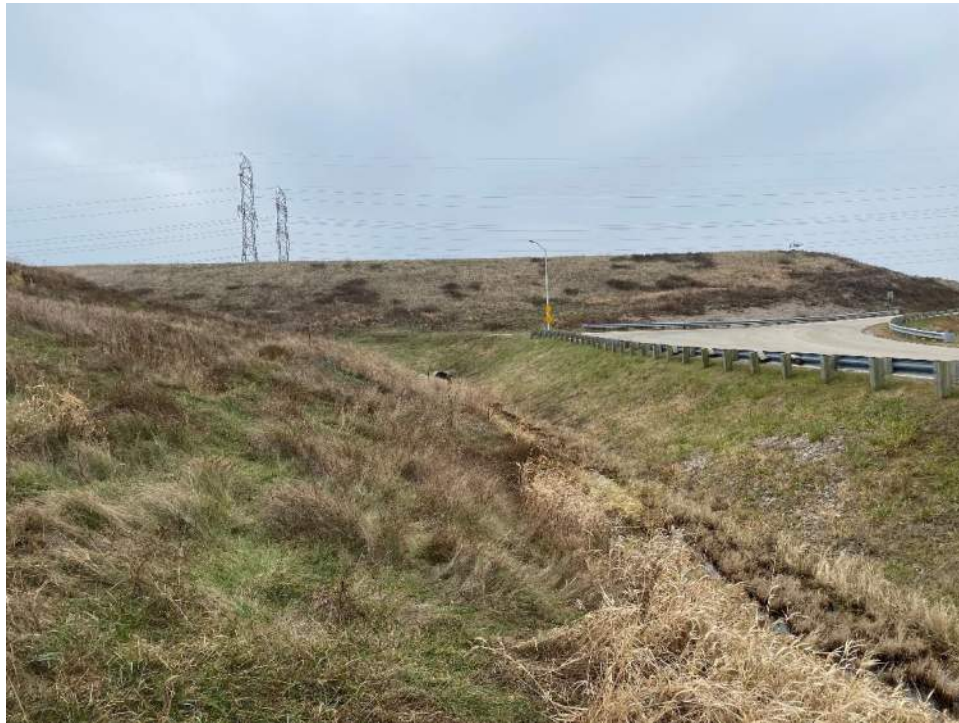
Photo No. 5: West perimeter berm looking south 12/07/2022

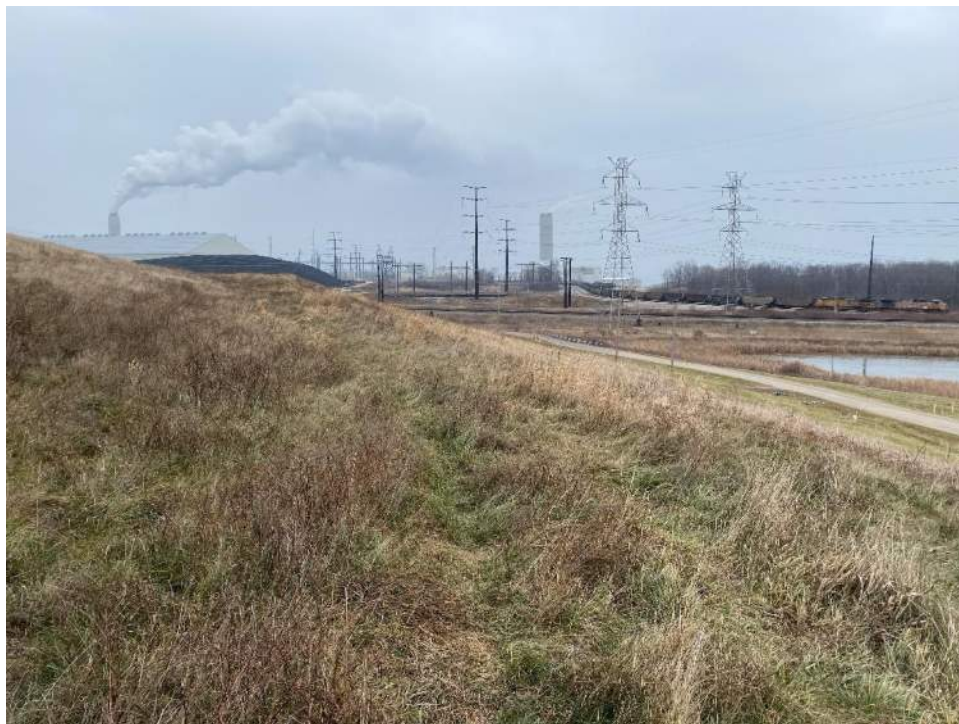
Photo No. 6: South perimeter berm looking east on 12/07/2022

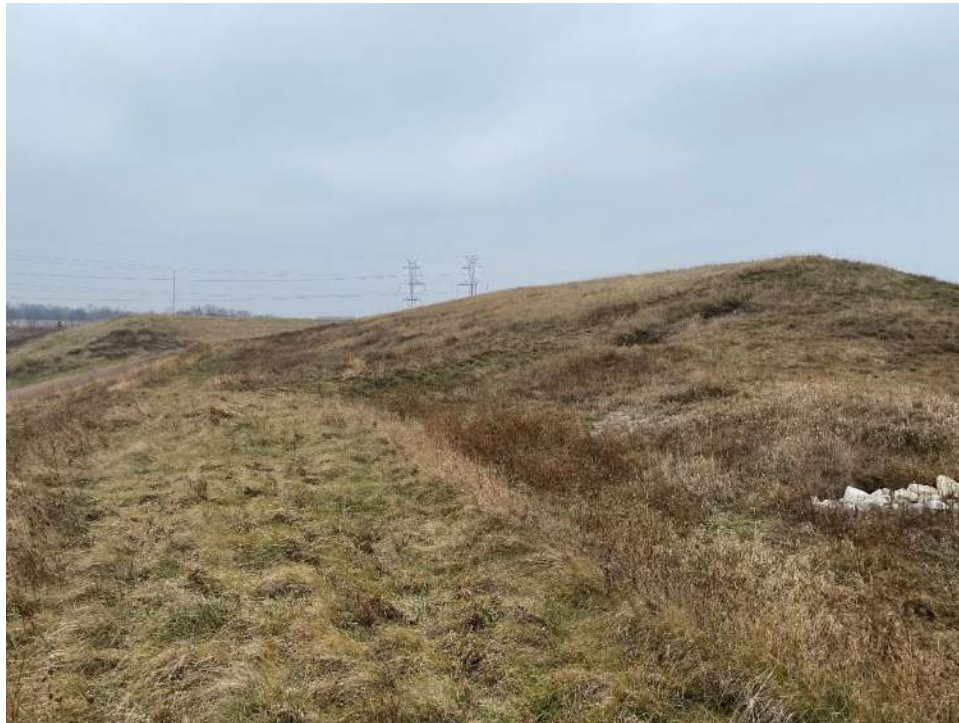
Photo No. 7: East perimeter berm looking south 12/07/2022

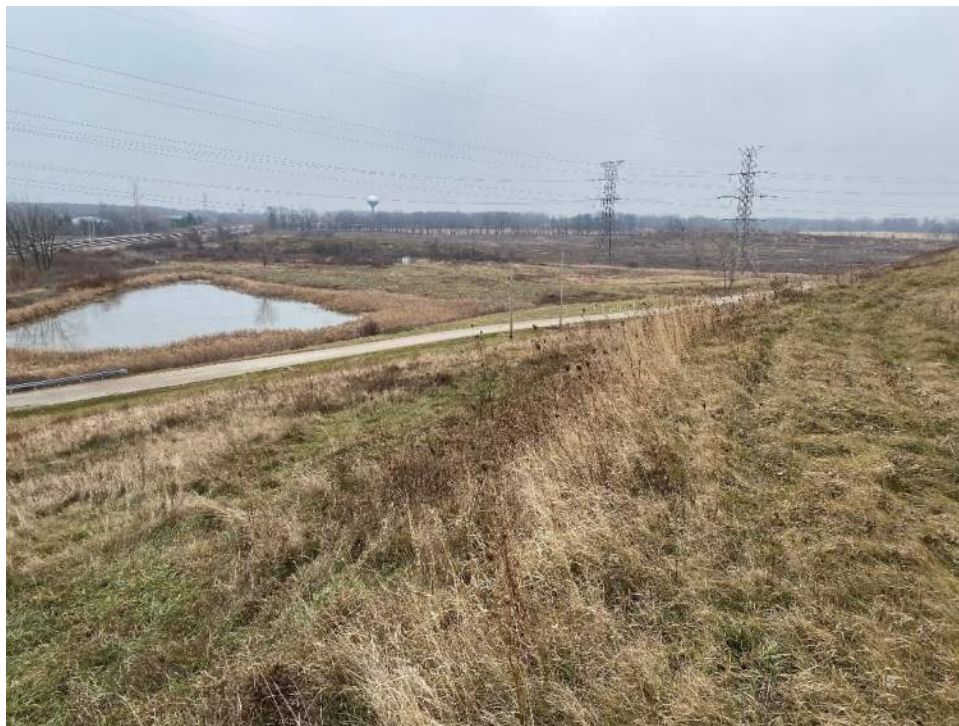
Photo No. 8: East perimeter berm looking south 12/07/2022
