December 19, 2023  
Project 2103691

**Re: 2023 Landfill Inspection Report  
Caledonia Ash Landfill  
We Energies  
Town of Caledonia, Racine County Wisconsin**

# Caledonia Ash Landfill CCR Inspection –

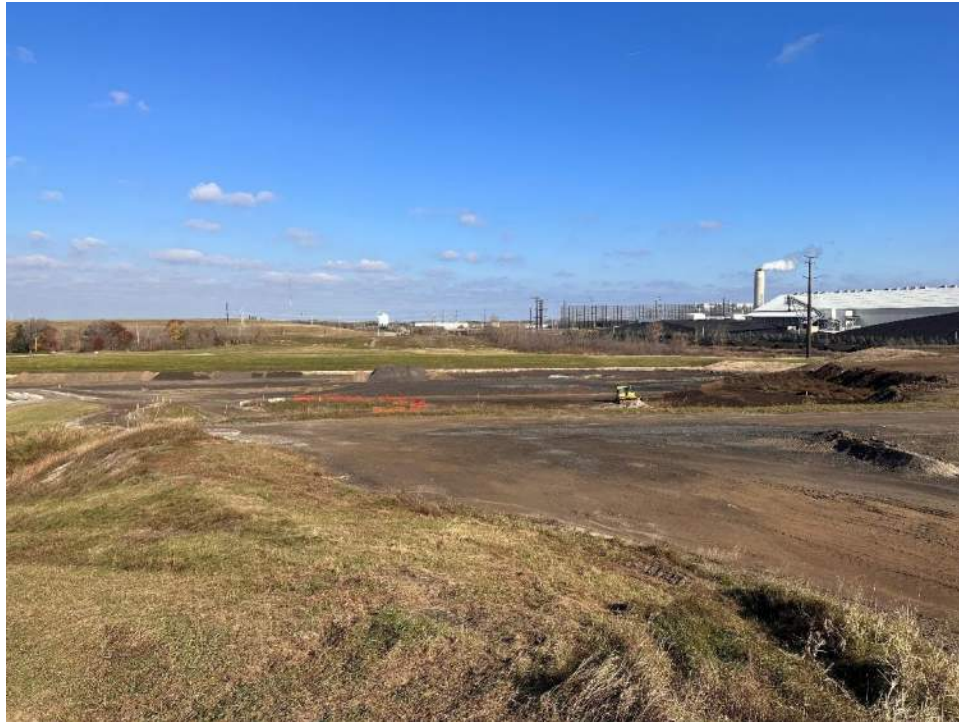
Photo No. 1 – Looking north at active cells.

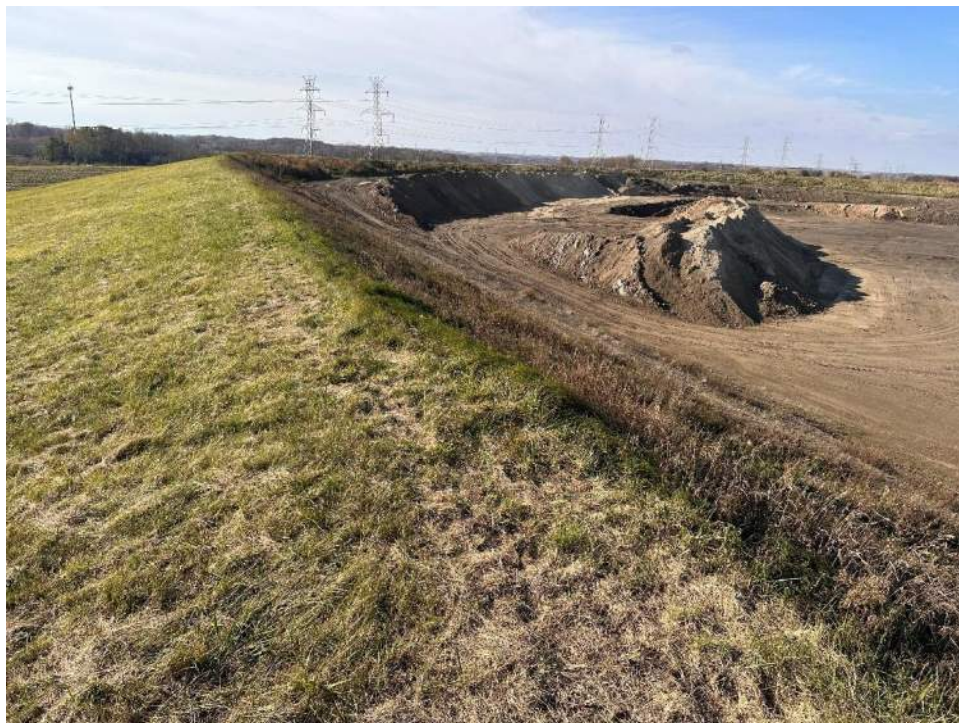
Photo No. 2 – Stockpiled CCR inside Cell 2.

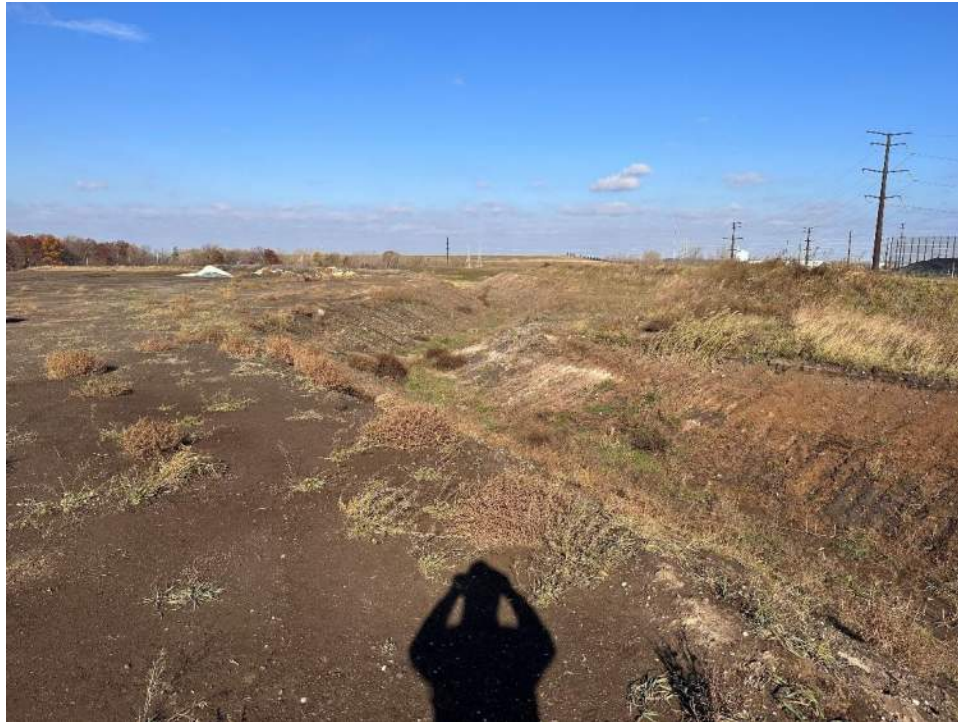
Photo No. 3 – Leachate collection ditch behind Cell 6 and 8 partial cover.

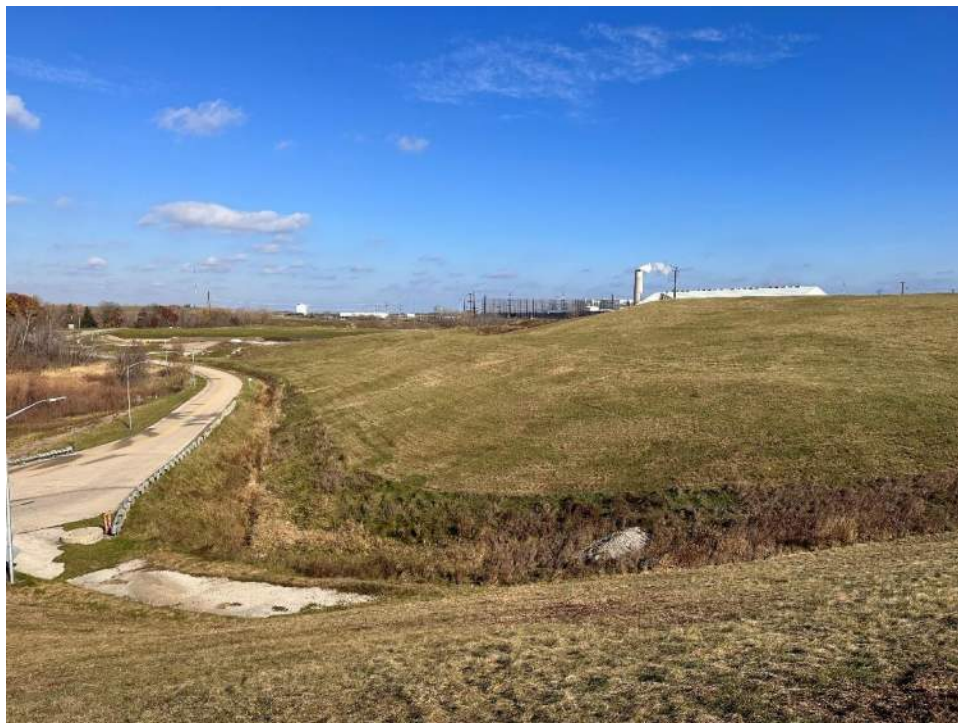
Photo No. 4 – West perimeter berm and stormwater collection ditch, looking north.

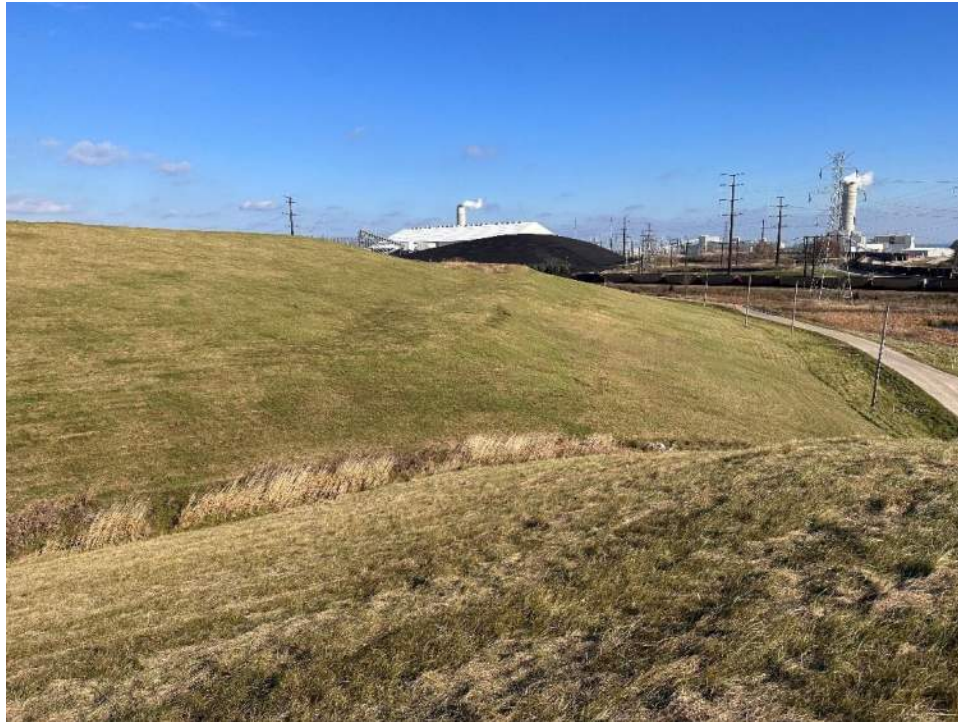
Photo No. 5 – South perimeter berm looking northeast.

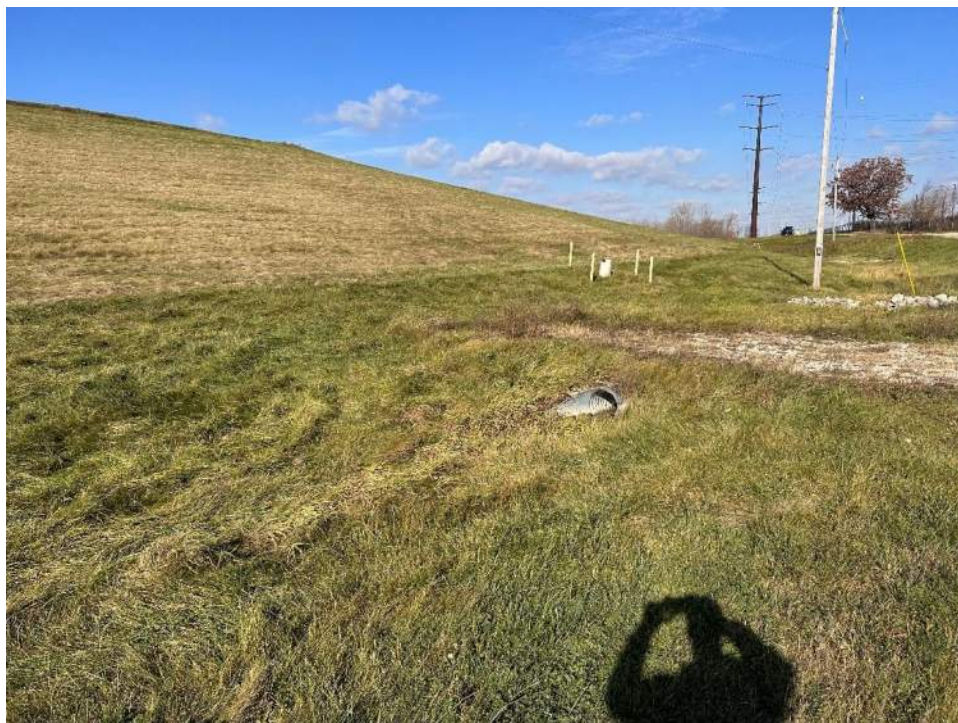
Photo No. 6 – East perimeter berm and stormwater ditch, looking north.

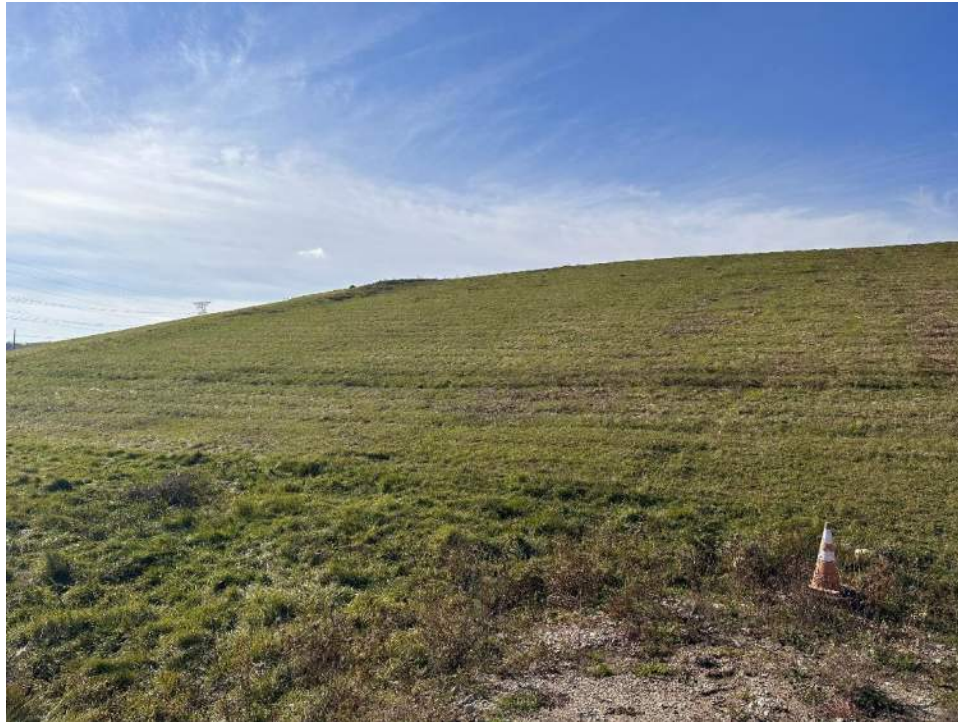
Photo No. 7 – Vegetation on Cell 6 and 8 perimeter slope.

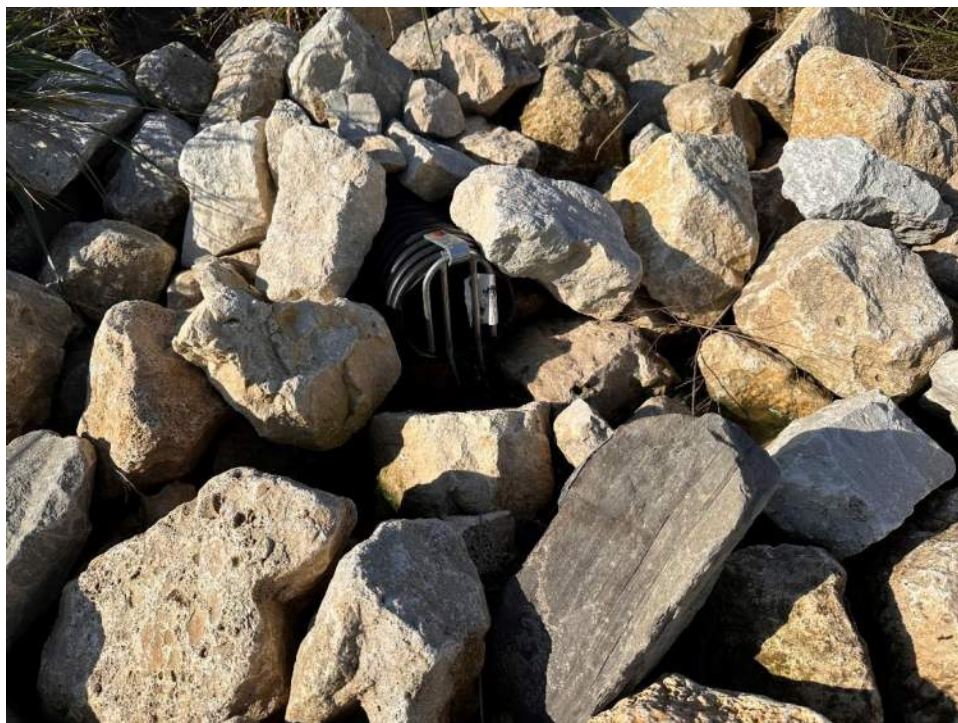
Photo No. 8 – Cover drain outlet at the toe of the Cell 6 and 8 slope.

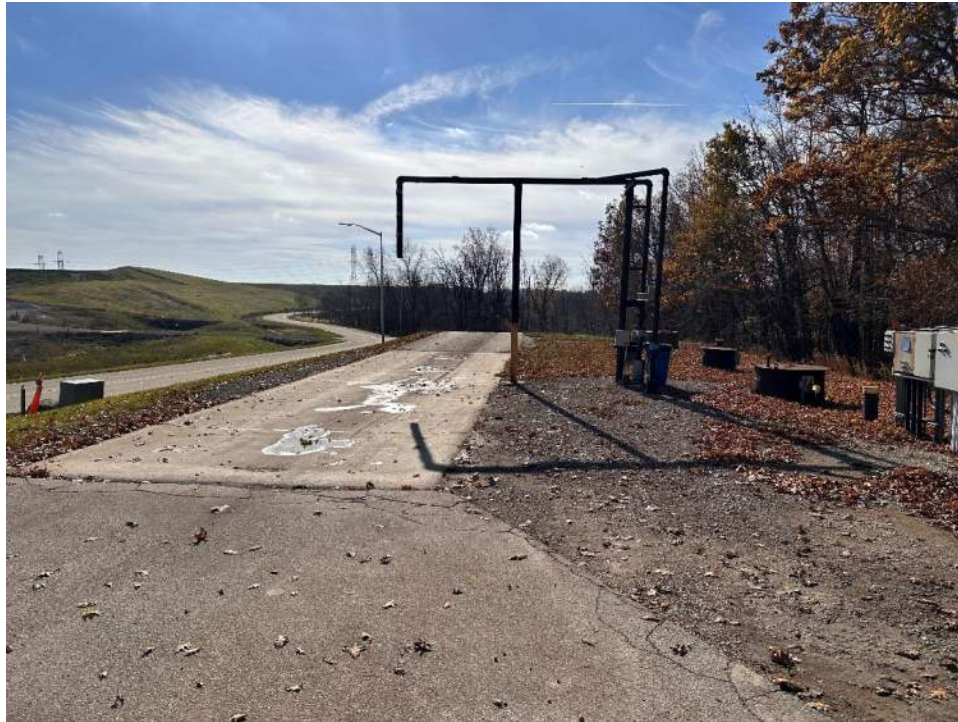
Photo No. 9 – Leachate load-out facility.

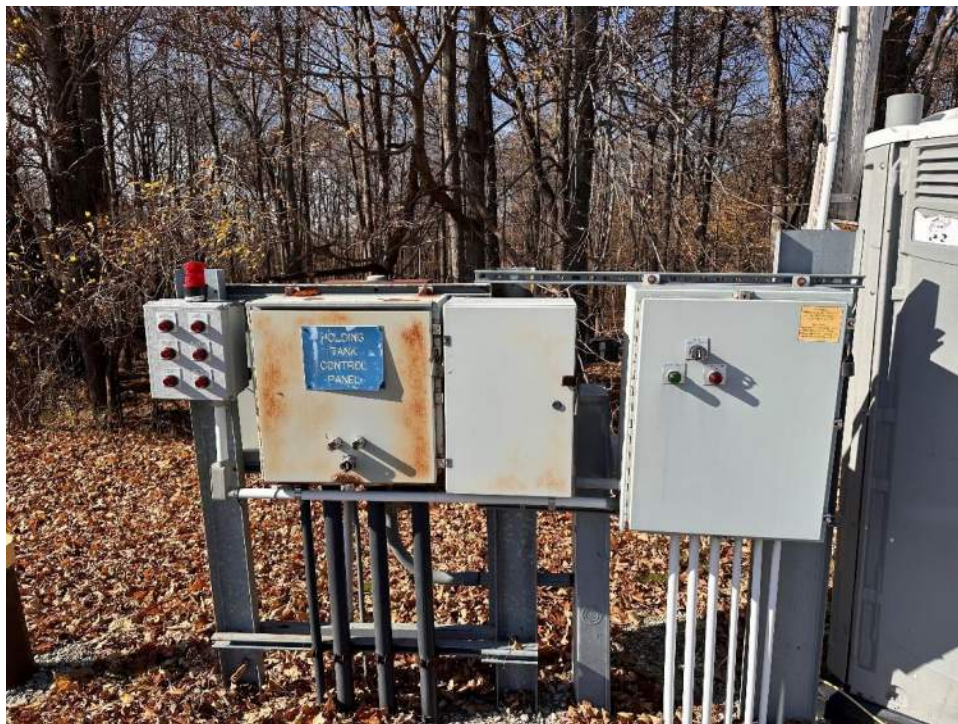
Photo No. 10 – Leachate tank control panel.

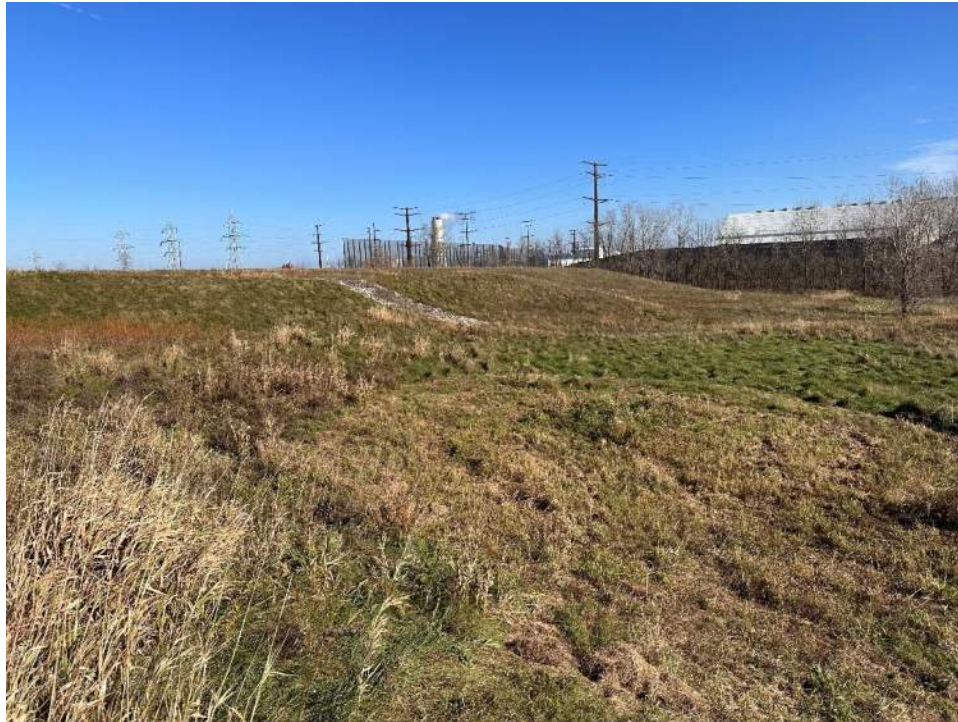
Photo No. 11 – Fully vegetated cover soil stockpile located north of the landfill.
