December 19, 2025

Project No. 2103691

Re: 2025 Landfill Inspection Report
Caledonia Ash Landfill
We Energies
Town of Caledonia, Racine County, Wisconsin

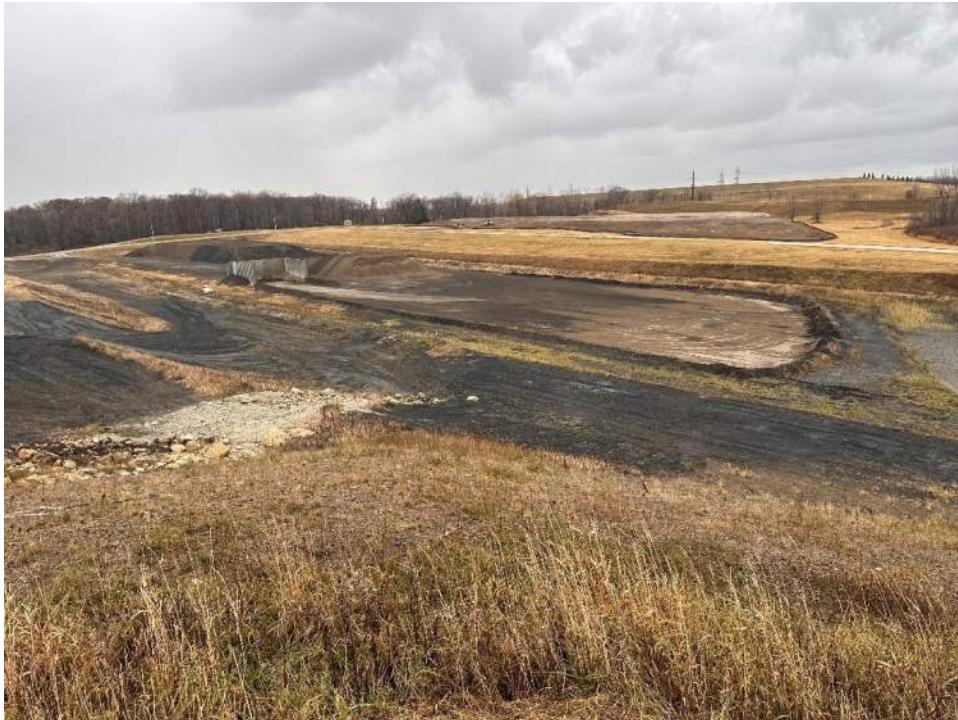
Photo No. 1 – Looking north at active Cells 8 and 10.

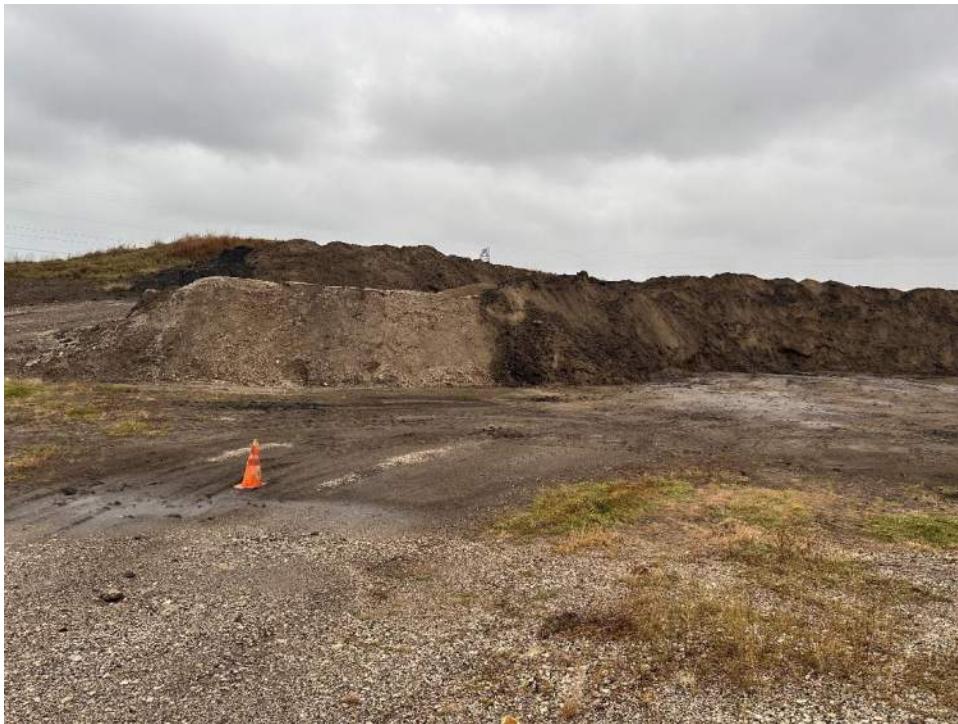
Photo No. 2 – Stockpiled CCR inside Cell 2.

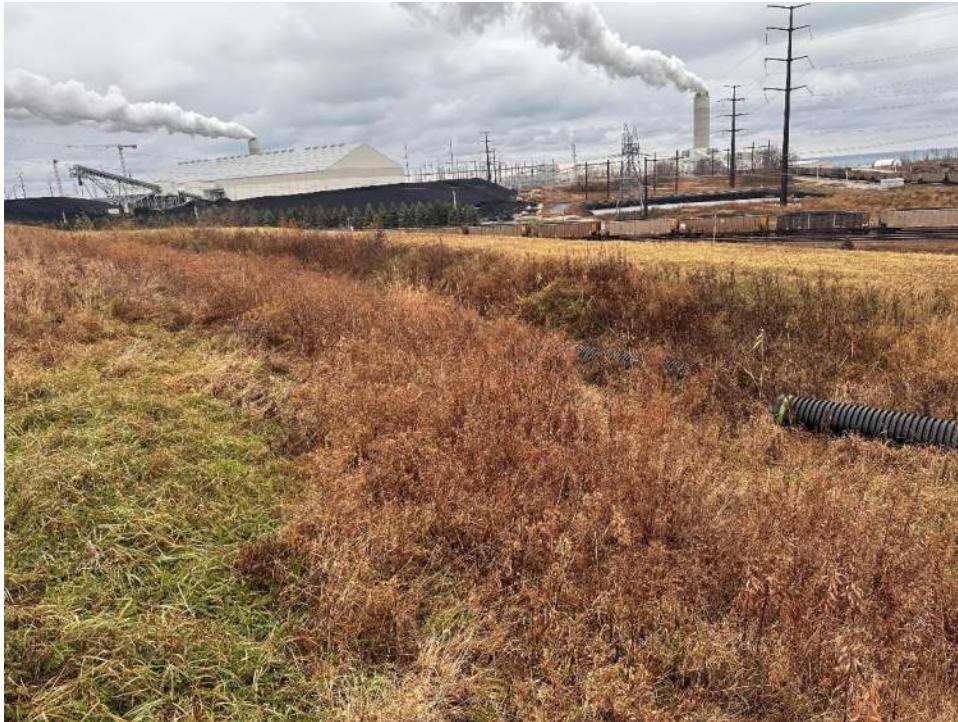
Photo No. 3 – Leachate collection ditch behind Cell 6 and 8 partial cover.

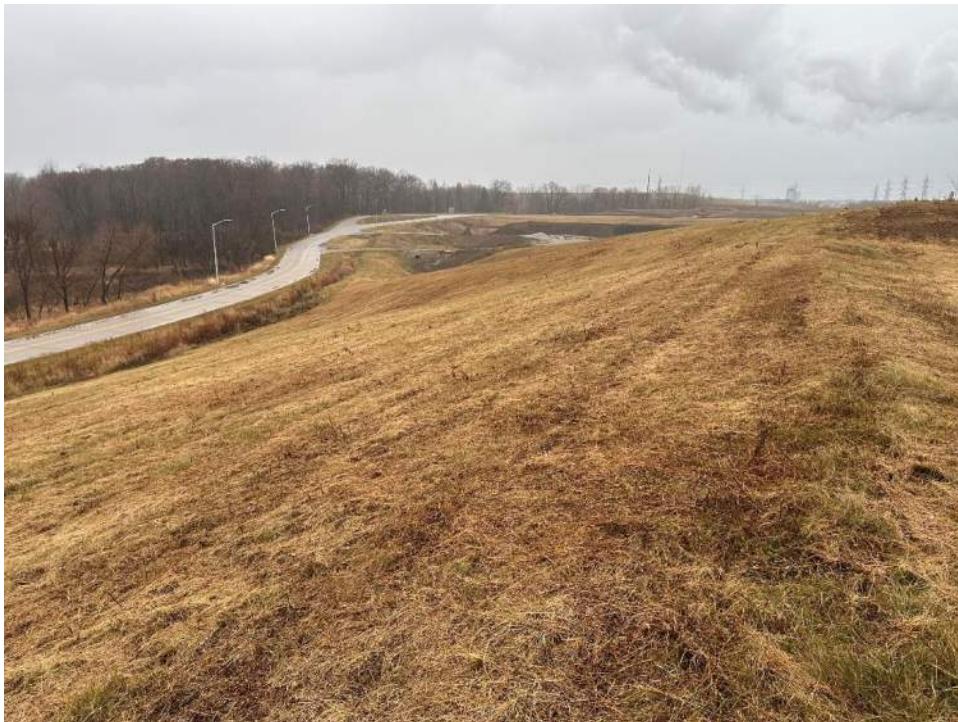
Photo No. 4 – West perimeter berm and stormwater collection ditch, looking north.

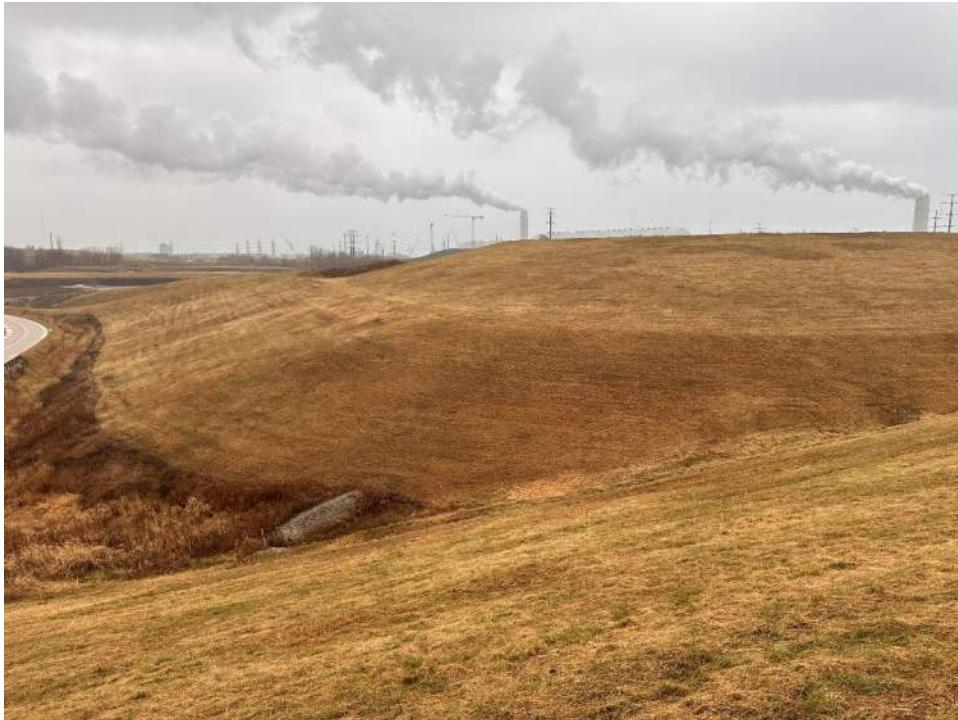
Photo No. 5 – South perimeter berm looking north.

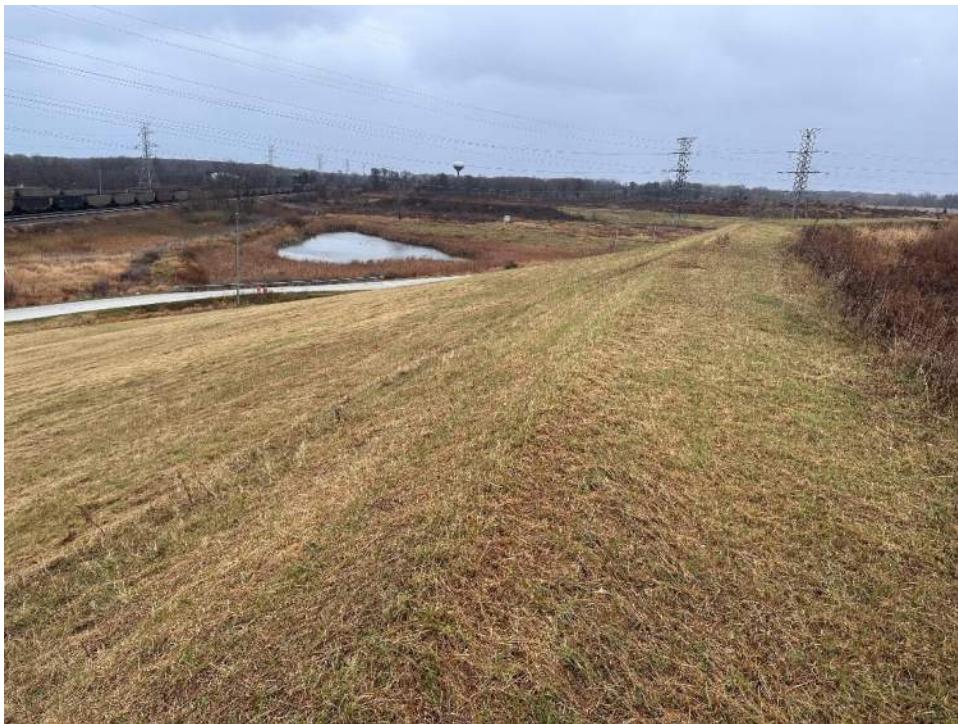
Photo No. 6 – East perimeter berm, looking south.

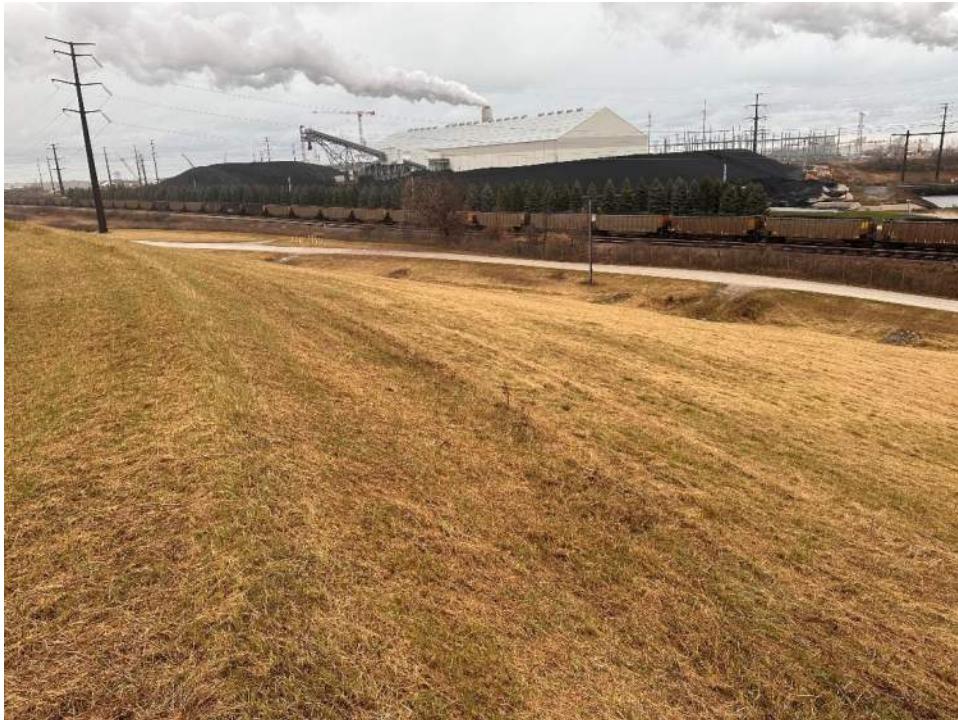
Photo No. 7 – Vegetation on Cell 6 and 8 perimeter slope.

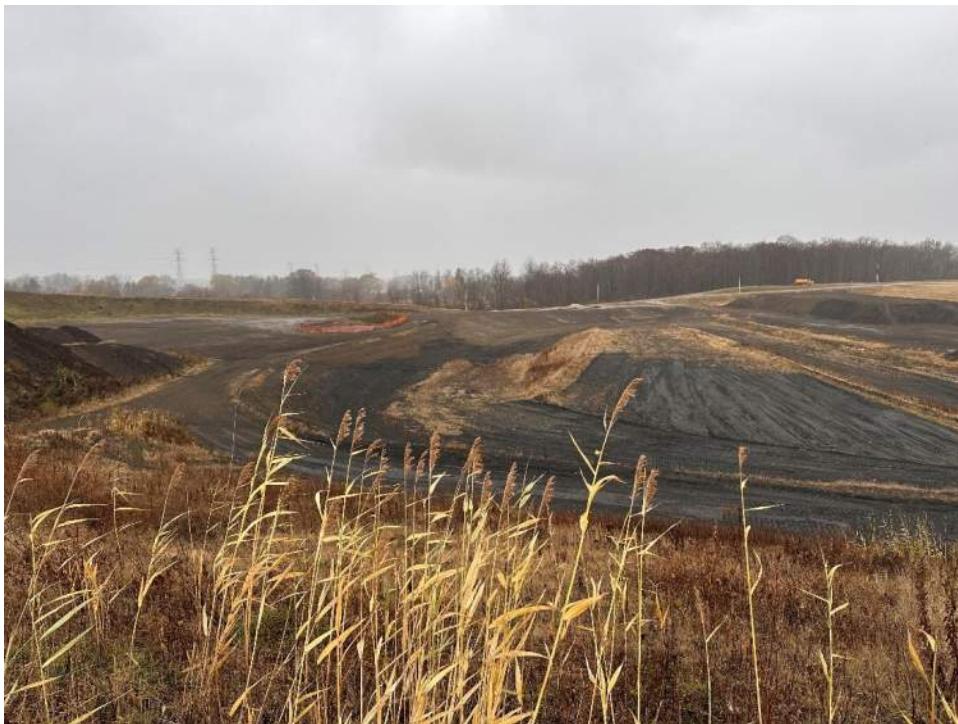
Photo No. 8 – Cell 10 active area.

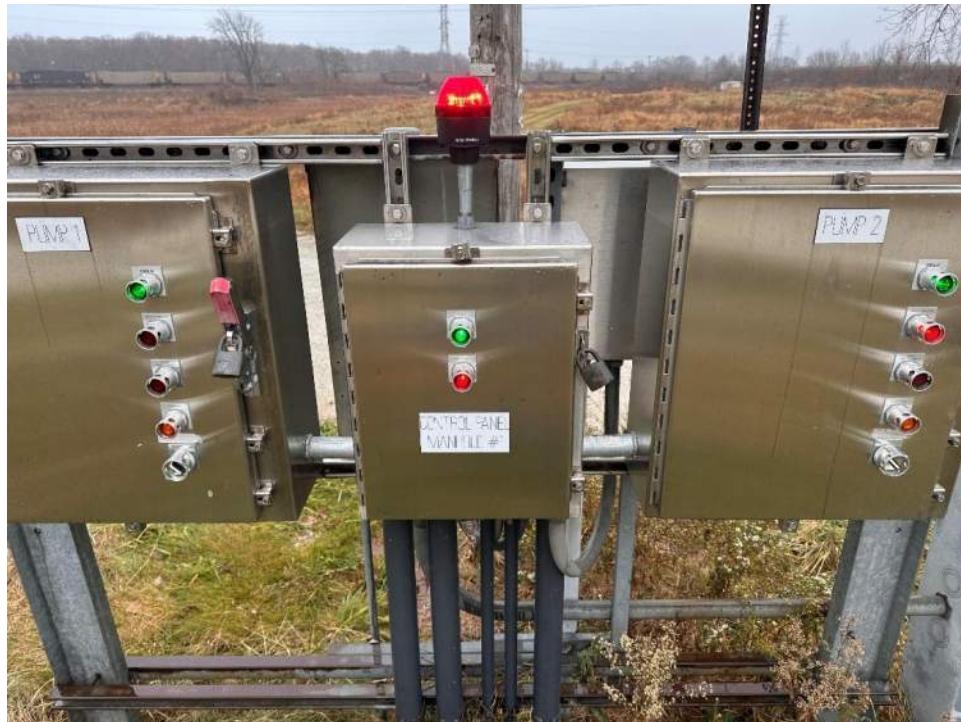
Photo No. 9 – Leachate tank control panel.

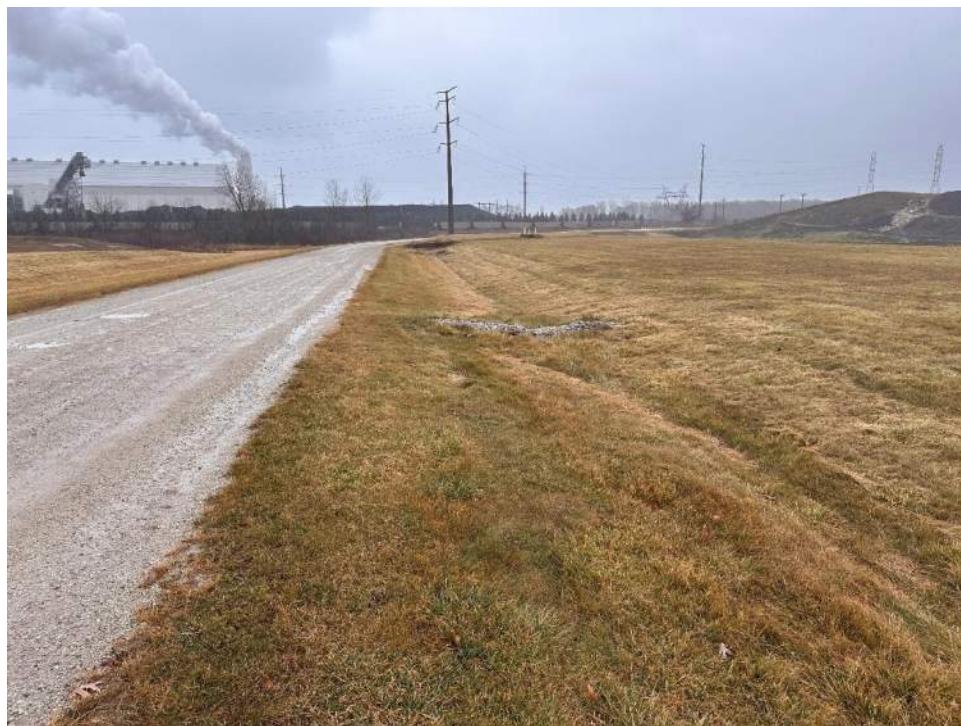
Photo No. 10 – Exterior stormwater ditch north of Cell 10.

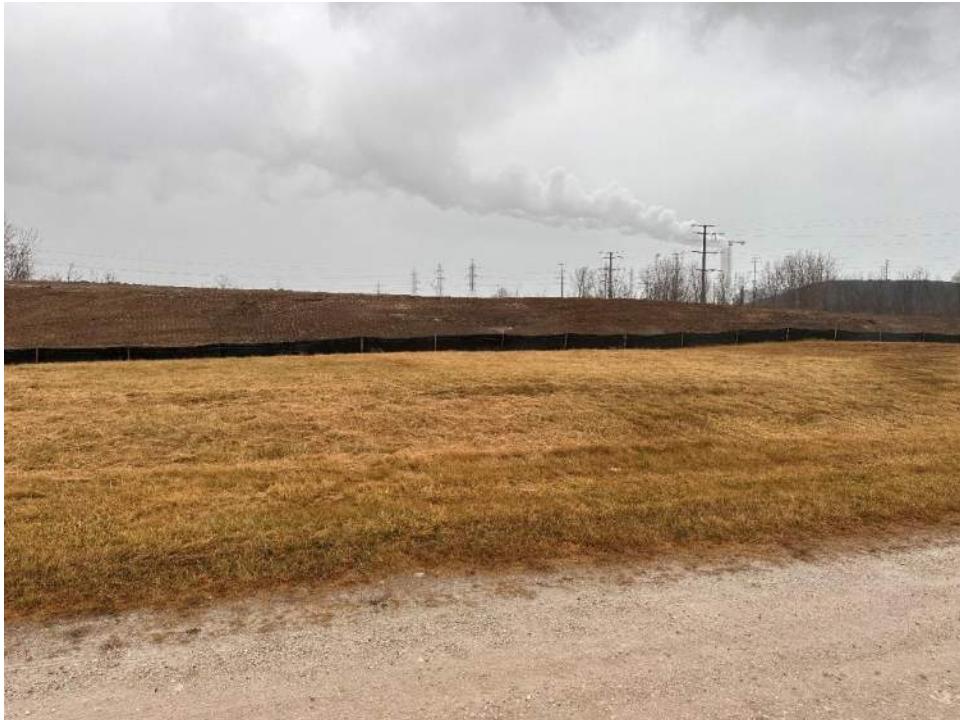
Photo No. 11 – New topsoil stockpile located north of the landfill.

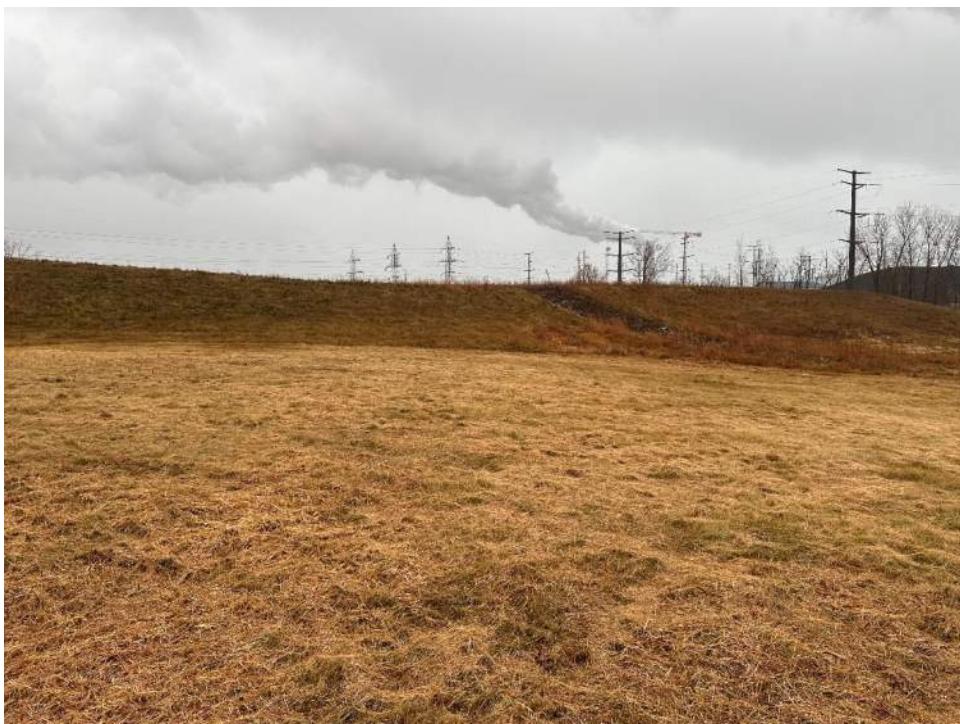
Photo No. 12 – Vegetated soil stockpile located north of the landfill.
