1.0 INTRODUCTION

This annual inspection report has been prepared to meet the requirements of 40 CFR 257.84(b).

The active area of the Caledonia Ash Landfill is divided into a disposal area and various segregated coal combustion residuals (CCR) stockpiles, which are staged for eventual beneficial utilization. The Caledonia Ash Landfill also includes areas that have been filled and have a final cover in place.

11/19/2015 Caledonia Landfill Inspection

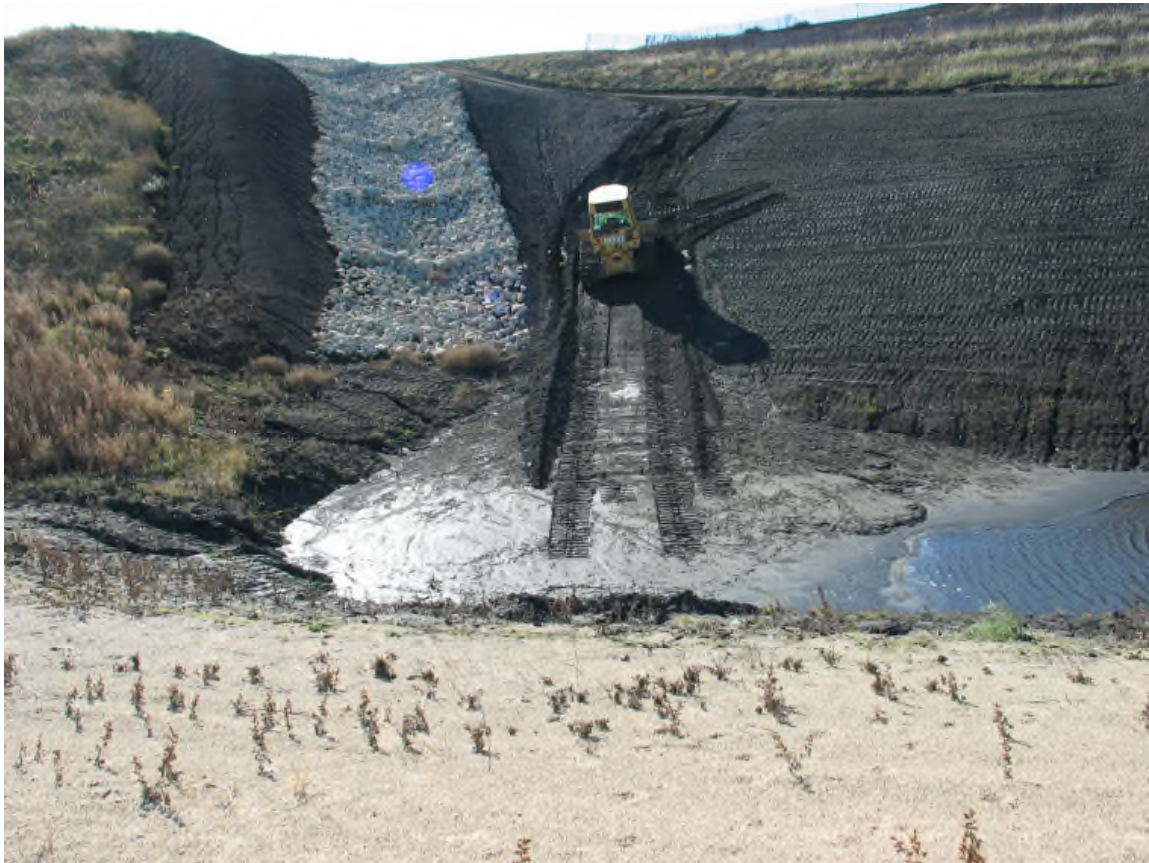
Repairing Erosion in East Stormwater Storage Area
