1.0 INTRODUCTION

This annual inspection report has been prepared to meet the requirements of 40 CFR 257.84(b).

11/18/2019 Pleasant Prairie Landfill Inspection

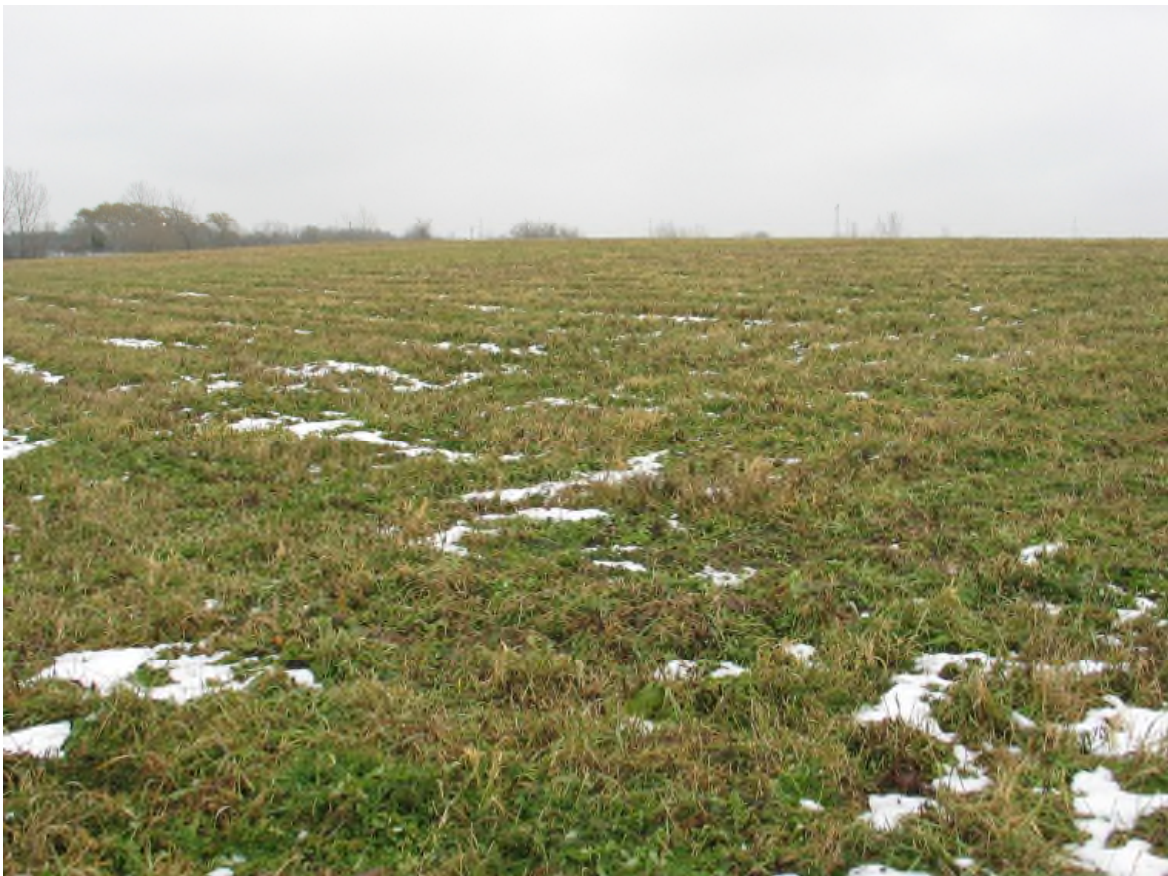
Final cover east end

Partial cover installed late-2018. Vegetation well established
