December 19, 2020

GEI Project No. 2004112

**Re: Landfill Inspection Report
Pleasant Prairie Power Plant Ash Landfill
Pleasant Prairie, Wisconsin**

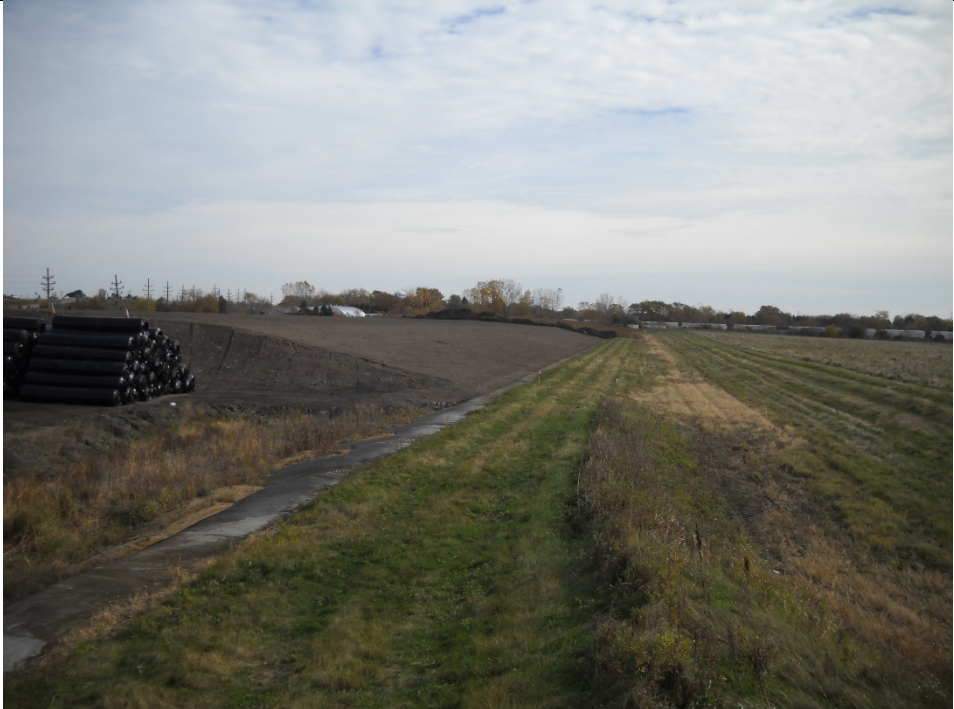
PHOTOGRAPH NO: 2	DATE: 10/19/2020	GEI PROJECT NO: 1610534	CLIENT: WEC BUSINESS SERVICES
DIRECTION: East		SITE LOCATION: PLEASANT PRAIRIE POWER PLANT ASH LANDFILL	
<p>DESCRIPTION:</p> <p>South slope of PPPP Landfill Cell 1 from west of cell.</p>

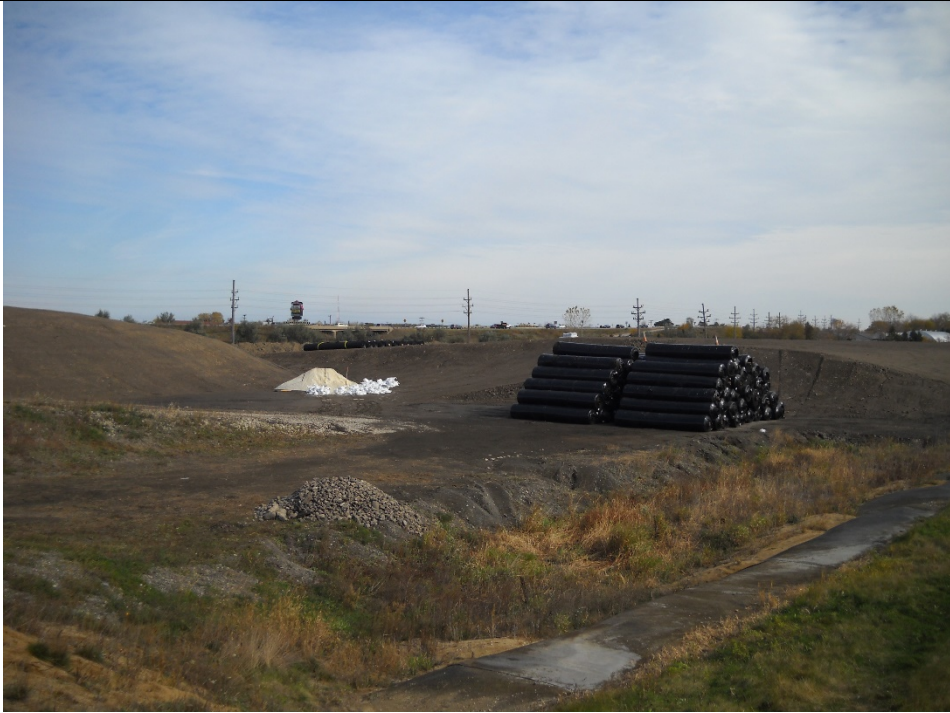
PHOTOGRAPH NO: 3	DATE: 10/19/2020	GEI PROJECT NO: 1610534	CLIENT: WEC BUSINESS SERVICES
DIRECTION: Northeast		SITE LOCATION: PLEASANT PRAIRIE POWER PLANT ASH LANDFILL	
<p>DESCRIPTION:</p> <p>Western active portion of PPPP Landfill Cell 1 from southwest corner of cell.</p>

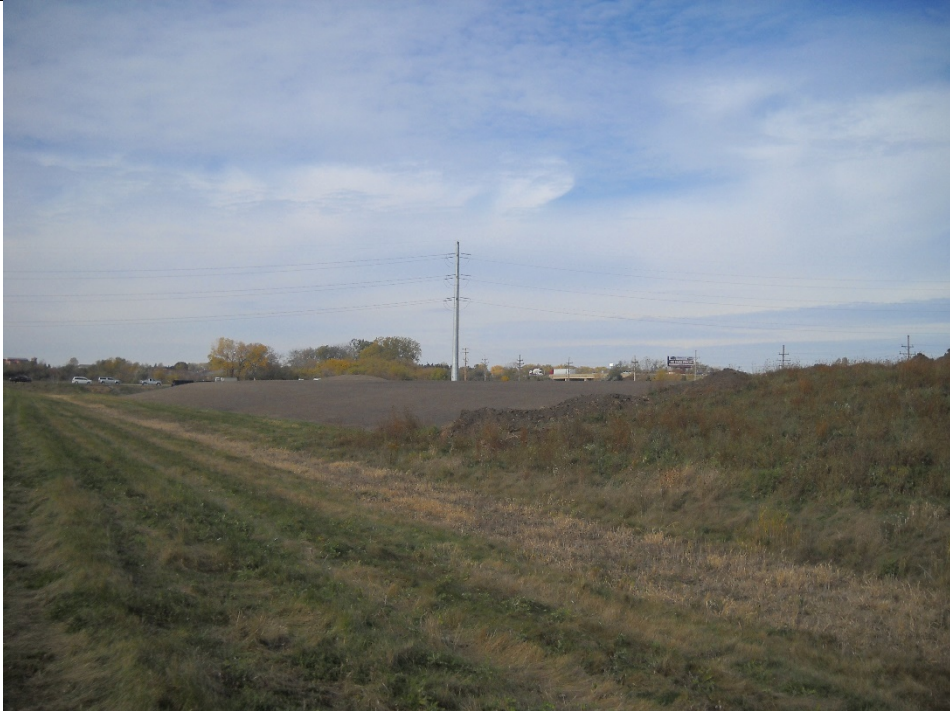
PHOTOGRAPH NO: 4	DATE: 10/19/2020	GEI PROJECT NO: 1610534	CLIENT: WEC BUSINESS SERVICES
DIRECTION: West		SITE LOCATION: PLEASANT PRAIRIE POWER PLANT ASH LANDFILL	
<p>DESCRIPTION:</p> <p>South slope of PPPP Landfill Cell 1 from approximately halfway east-west of cell.</p>

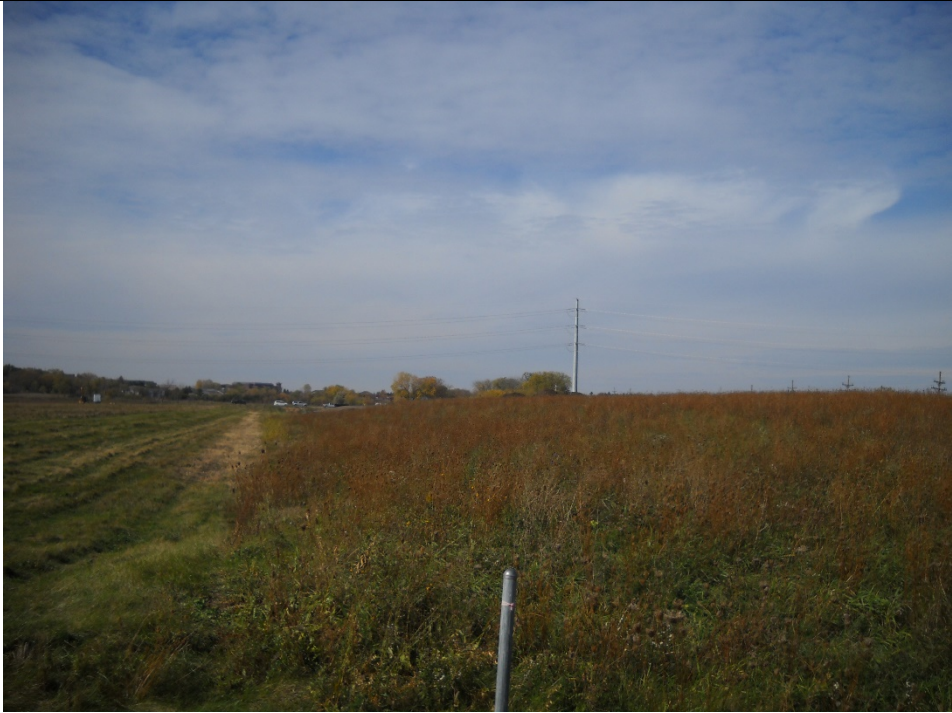
PHOTOGRAPH NO: 5	DATE: 10/19/2020	GEI PROJECT NO: 1610534	CLIENT: WEC BUSINESS SERVICES
DIRECTION: West		SITE LOCATION: PLEASANT PRAIRIE POWER PLANT ASH LANDFILL	
<p>DESCRIPTION:</p> <p>South slope of PPPP Landfill Cell 1 from east of cell. The eastern third of the cell was closed and vegetated in Q4 2018 and Q1 2019.</p>

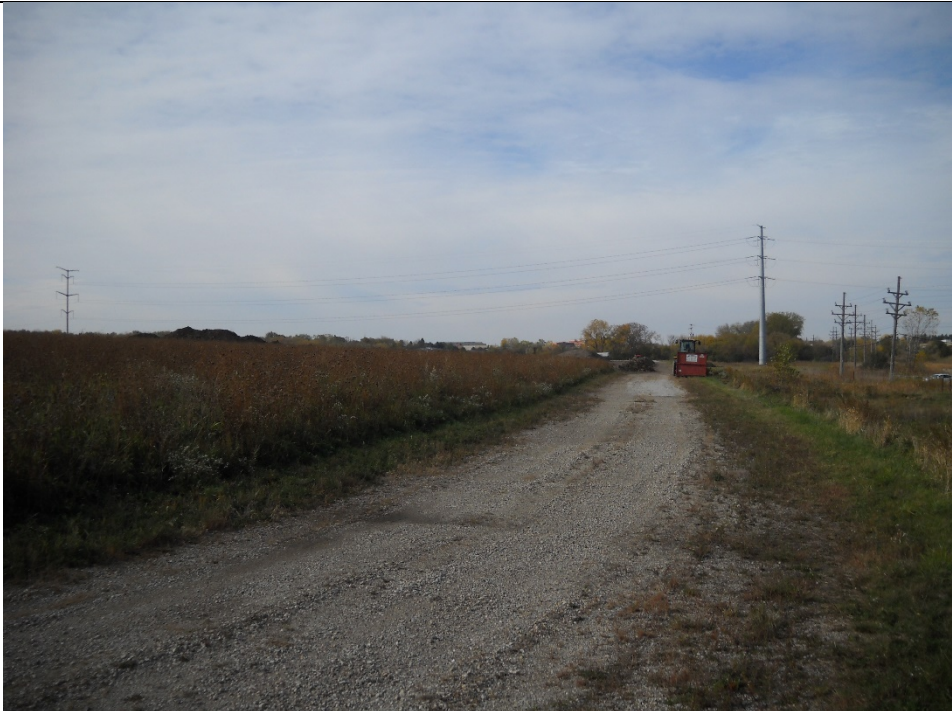
PHOTOGRAPH NO: 6	DATE: 10/19/2020	GEI PROJECT NO: 1610534	CLIENT: WEC BUSINESS SERVICES
DIRECTION: West		SITE LOCATION: PLEASANT PRAIRIE POWER PLANT ASH LANDFILL	
<p>DESCRIPTION:</p> <p>North slope of PPPP Ash Landfill Cell 1 from east of cell.</p>

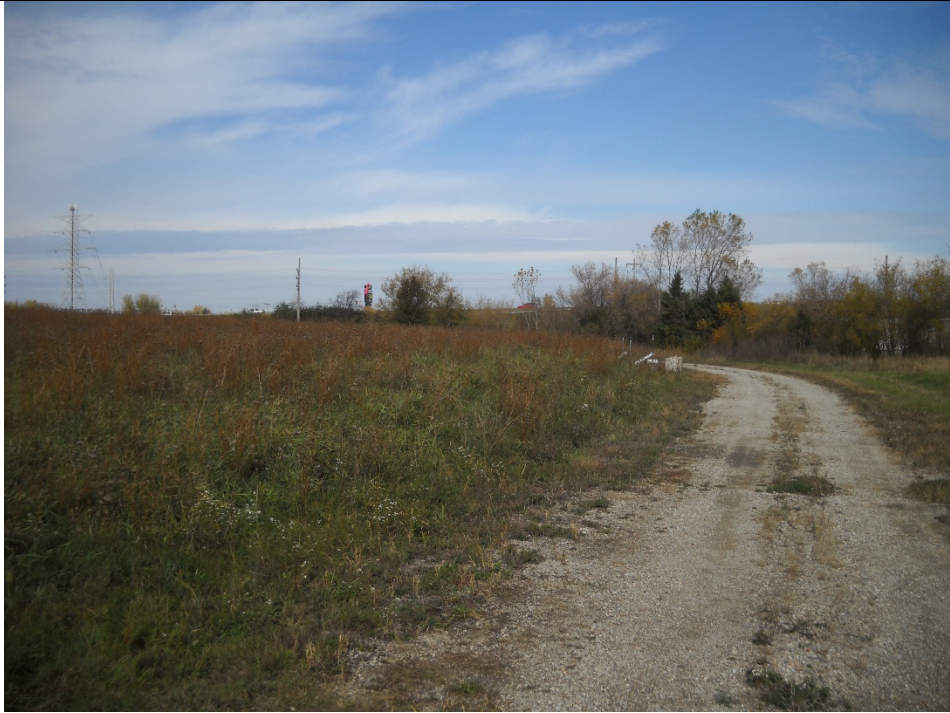
PHOTOGRAPH NO: 7	DATE: 10/19/2020	GEI PROJECT NO: 1610534	CLIENT: WEC BUSINESS SERVICES
DIRECTION: North		SITE LOCATION: PLEASANT PRAIRIE POWER PLANT ASH LANDFILL	
DESCRIPTION: East slope of PPPP Ash Landfill Cell 1
