December 19, 2022
Project 2103683

**Re: 2002 Landfill Inspection Report
Pleasant Prairie Power Plant Ash Landfill
Pleasant Prairie, Wisconsin**

PLEASANT PRAIRIE ASH LANDFILL - ANNUAL INSPECTION & CONDITION SUMMARY

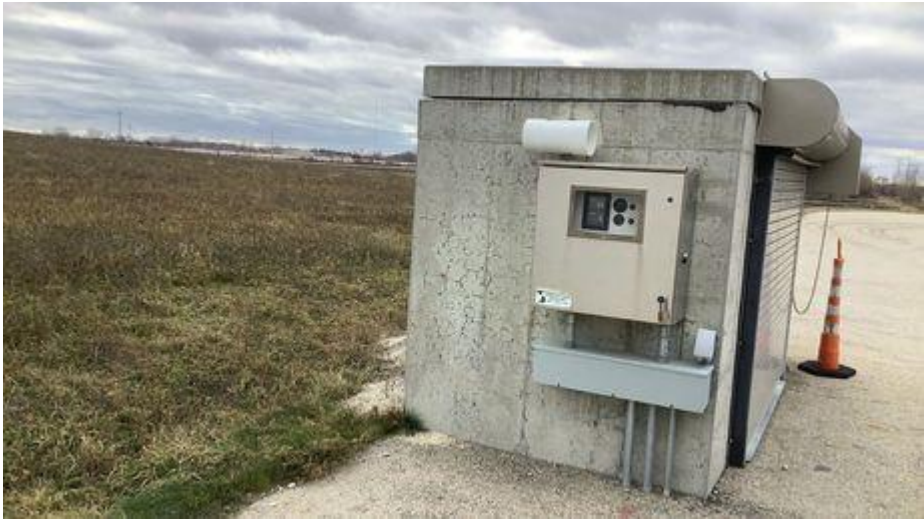
PHOTOGRAPH NO: 3	DATE: December 8, 2022	LATITUDE: 42.5652028052379	LONGITUDE: -87.9038712945214
SITE LOCATION: PLEASANT PRARIE, WISCONSIN			
DESCRIPTION: Looking south at building

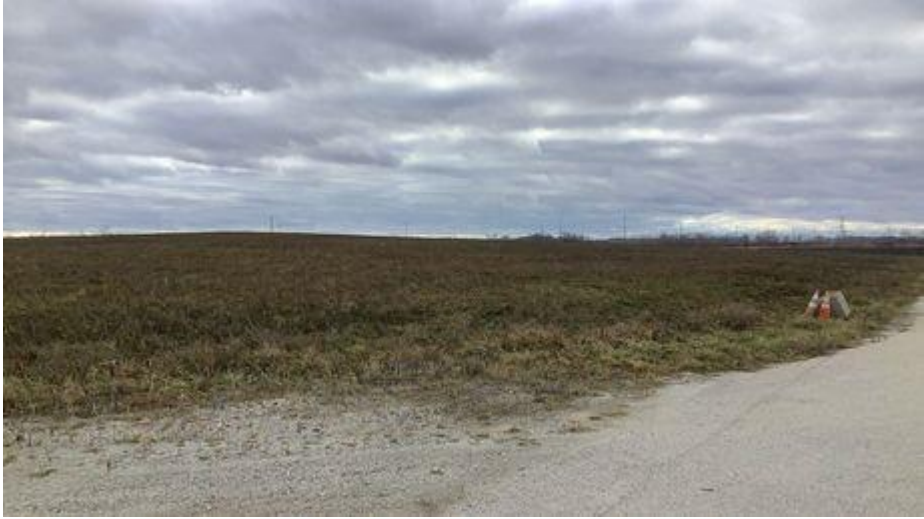
PHOTO BY: BILL BUTLER			
PHOTOGRAPH NO: 4	DATE: December 8, 2022	LATITUDE: 42.5653680795218	LONGITUDE: -87.9038952726176
SITE LOCATION: PLEASANT PRARIE, WISCONSIN			
DESCRIPTION: West slope of cell 1, looking south. Slope is well vegetated, which was planted in 2022

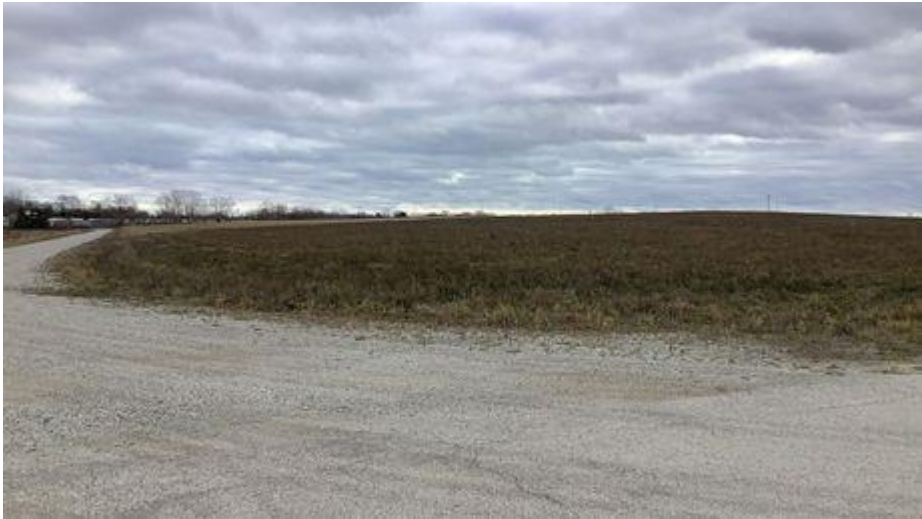
<p>PHOTOGRAPH NO: 5</p>	<p>DATE: December 8, 2022</p>	<p>LATITUDE: 42.5654941245838</p>	<p>LONGITUDE: -87.9038775582482</p>
<p>SITE LOCATION: PLEASANT PRARIE, WISCONSIN</p>			
<p>DESCRIPTION:</p> <p>Looking East at north slope of cell 1. The dark color vegetation is the phase 3 color area, the light color vegetation in the background is the phase 1 and 2 cover areas</p>

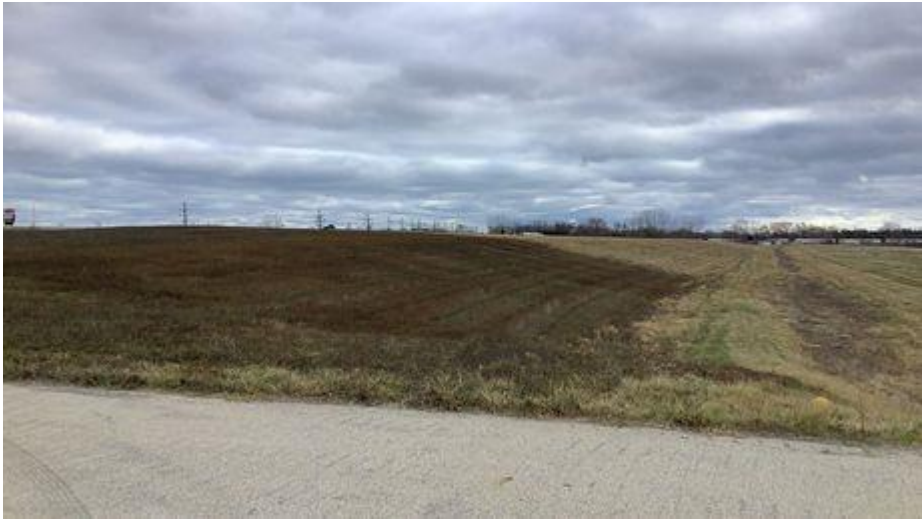
<p>PHOTO BY: BILL BUTLER</p>			
<p>PHOTOGRAPH NO: 6</p>	<p>DATE: December 8, 2022</p>	<p>LATITUDE: 42.564695398397</p>	<p>LONGITUDE: -87.9039438091286</p>
<p>SITE LOCATION: PLEASANT PRARIE, WISCONSIN</p>			
<p>DESCRIPTION:</p> <p>South slope of cell 1, looking east. The dark color vegetation is the phase 3 color area, the light color vegetation in the background is the phase 1 and 2 cover areas</p>

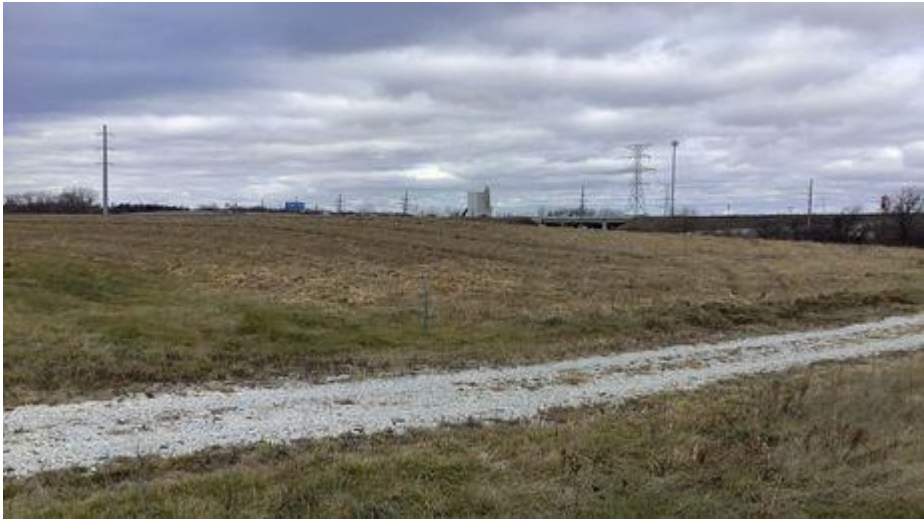
PHOTOGRAPH No: 11	DATE: December 8, 2022	LATITUDE: 42.5645984000194	LONGITUDE: -87.8989861795719
SITE LOCATION: PLEASANT PRARIE, WISCONSIN			
DESCRIPTION: Looking at east slope of cell 1, looking in the northwest direction

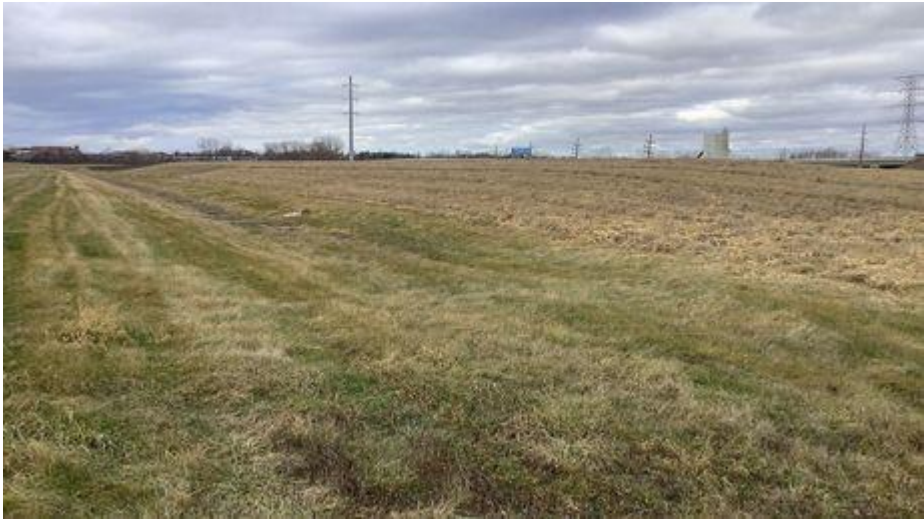
PHOTO BY: BILL BUTLER			
PHOTOGRAPH No: 12	DATE: December 8, 2022	LATITUDE: 42.5645505908226	LONGITUDE: -87.8991910470882
SITE LOCATION: PLEASANT PRARIE, WISCONSIN			
DESCRIPTION: Looking at the south slope of cell 1, taken at east end of cell, looking west

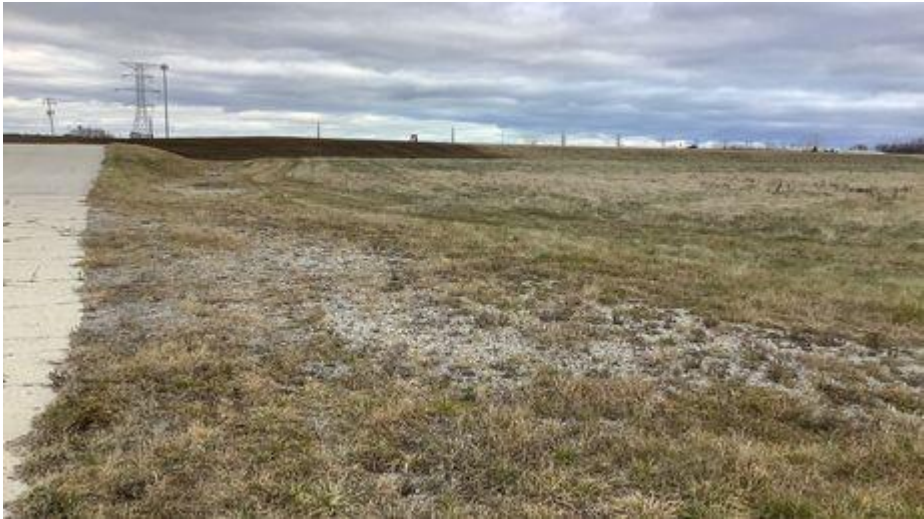
PHOTOGRAPH No: 13	DATE: December 8, 2022	LATITUDE: 42.5638889075466	LONGITUDE: -87.9041596081722
SITE LOCATION: PLEASANT PRARIE, WISCONSIN			
DESCRIPTION: Looking at cell 2 cover

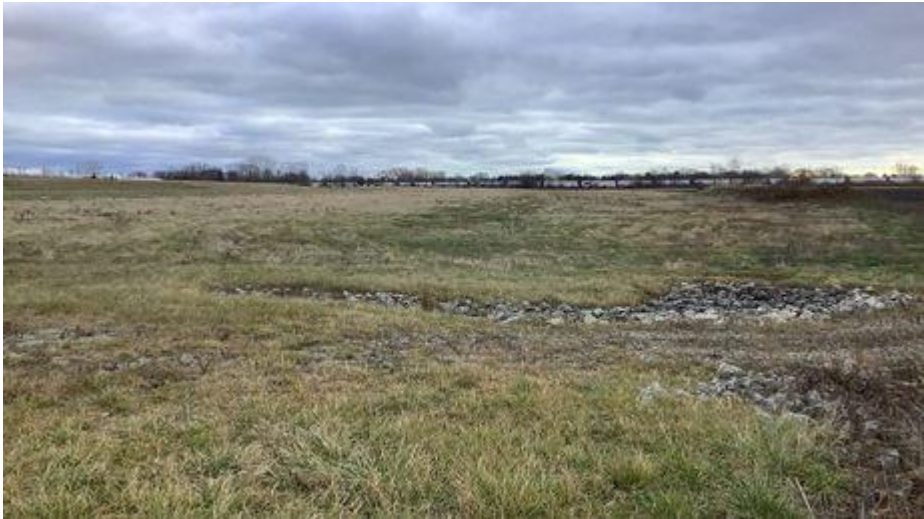
PHOTO BY: BILL BUTLER			
PHOTOGRAPH No: 14	DATE: December 8, 2022	LATITUDE: 42.5638775288043	LONGITUDE: -87.9042108580421
SITE LOCATION: PLEASANT PRARIE, WISCONSIN			
DESCRIPTION: Looking at cell 2 cover and south slope, looking northeast
