December 19, 2023
Project 2103683

**Re: 2023 Landfill Inspection Report
Pleasant Prairie Power Plant Ash Landfill
We Energies
Pleasant Prairie, Kenosha County, Wisconsin**

Pleasant Prairie Power Plant Ash Landfill CCR Inspection – Photo Log

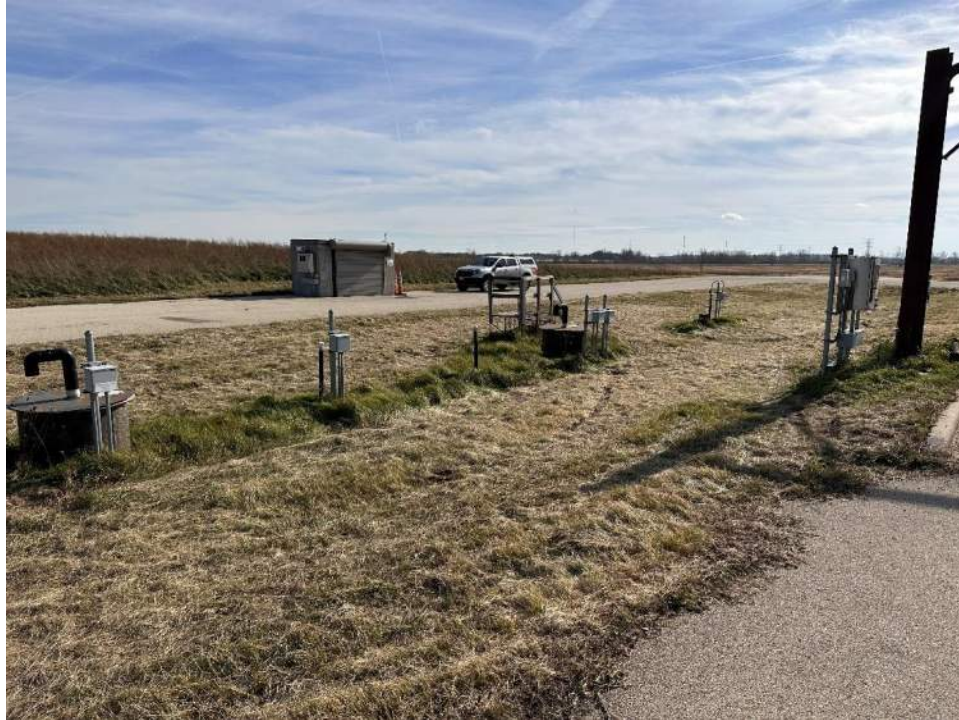
Photo No. 1 – Looking southeast at underground leachate storage tanks.

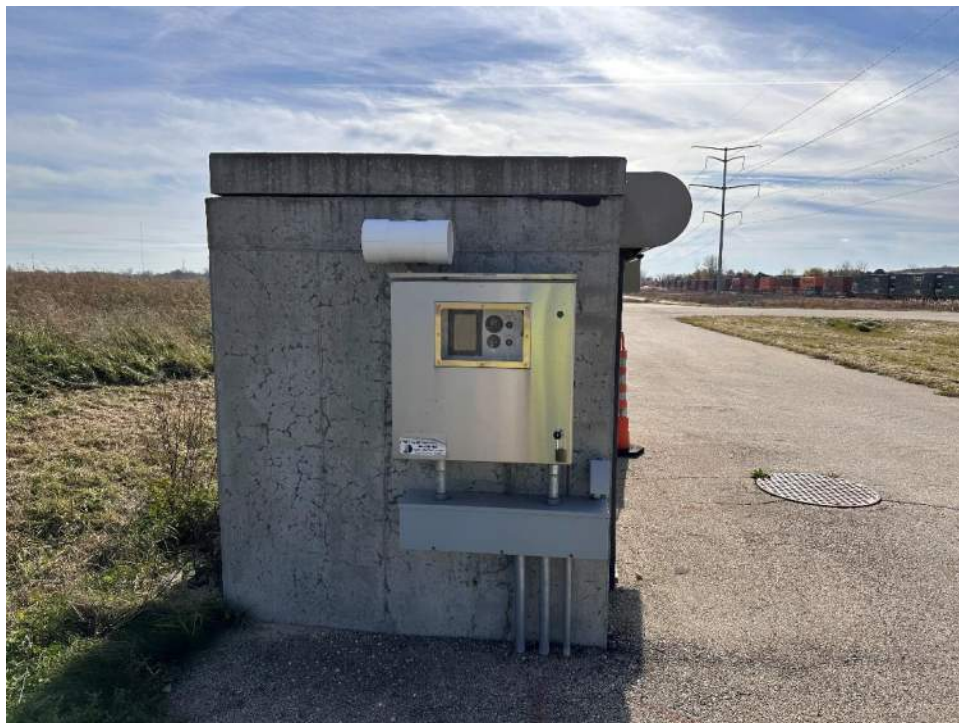
Photo No. 2 – Leachate sump collection vault.

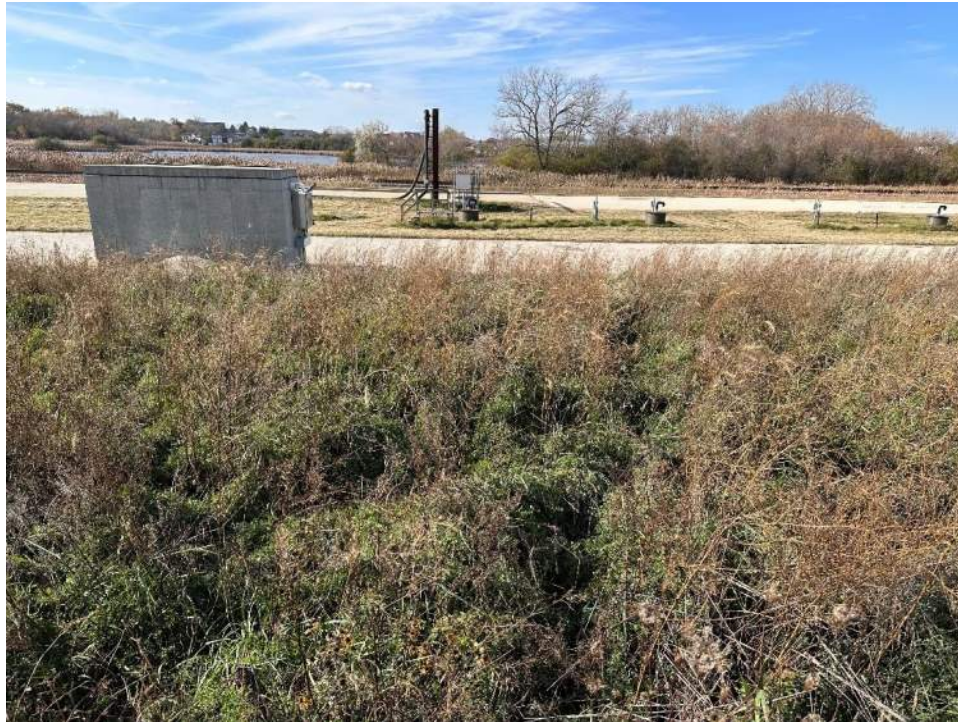
Photo No. 3 – Looking west from the Cell 1 cover at the leachate loadout pad.

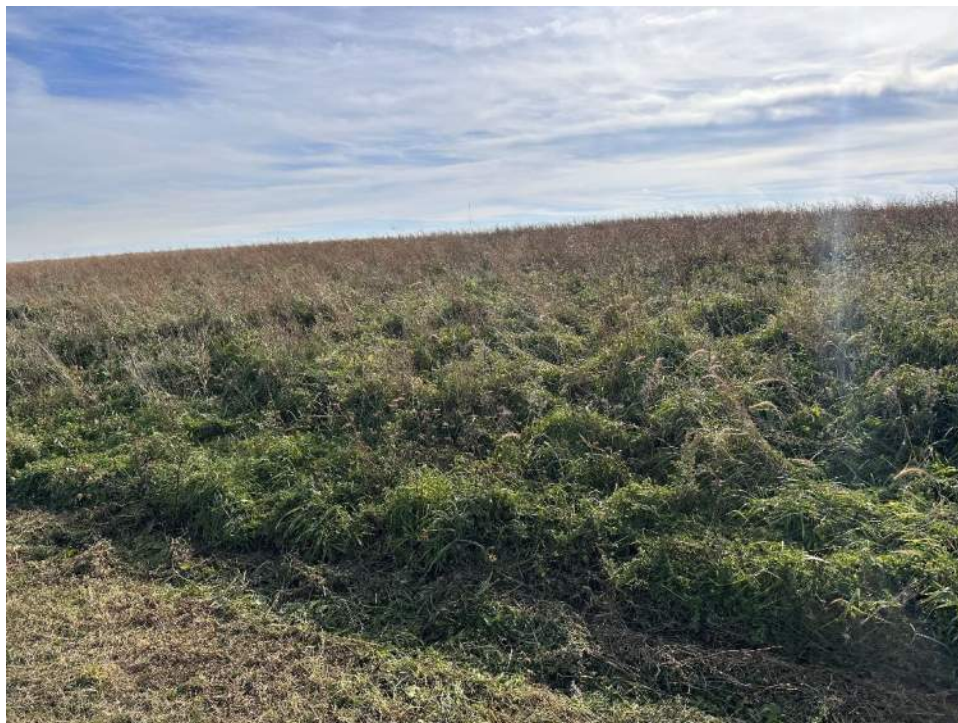
Photo No. 4 – North slope of Cell 1, looking southeast, showing thick vegetation.

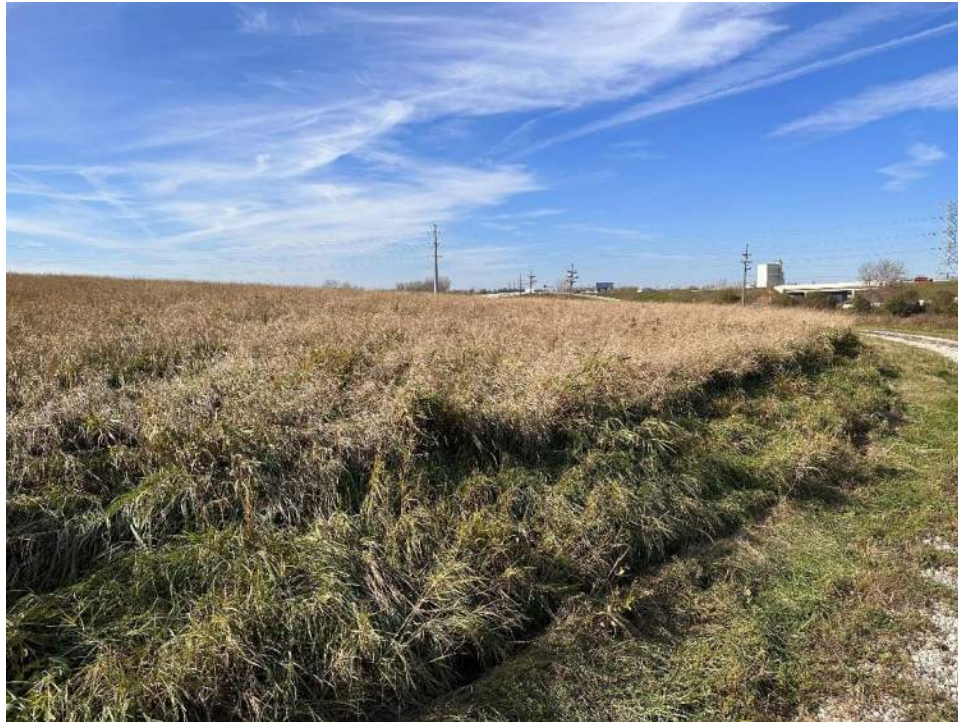
Photo No. 5 – East slope of Cell 1, looking northwest.

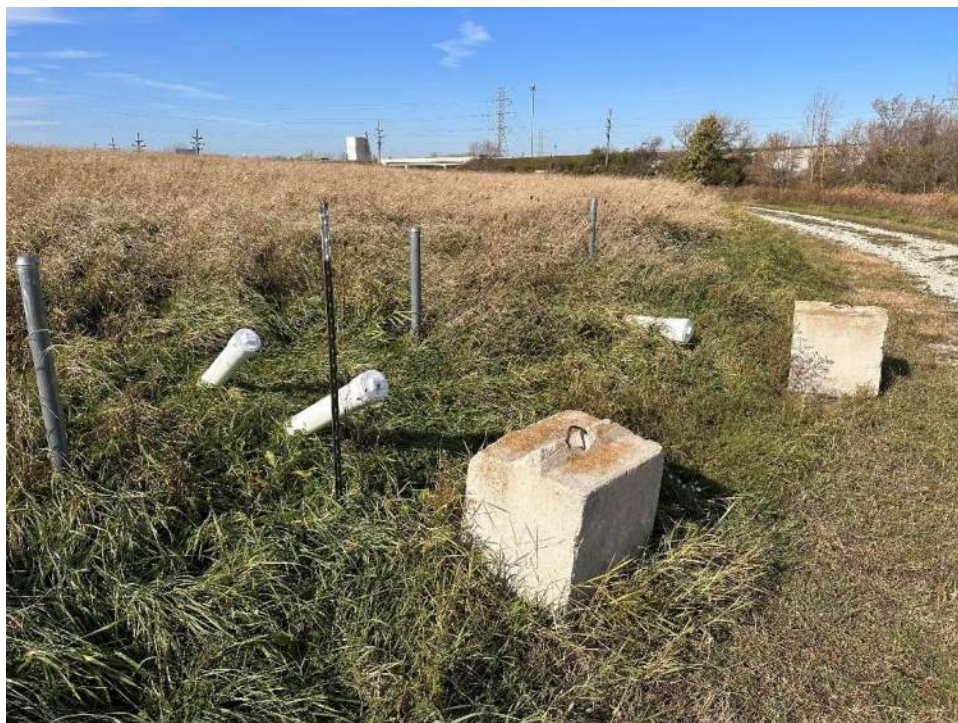
Photo No. 6 – Cleanout and leachate headwell on the east end of Cell 1.

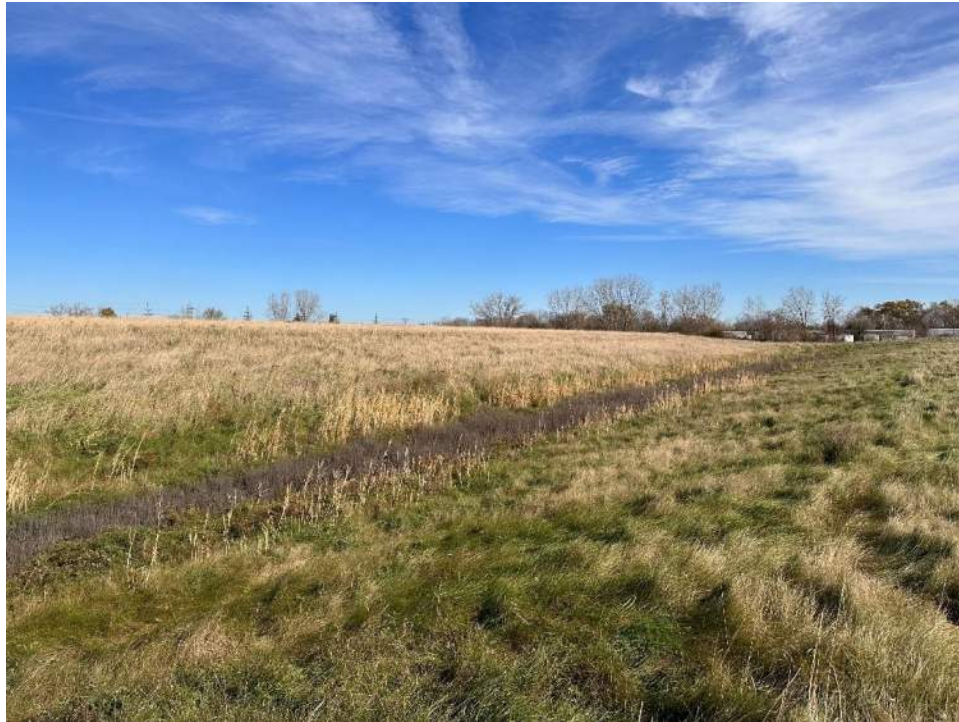
Photo No. 7 – South slope of Cell 1 and perimeter stormwater ditch.

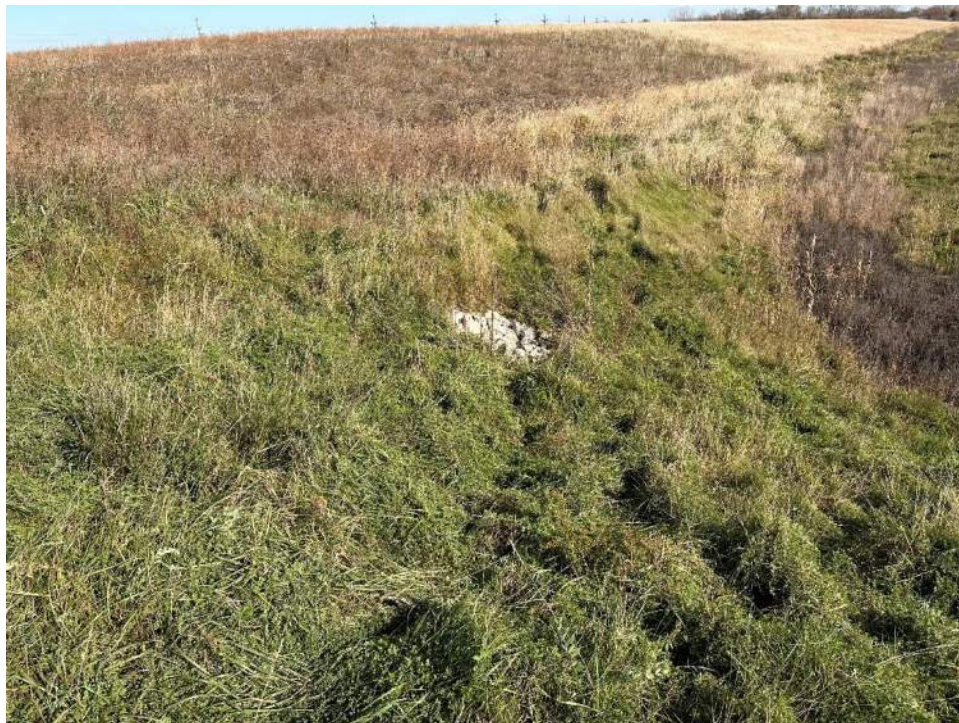
Photo No. 8 – Final cover drain pipe outlet on the south slope.

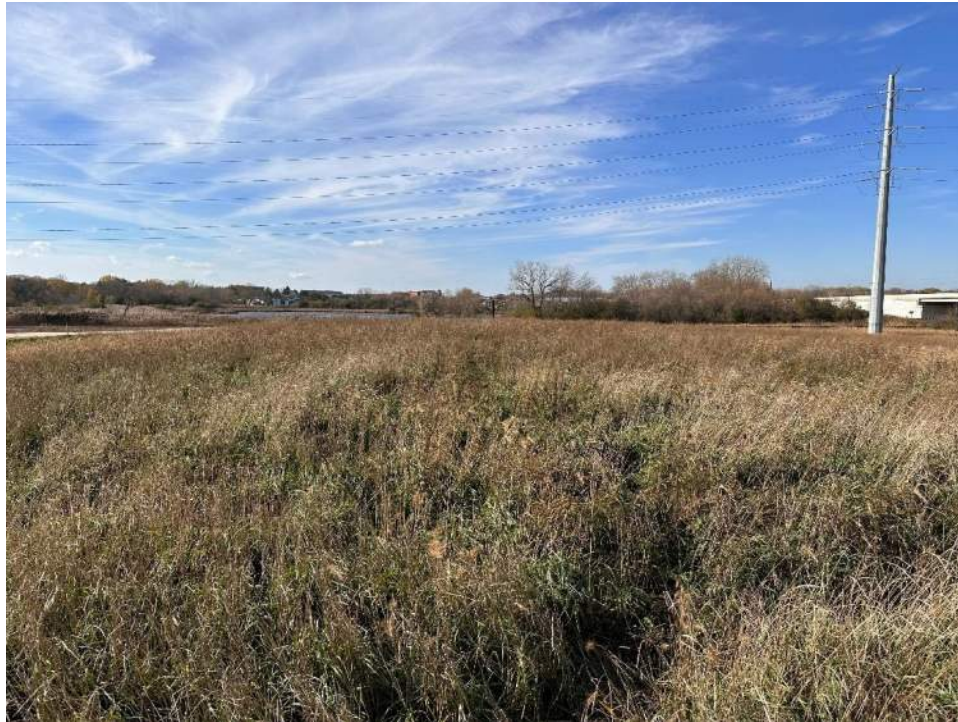
Photo No. 9 – Top of Cell 1 cover, looking northwest.

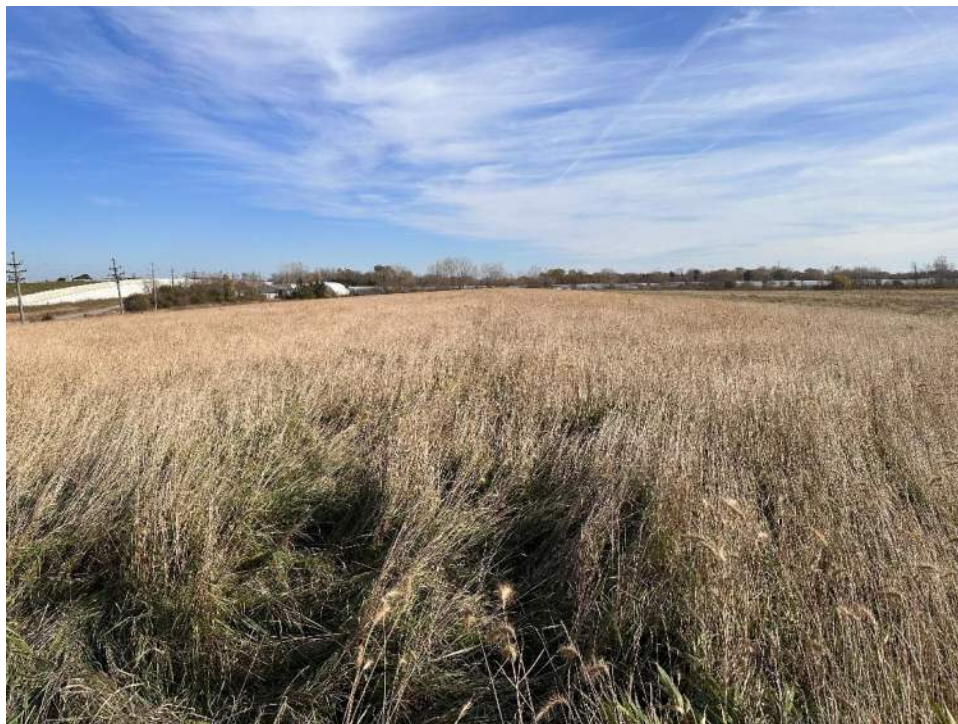
Photo No. 10 – Top of Cell 1 cover, looking east.

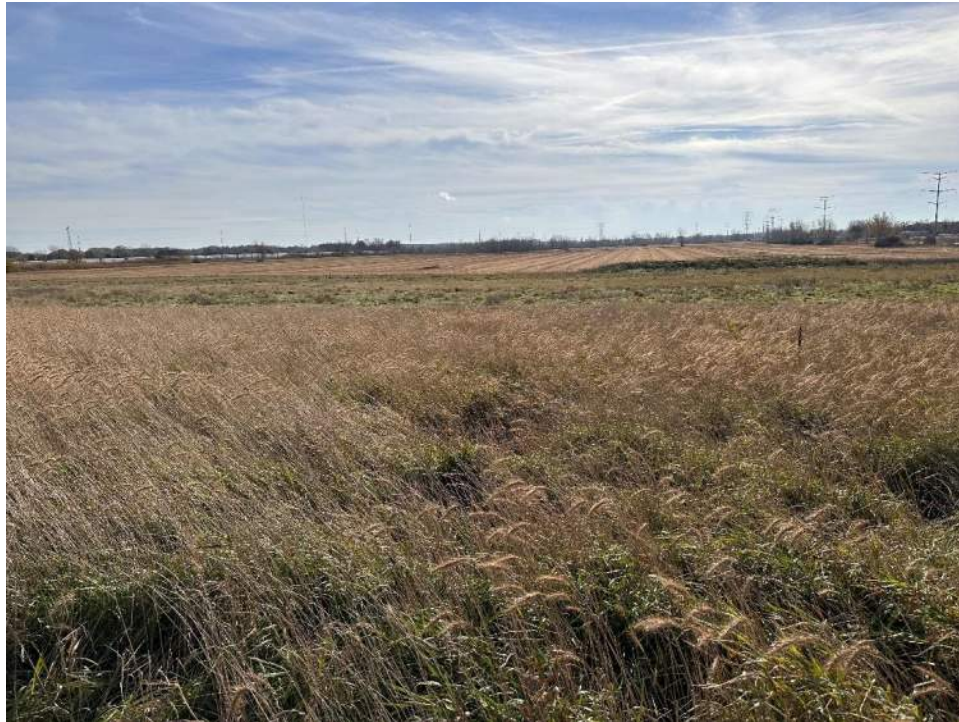
Photo No. 11 – Top of Cell 1 cover, looking south.
