December 19, 2025

Project No. 2103683

Re: 2025 Landfill Inspection Report
Pleasant Prairie Power Plant Ash Landfill
We Energies
Pleasant Prairie, Kenosha County, Wisconsin

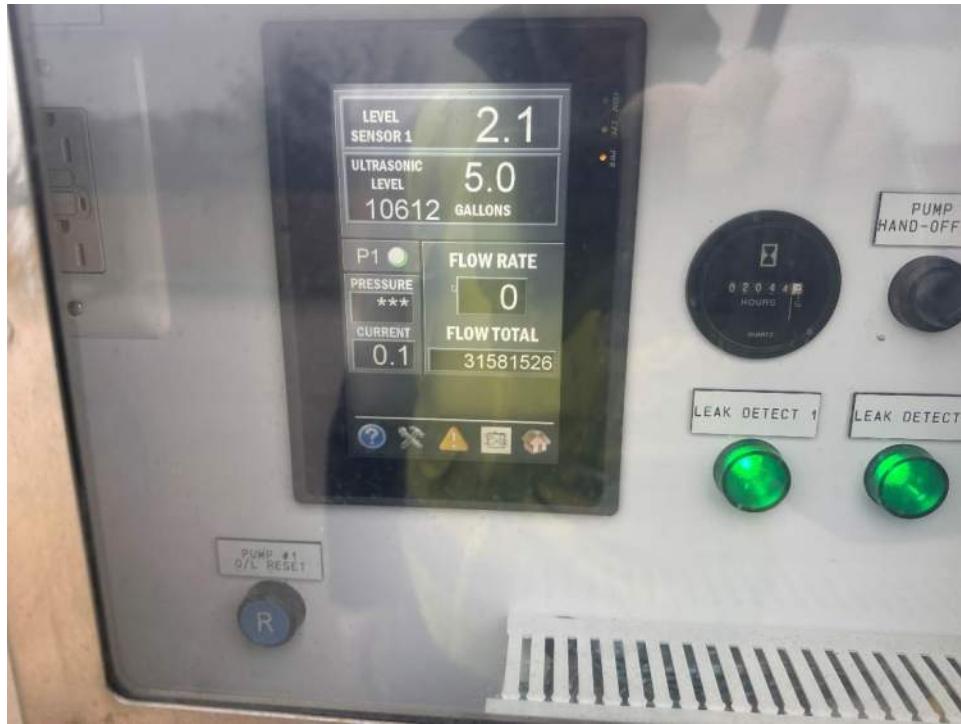
Photo No. 1 – Leachate loadout screen.

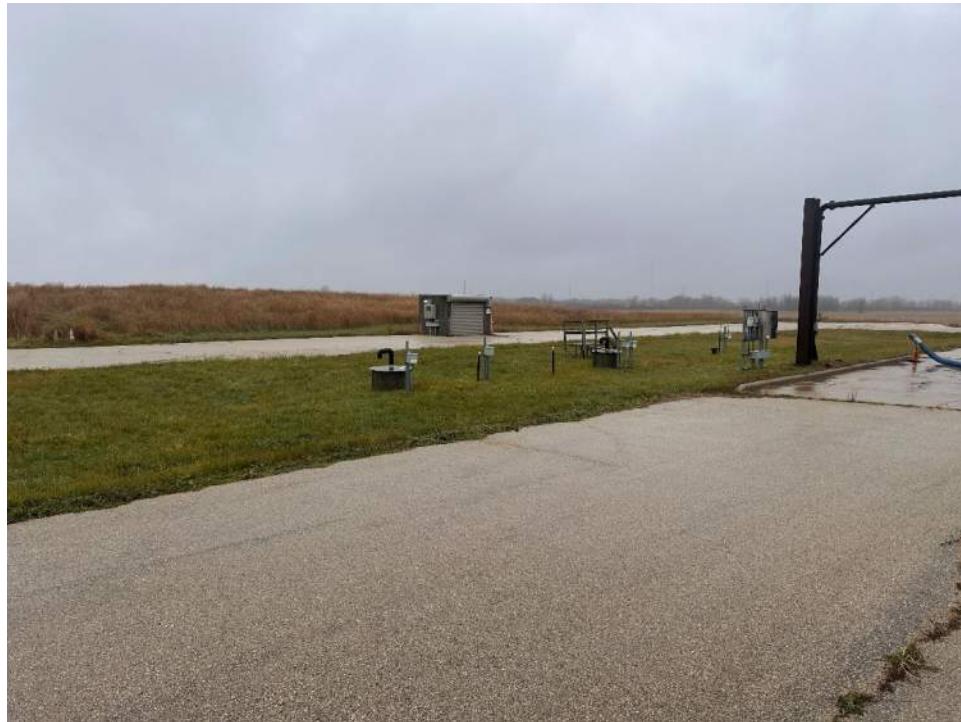
Photo No. 2 – Leachate sump collection vault.

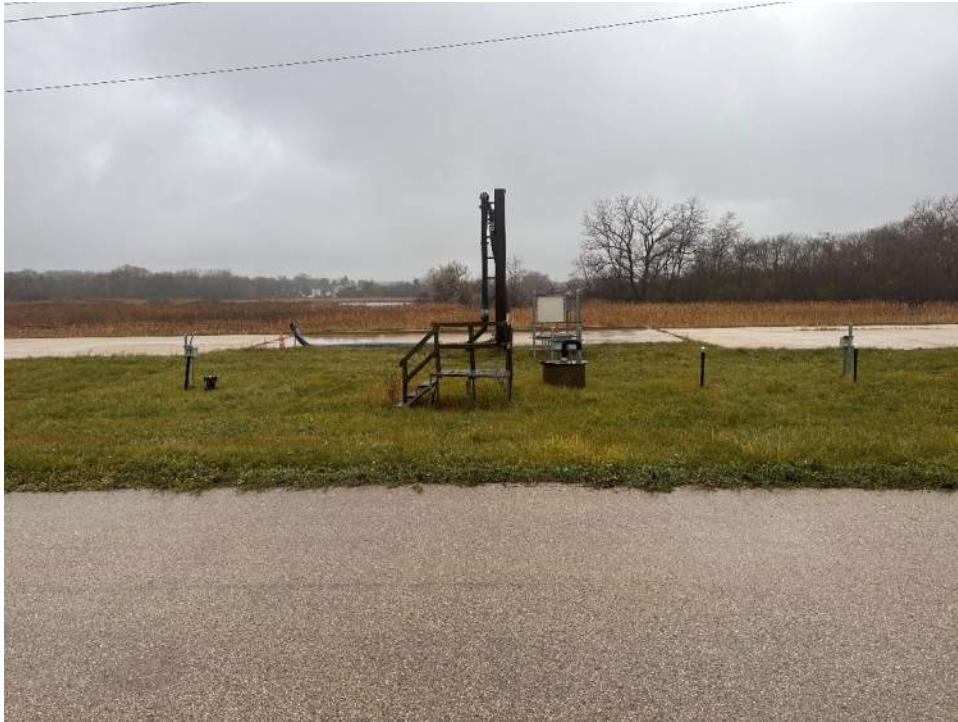
Photo No. 3 – Looking west from the Cell 1 cover at the leachate loadout pad.

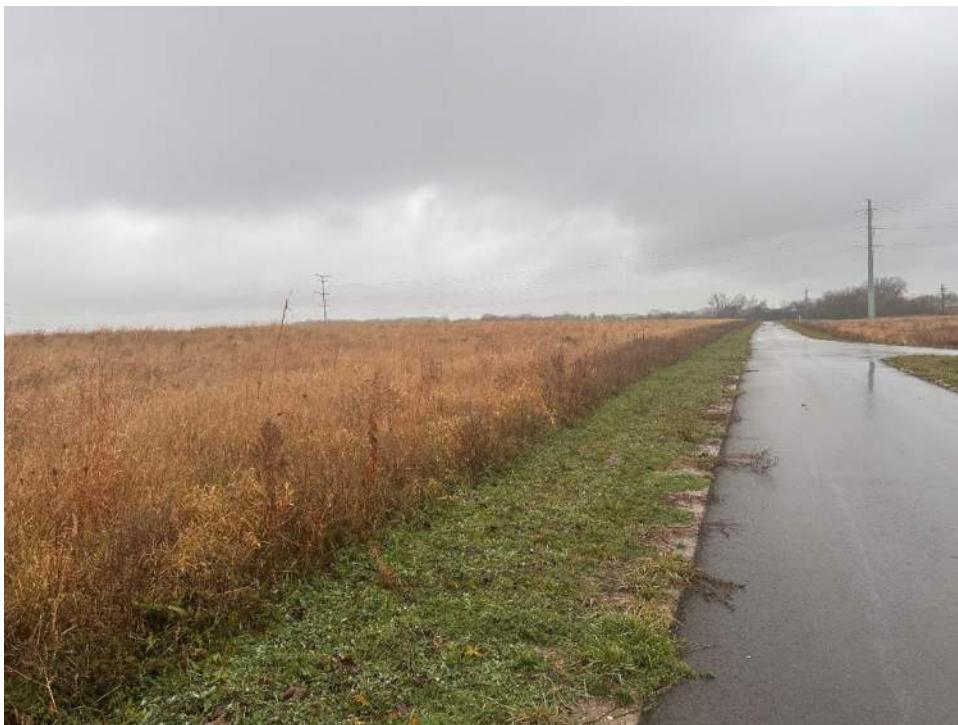
Photo No. 4 – North slope of Cell 1, looking west.

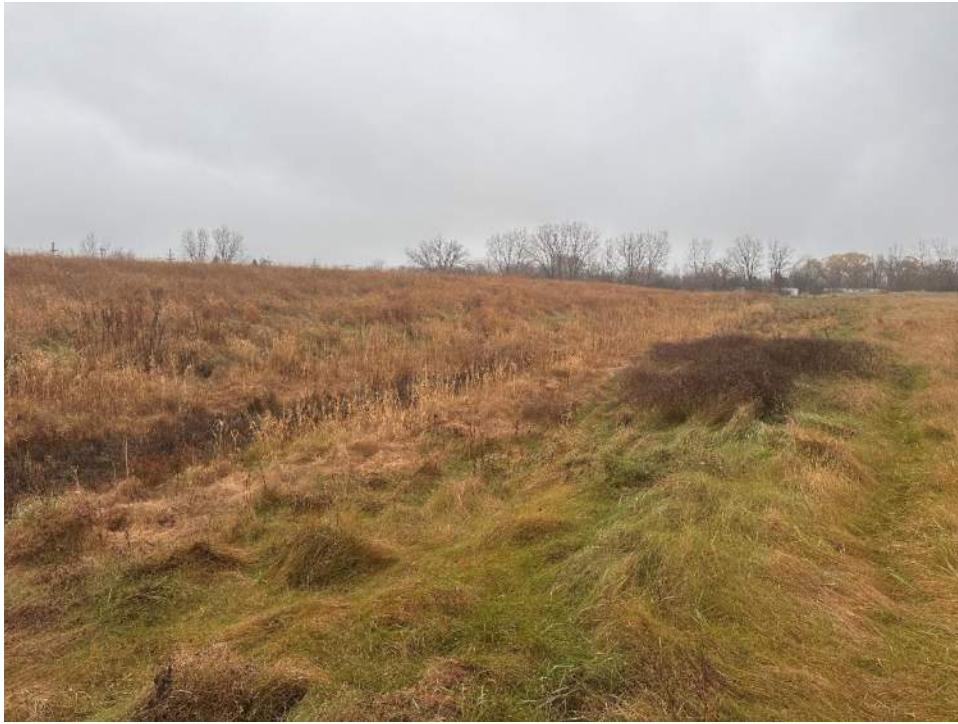
Photo No. 5 – South slope of Cell 1 and perimeter stormwater ditch, looking east.

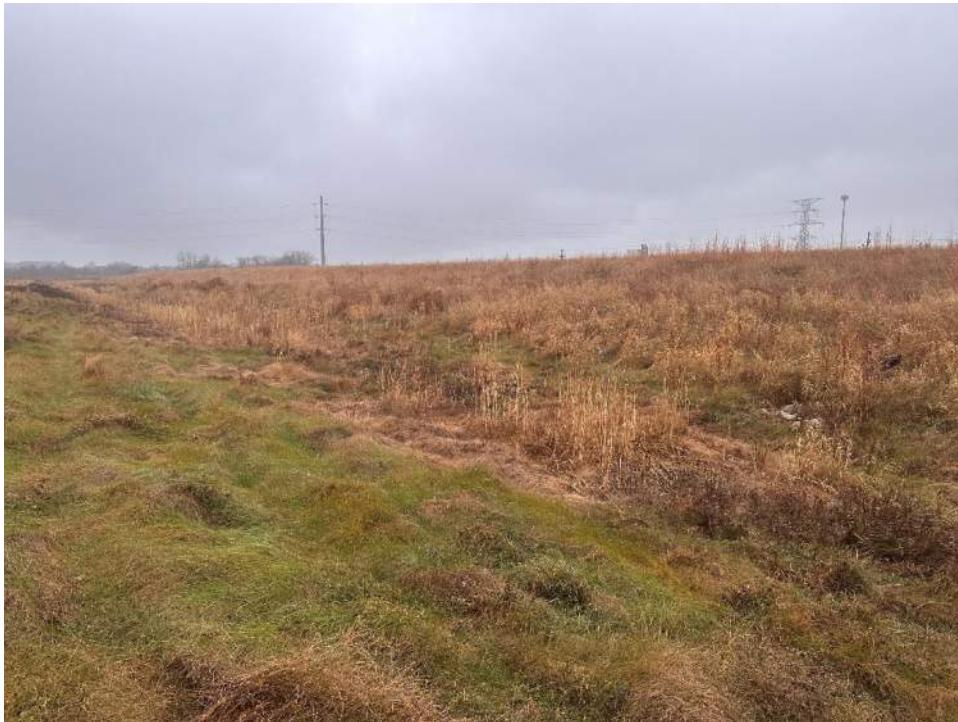
Photo No. 6 – South slope of Cell 1 and perimeter stormwater ditch, looking west.

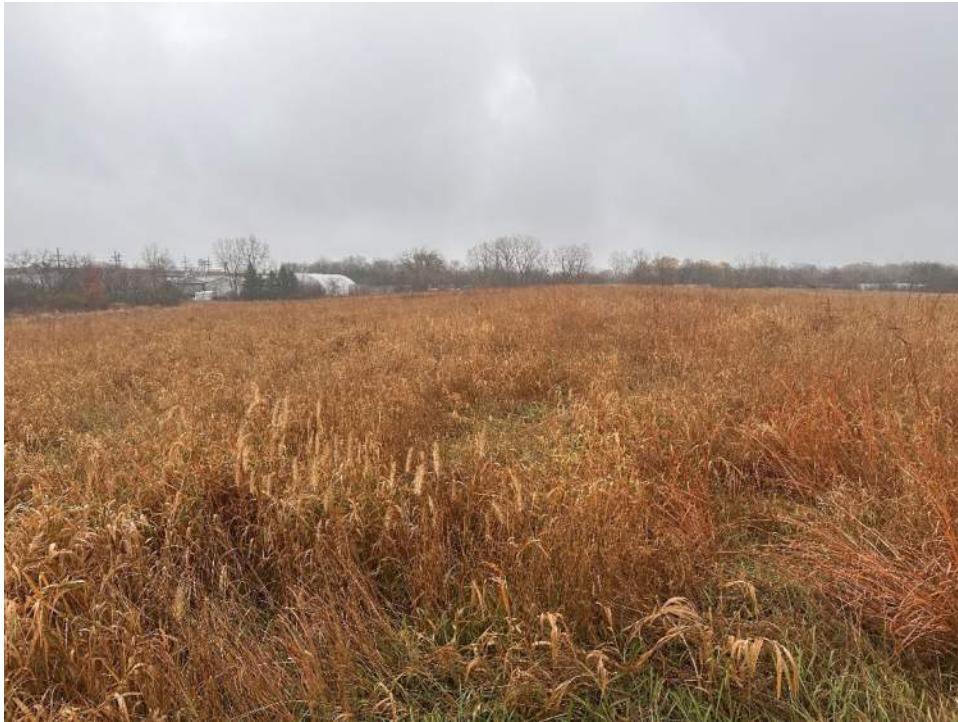
Photo No. 7 – Top of Cell 1 cover, looking east.

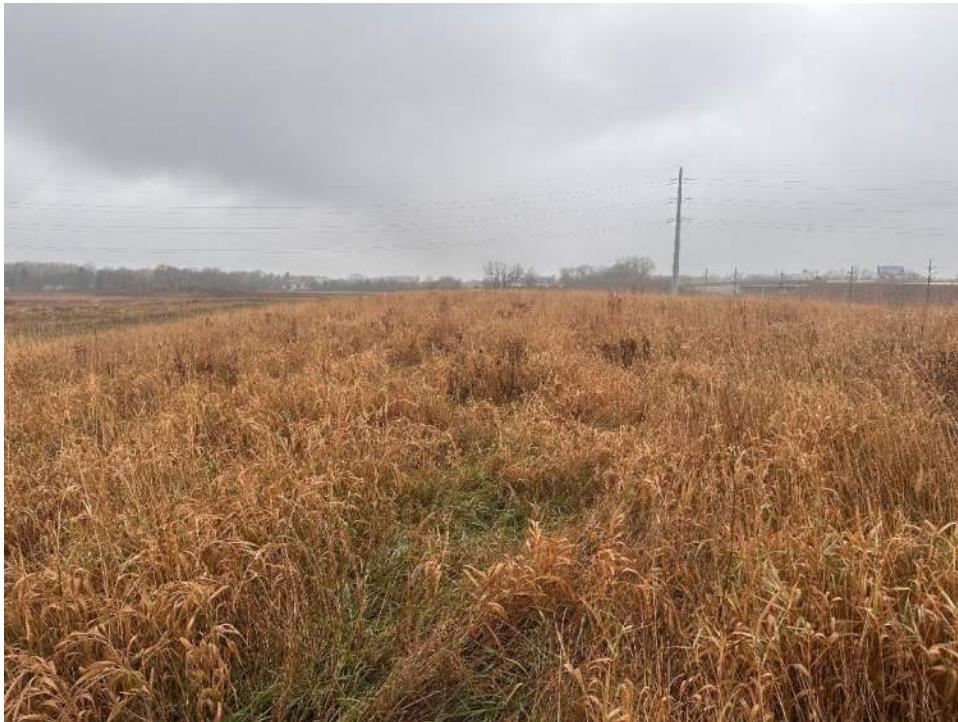
Photo No. 8 – Top of Cell 1 cover, looking northwest.

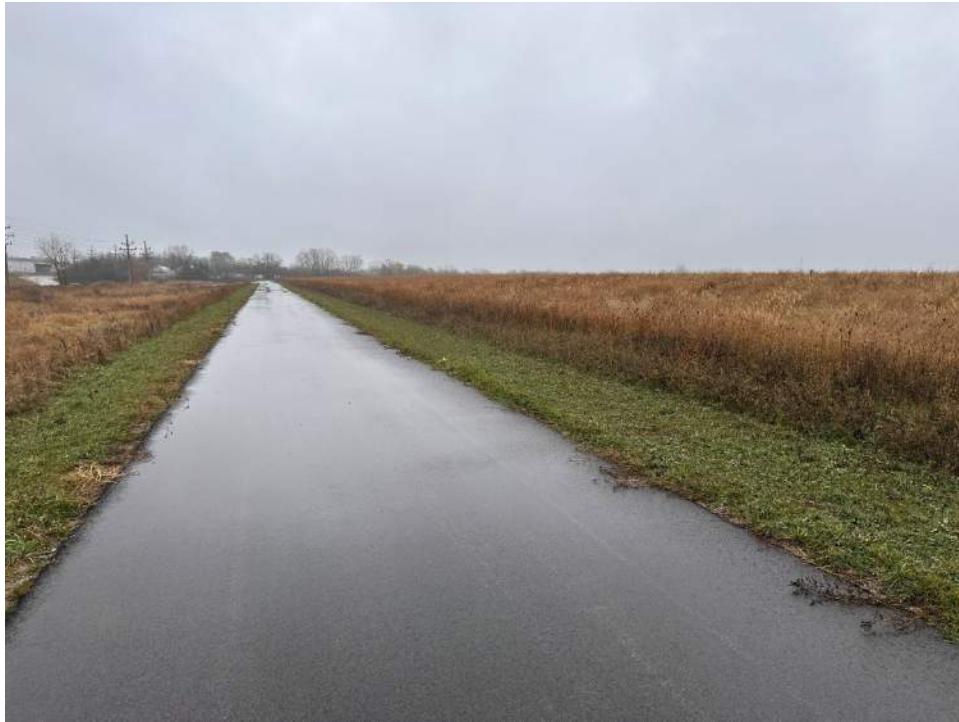
Photo No. 9 – Southwest corner of Cell 1 cover, looking east.

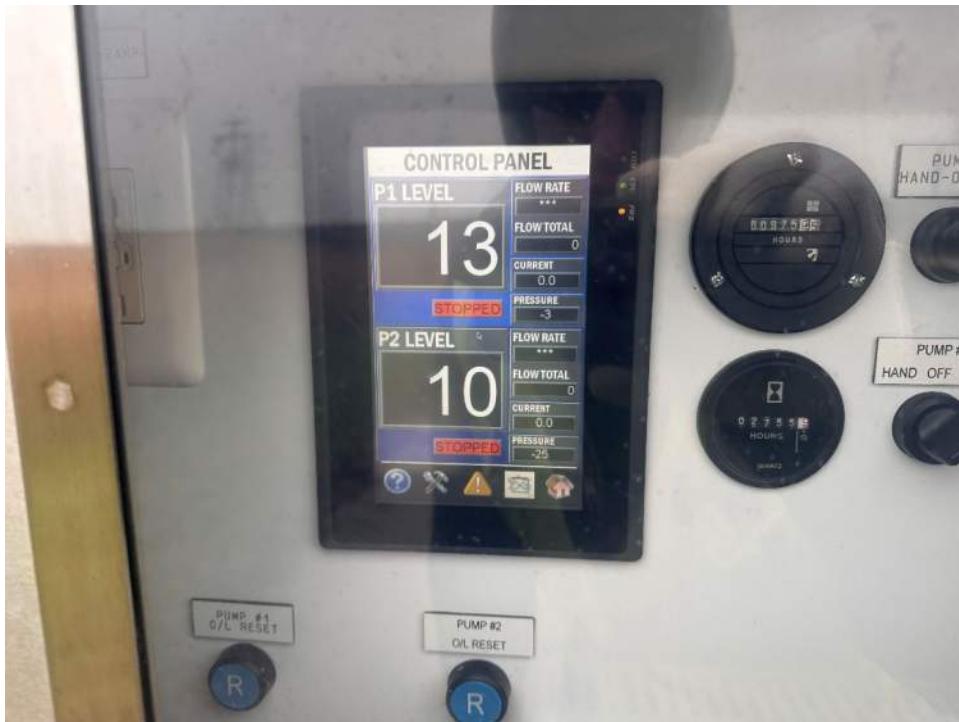
Photo No. 10 – Leachate loadout screen.

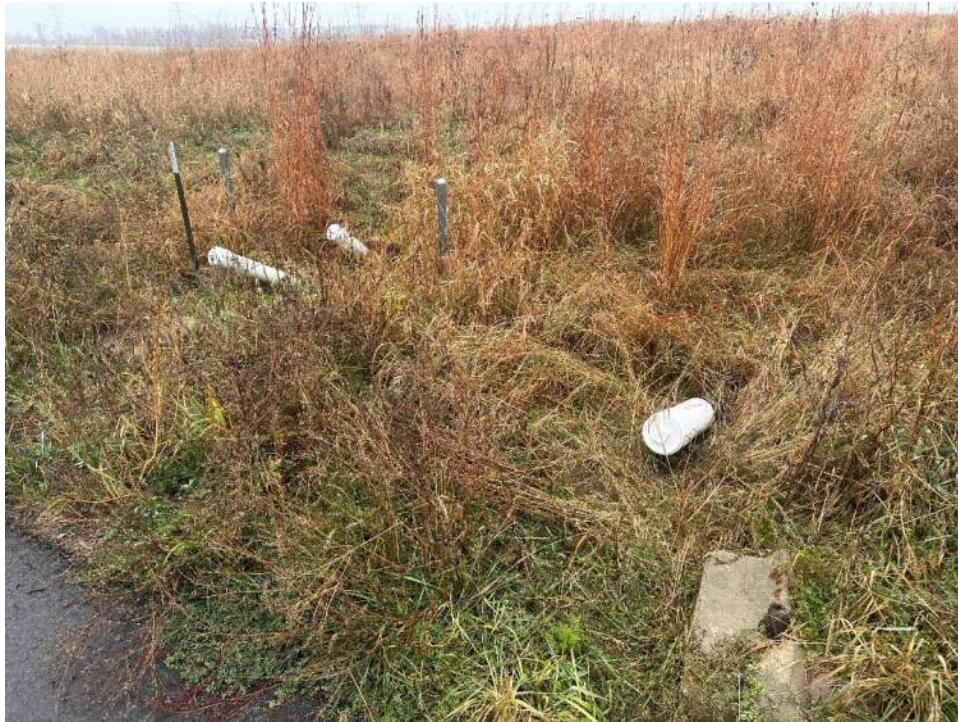
Photo No. 111 – Leachate headwell and cleanouts.
