December 19, 2016

GEI Project No. 1610536

**Re: Landfill Inspection Report for the We Energies Presque Isle Power Plant Landfill No. 3
Marquette Township, Michigan**

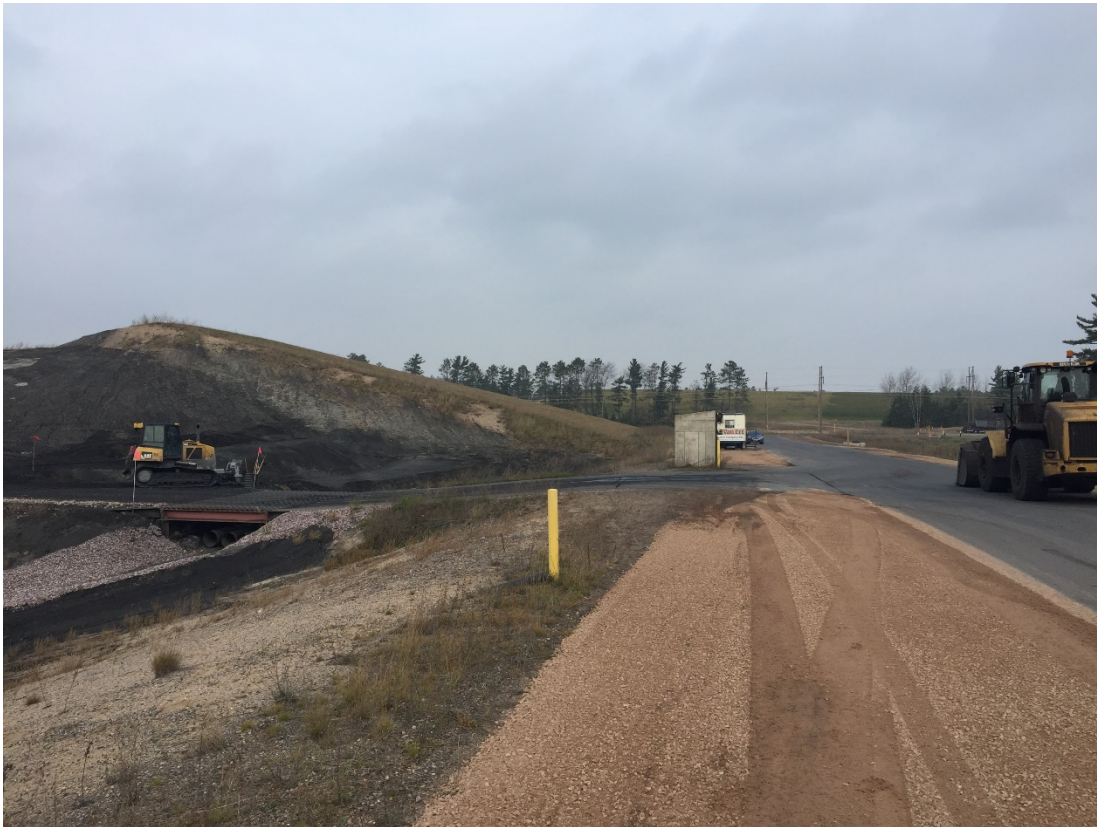
Photo 1- Landfill No. 3 access road and entrance to the landfill, looking north along east perimeter road.

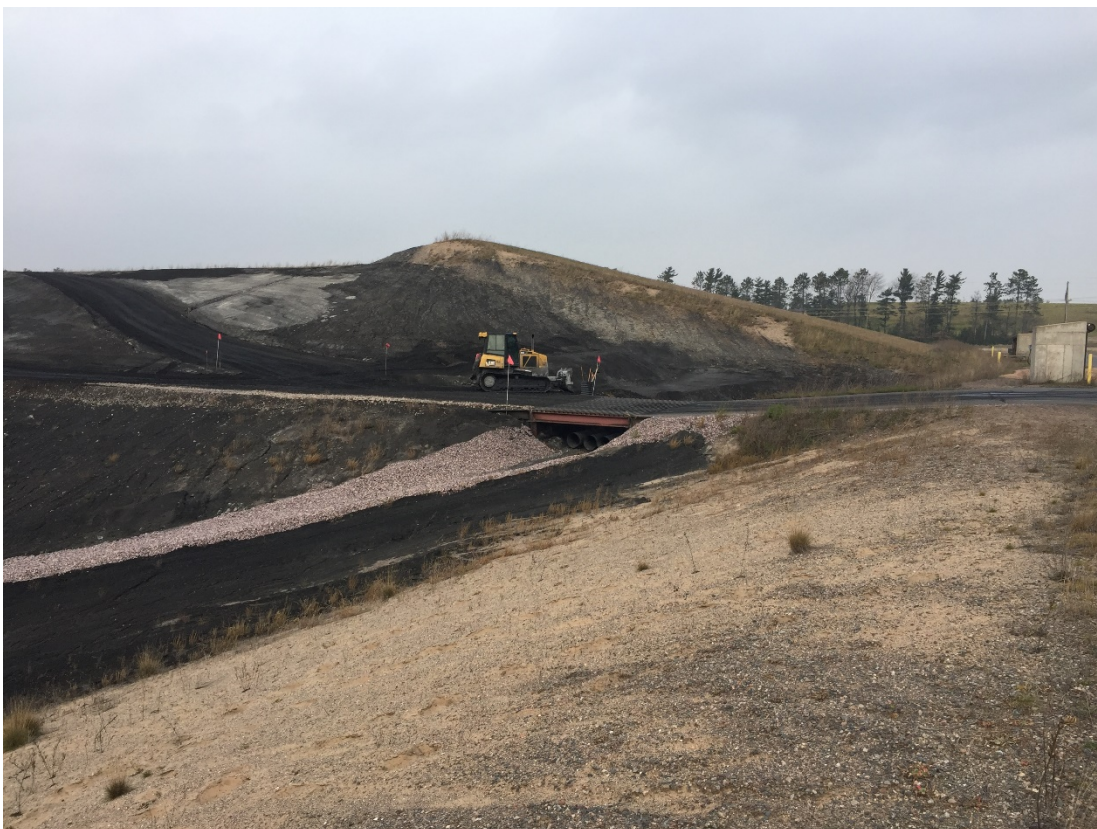
Photo 2- Landfill No. 3 access road looking north along east perimeter road.

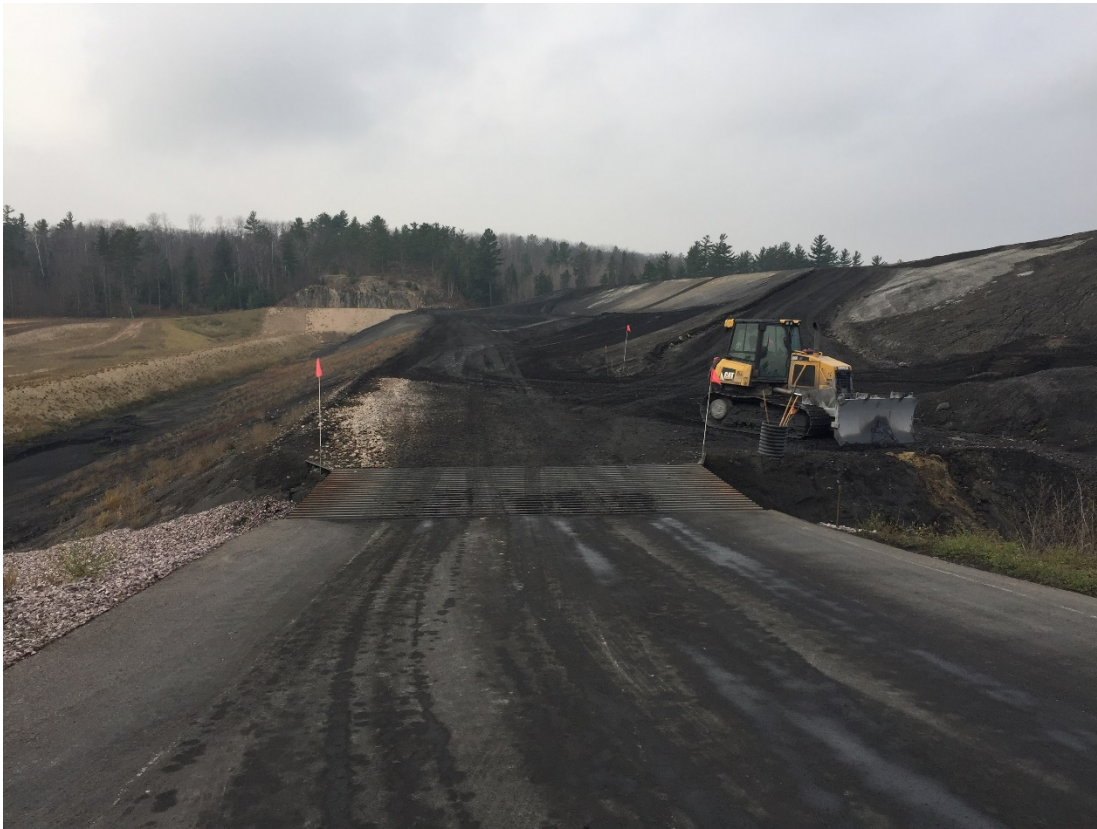
Photo 3- Entrance into Cell 2 looking west at cattle crossing used for storm water and track-out control.

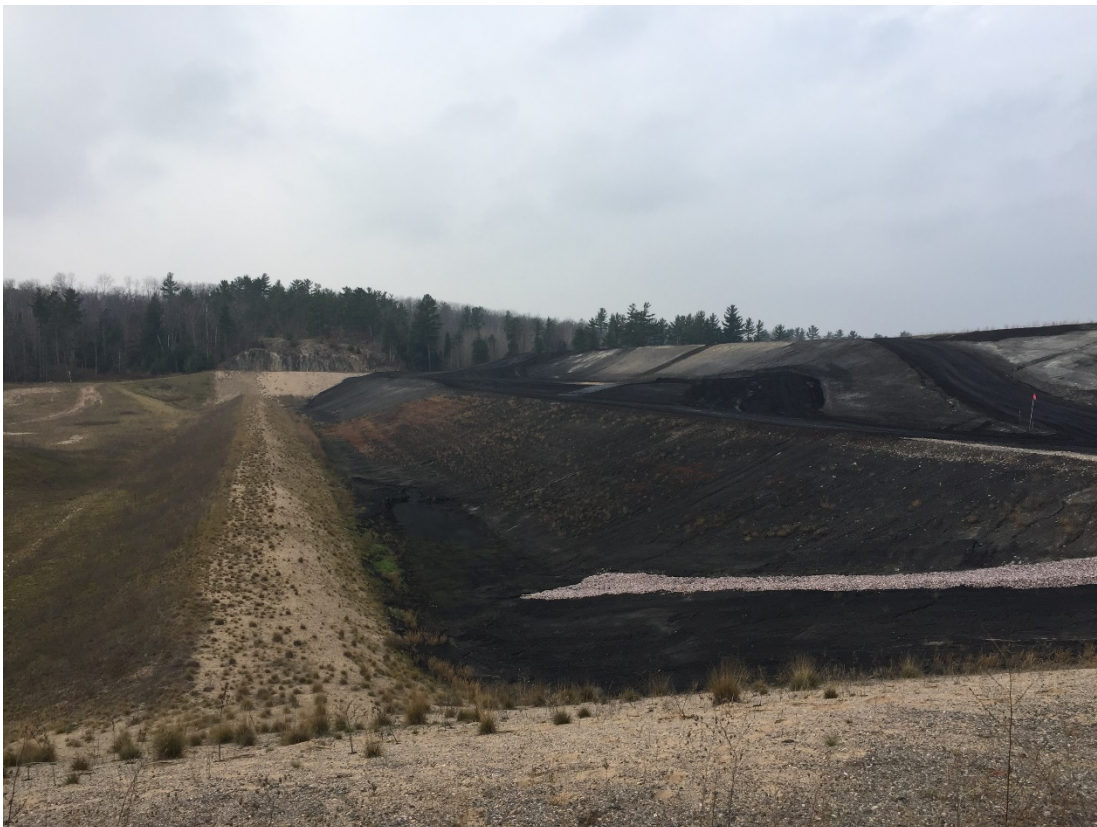
Photo 4- Looking west at the south containment berm and operational storm water containment area. The operational storm water containment area is graded as required by the design.

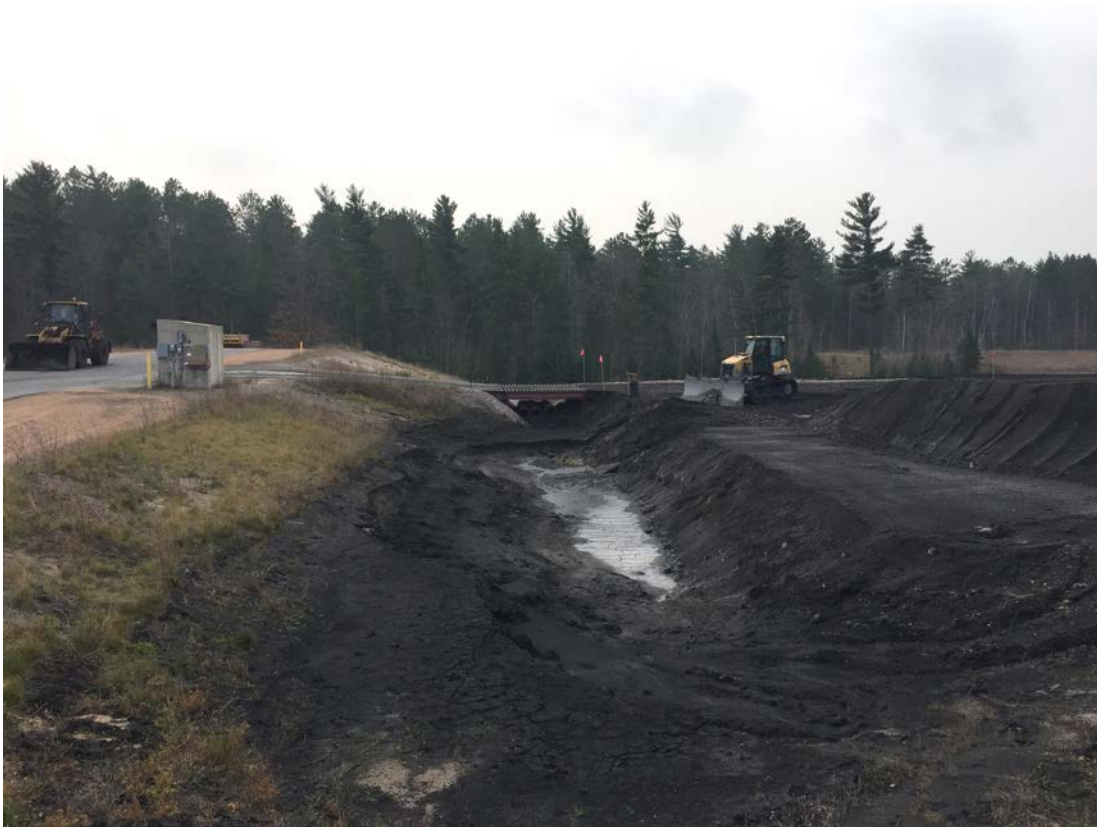
Photo 5- Operational storm water containment ditch north of the entrance. The ditch was recently cleaned out and in the process of regrading in preparation for winter and eventual spring runoff.

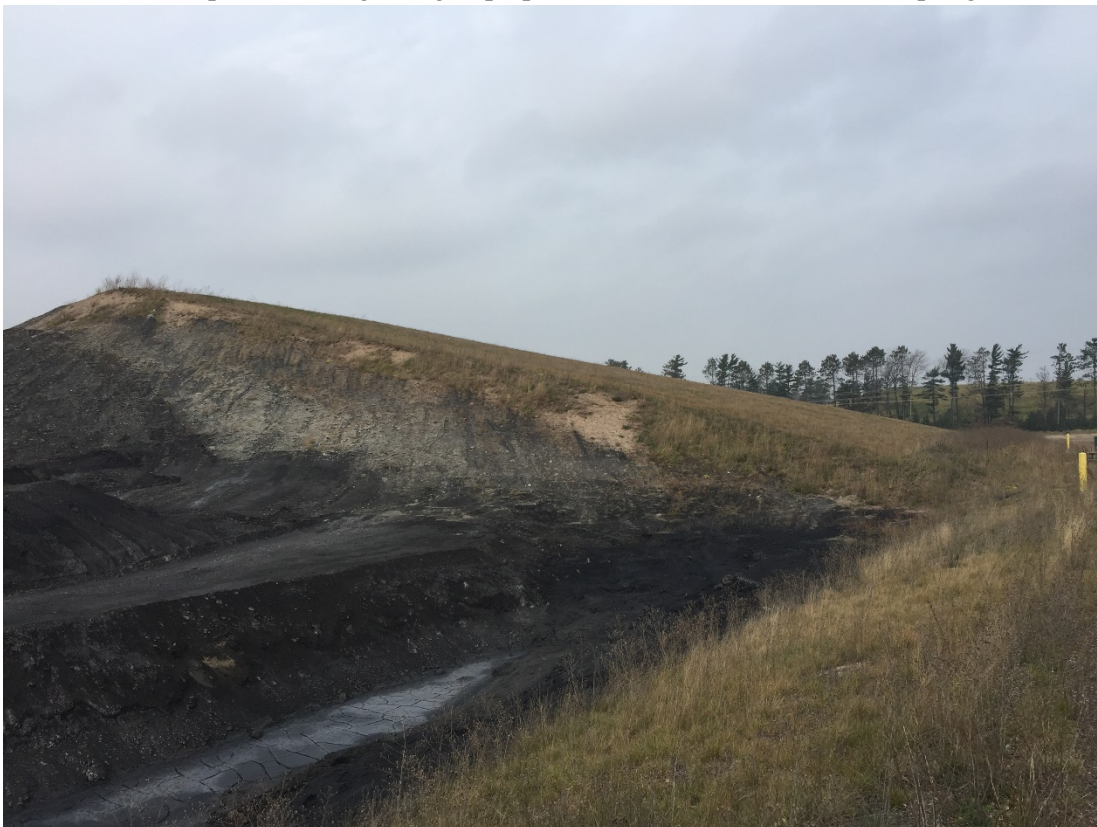
Photo 6- East Slope of Cell 1 which was closed in 2014. Slope appears to be in very good condition, well vegetated, no signs of instability or erosion, no woody vegetation, and no observed animal burrows.

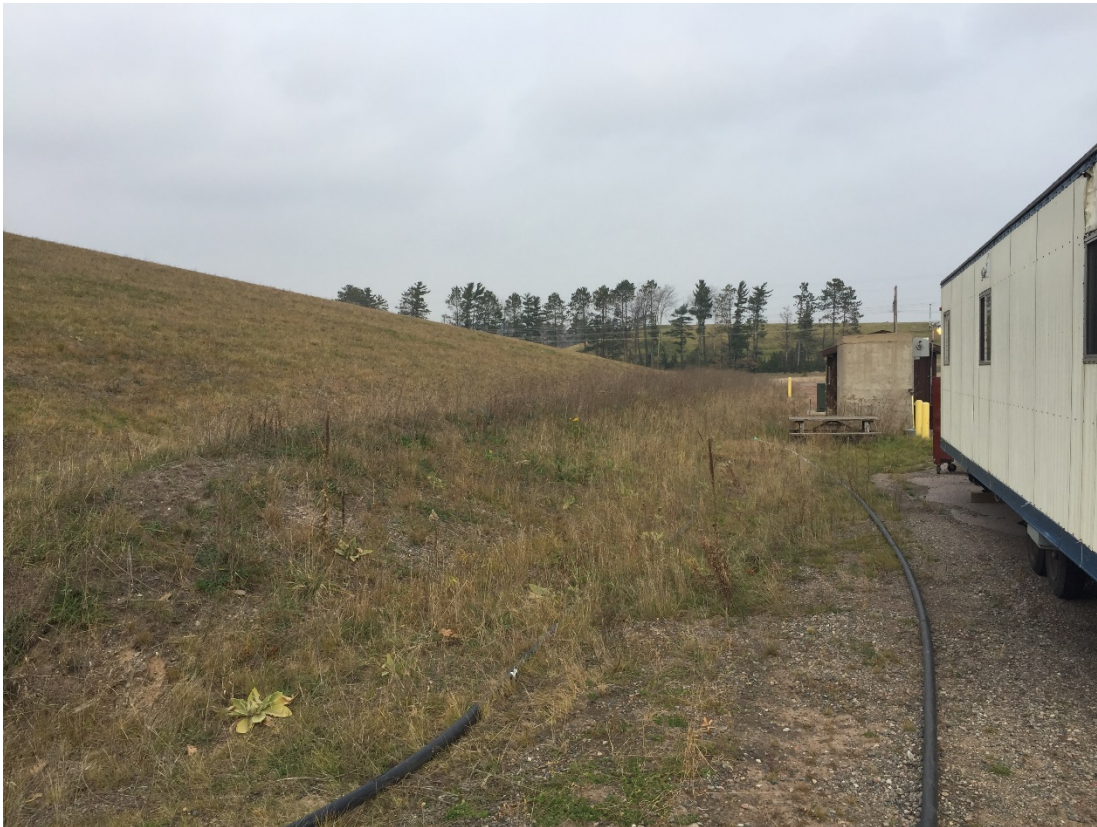
Photo 7- East Slope of Cell 1. Slope appears to be in very good condition, well vegetated, no signs of instability or erosion, no woody vegetation, and no observed animal burrows.

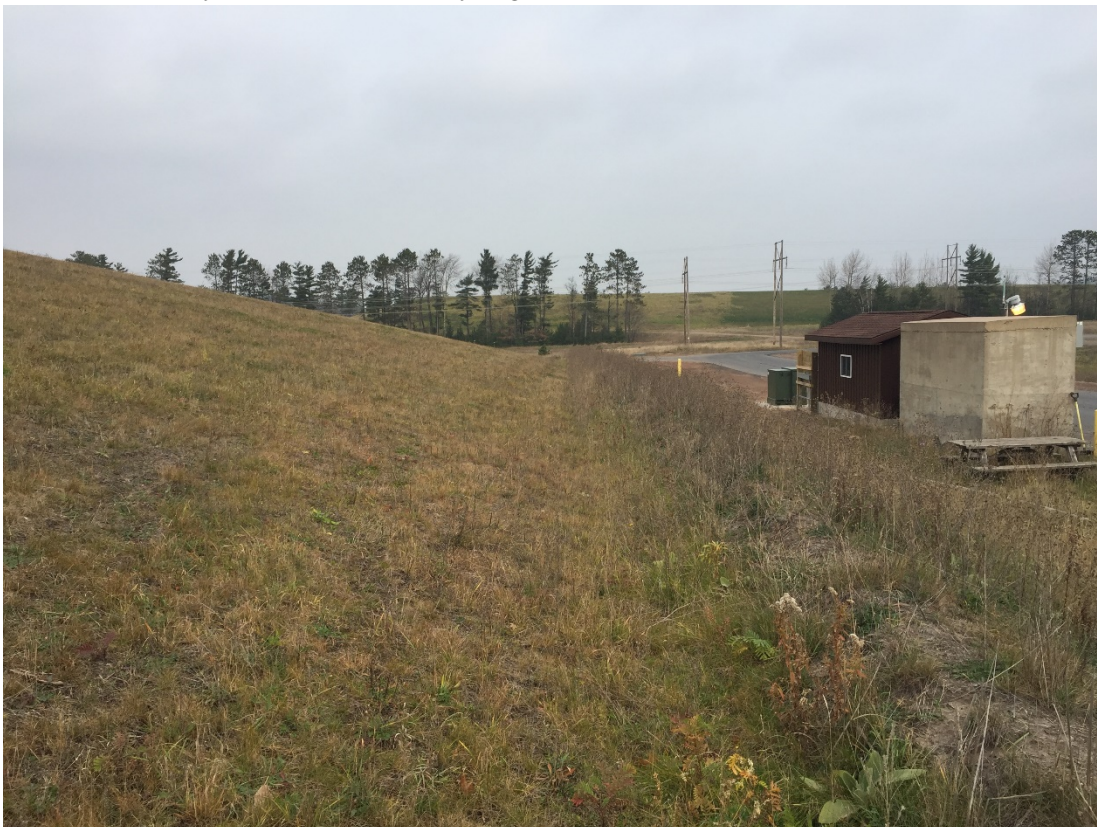
Photo 8- East Slope of Cell 1. Slope appears to be in very good condition, well vegetated, no signs of instability or erosion, no woody vegetation, and no observed animal burrows.

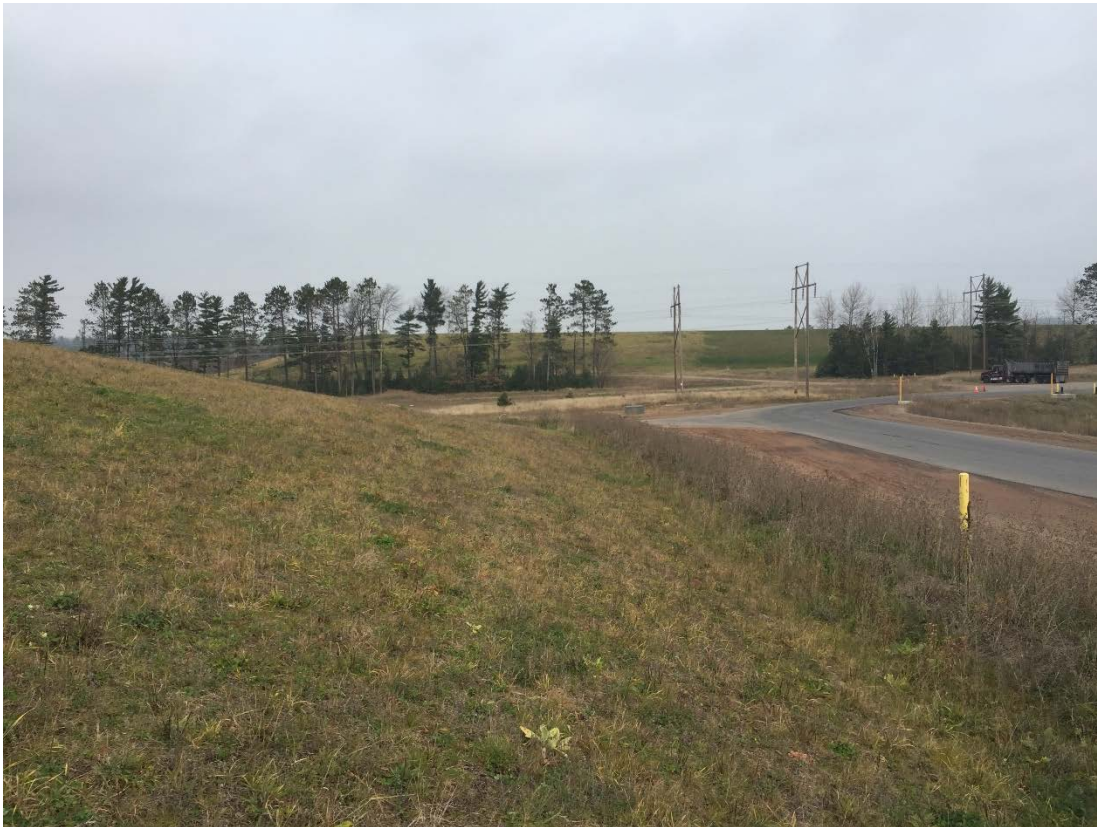
Photo 9- East Slope of Cell 1. Slope appears to be in very good condition, well vegetated, no signs of instability or erosion, no woody vegetation, and no observed animal burrows.

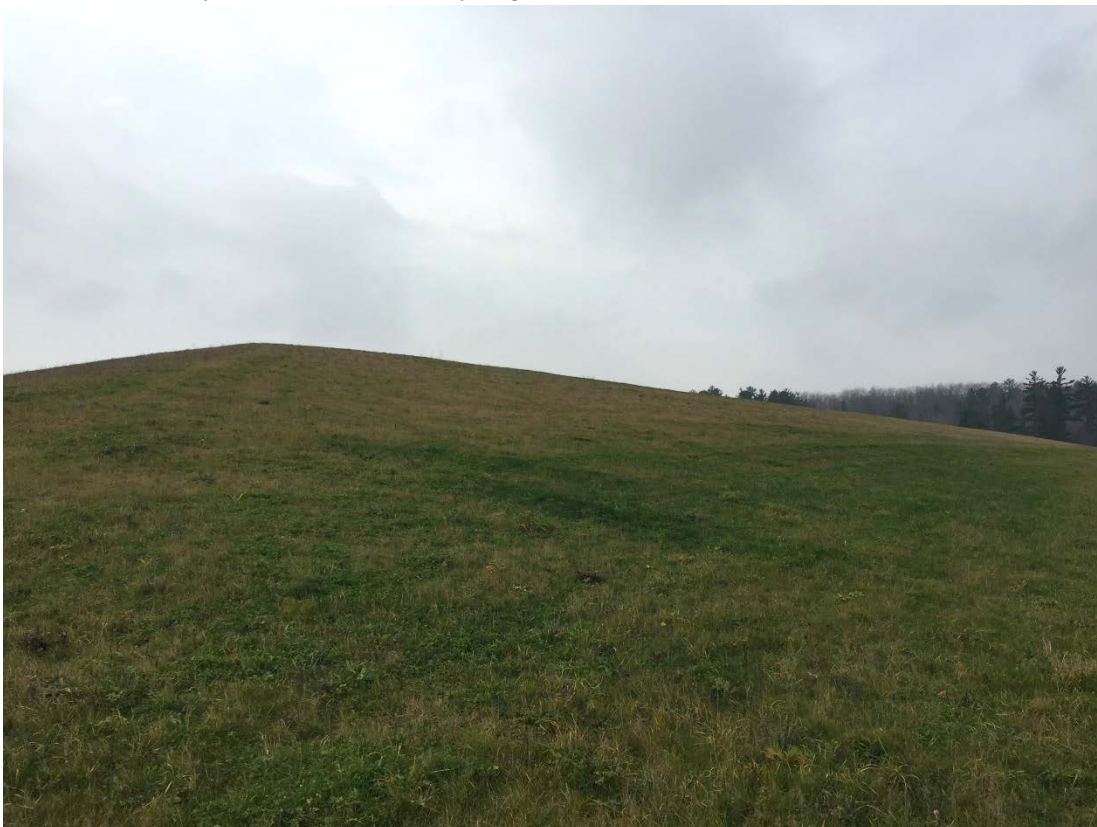
Photo 11- East Slope of Cell 1. Slope appears to be in very good condition, well vegetated, no signs of instability or erosion, no woody vegetation, and no observed animal burrows.

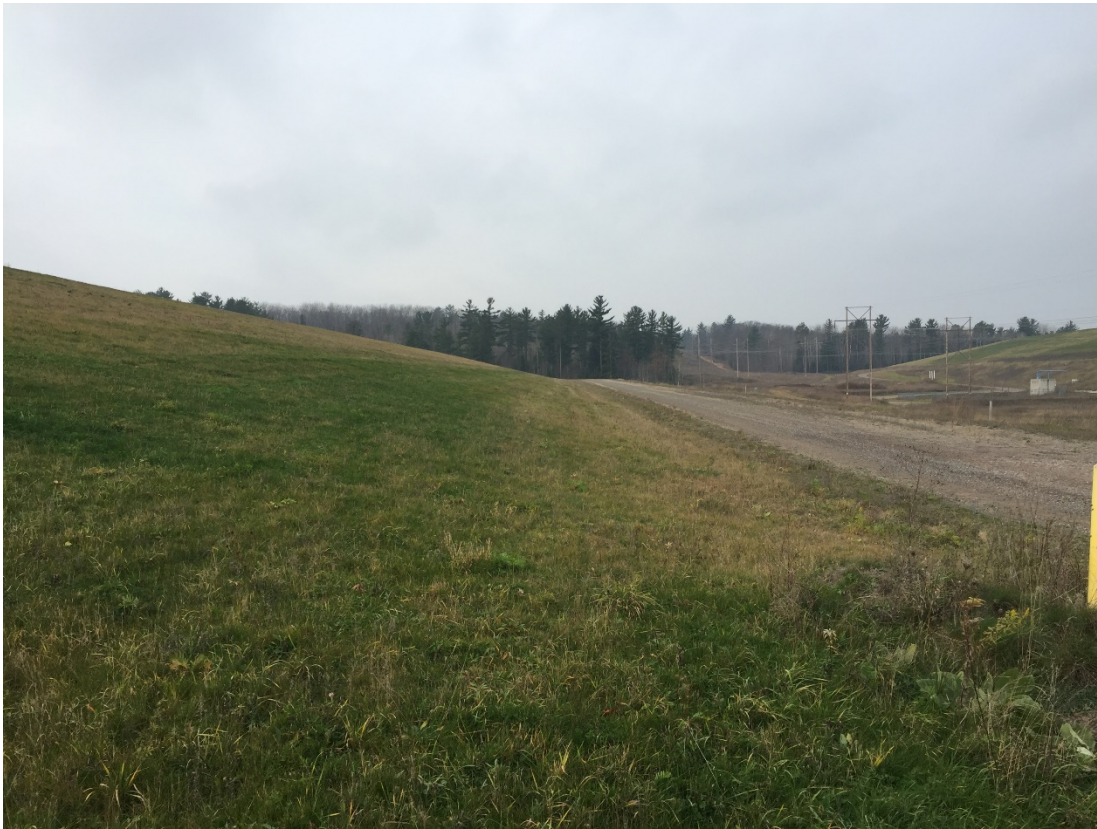
Photo 10- North Slope of Cell 1. Slope appears to be in very good condition, well vegetated, no signs of instability or erosion, no woody vegetation, and no observed animal burrows.

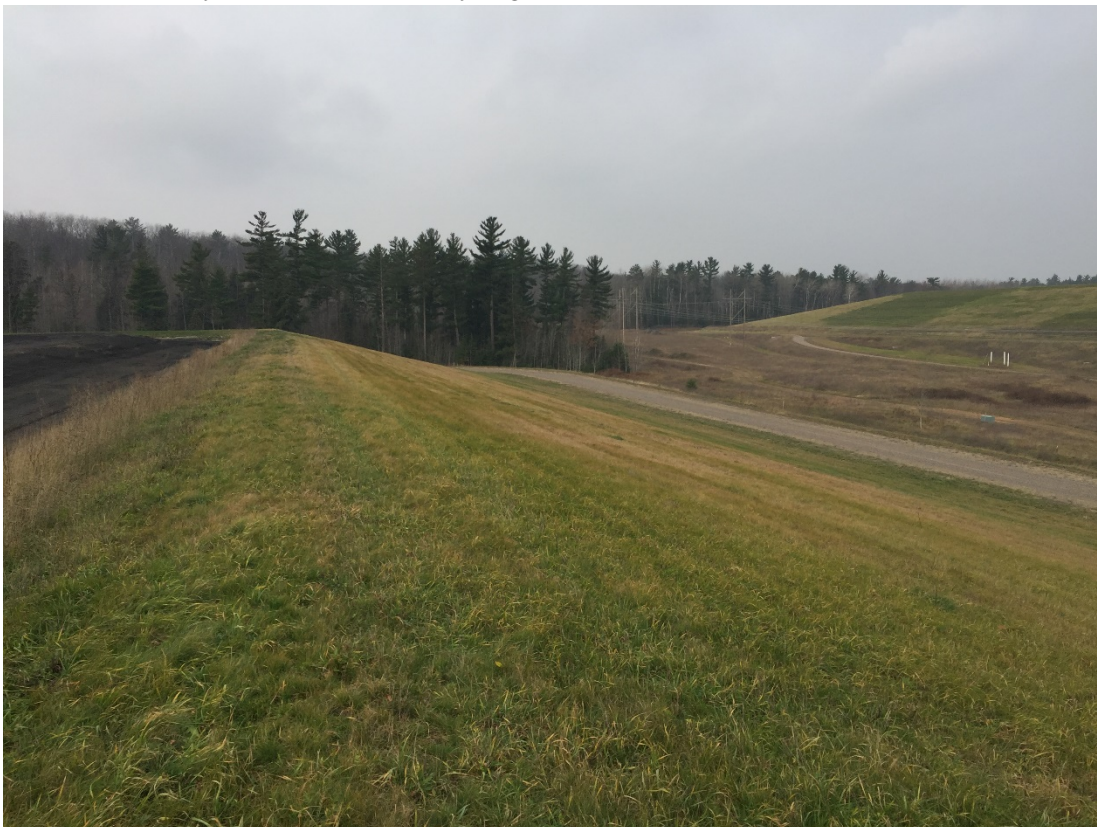
Photo 12- - North Slope of Cell 1. Slope appears to be in very good condition, well vegetated, no signs of instability or erosion, no woody vegetation, and no observed animal burrows.

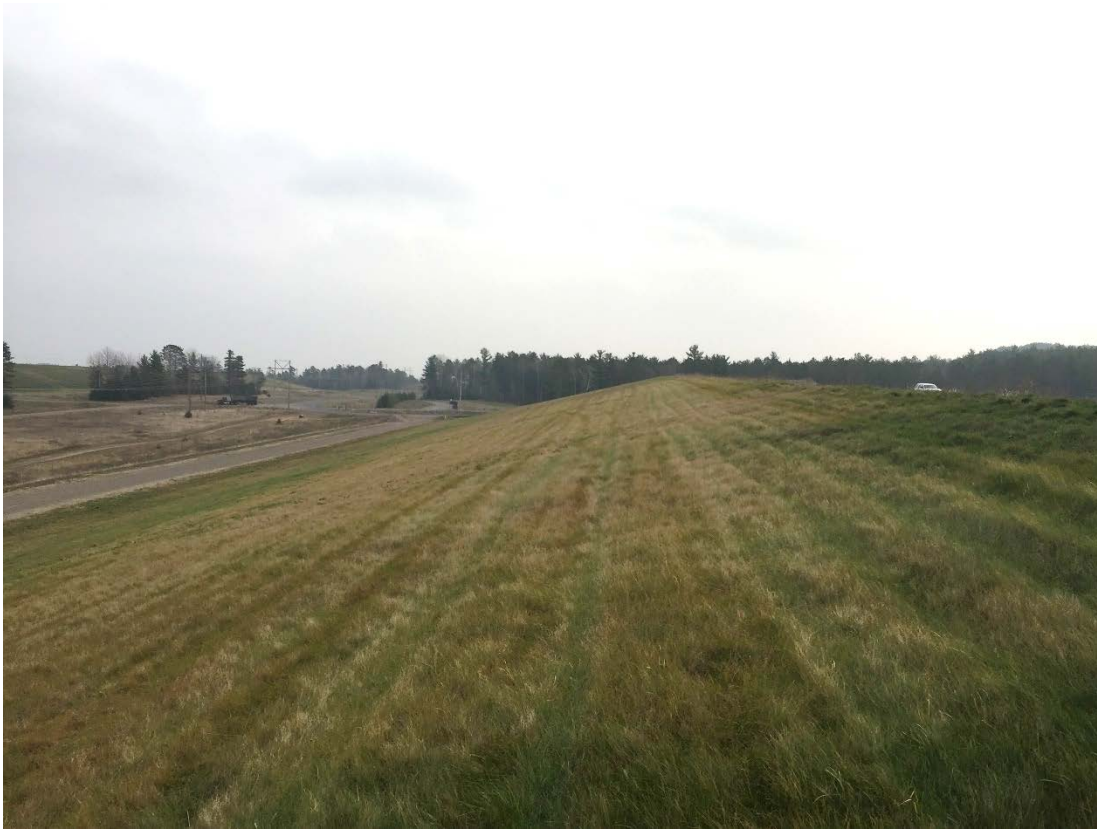
Photo 13- - North Slope of Cell 1. Slope appears to be in very good condition, well vegetated, no signs of instability or erosion, no woody vegetation, and no observed animal burrows.

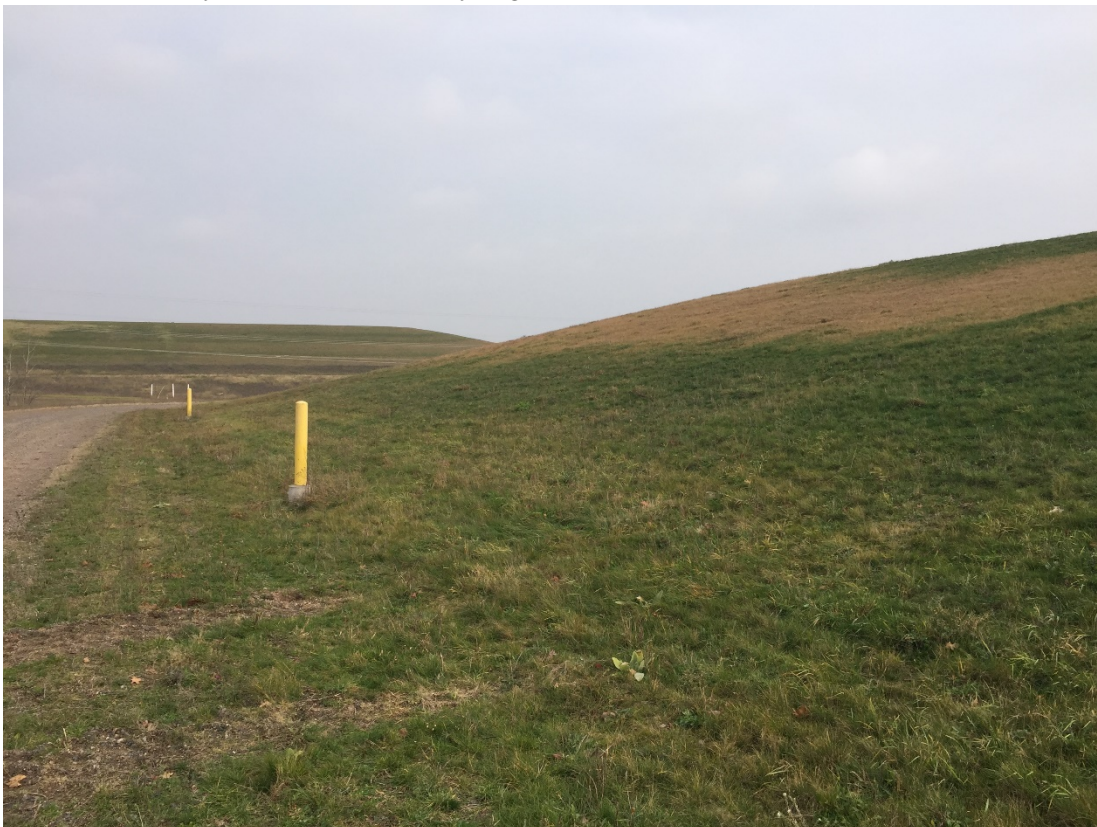
Photo 14 - West Slope of Cell 1. Slope appears to be in very good condition, well vegetated, no signs of instability or erosion, no woody vegetation, and no observed animal burrows.

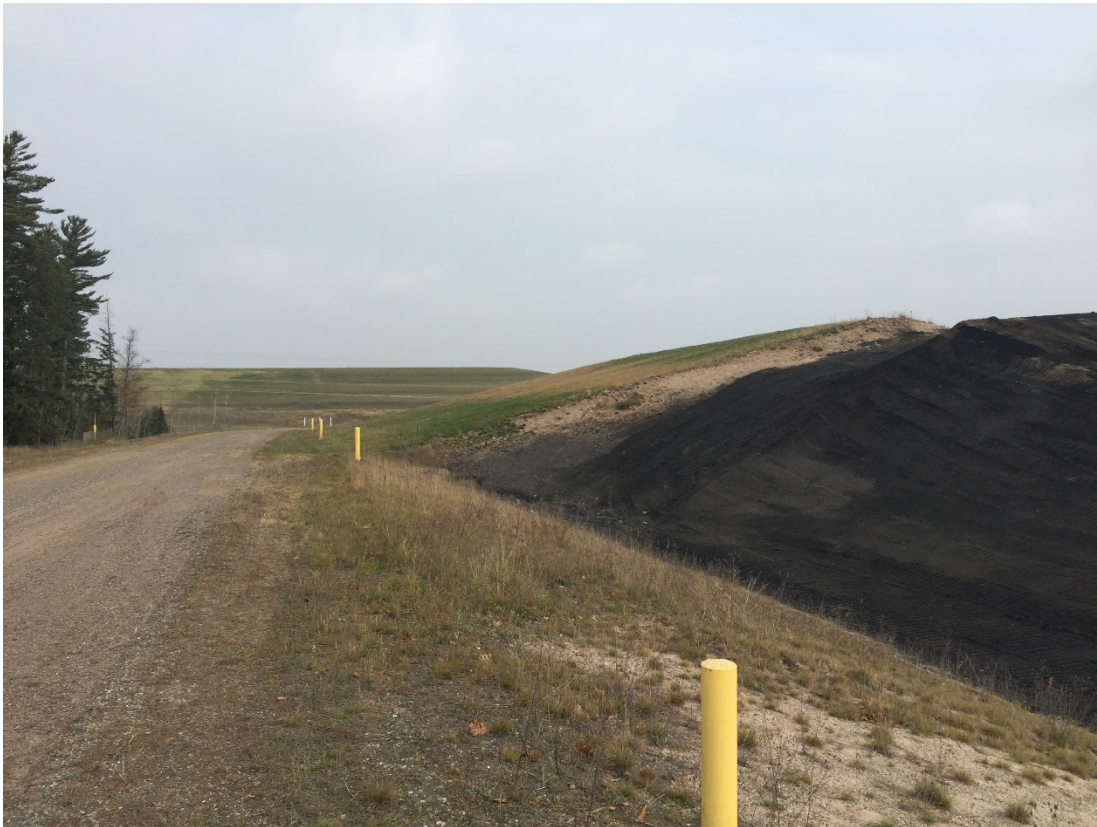
Photo 15 - West slope and operational storm water containment ditch. The ditch is in very good condition and prepared for winter and eventual spring runoff

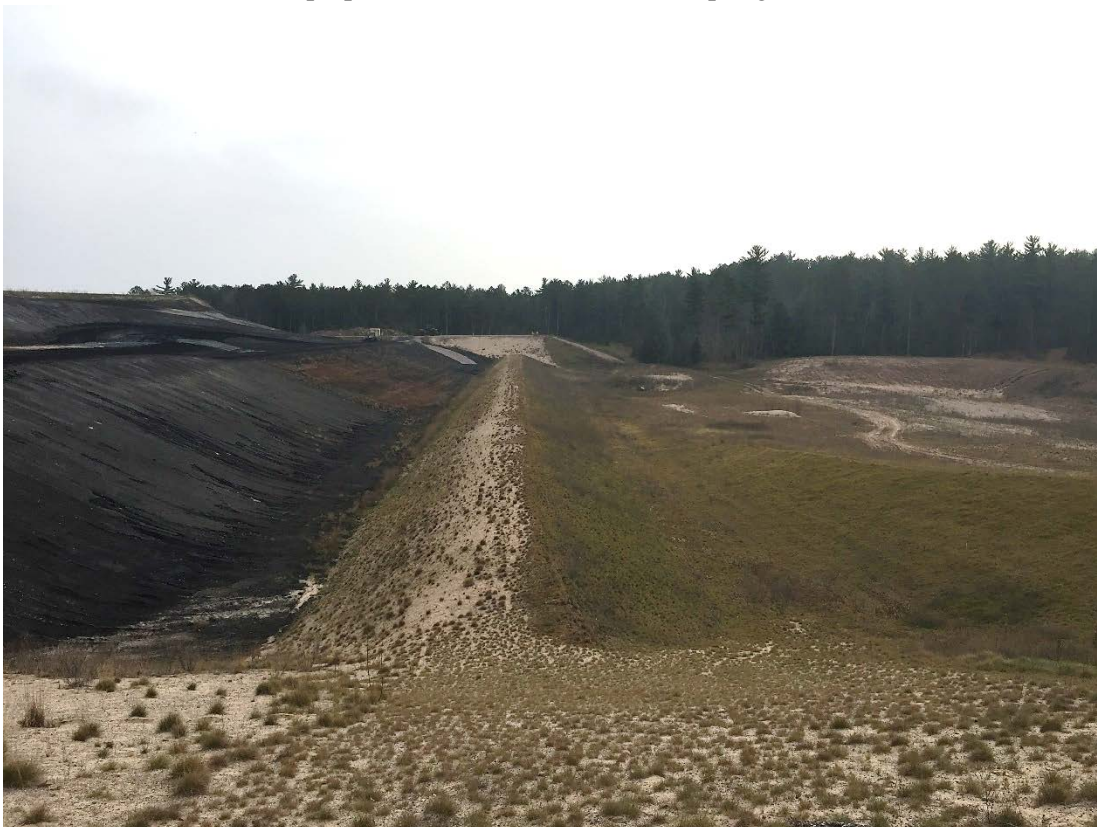
Photo 16 - Looking east at the south containment berm and operational storm water containment area. The operational storm water containment area is graded as required by the design.

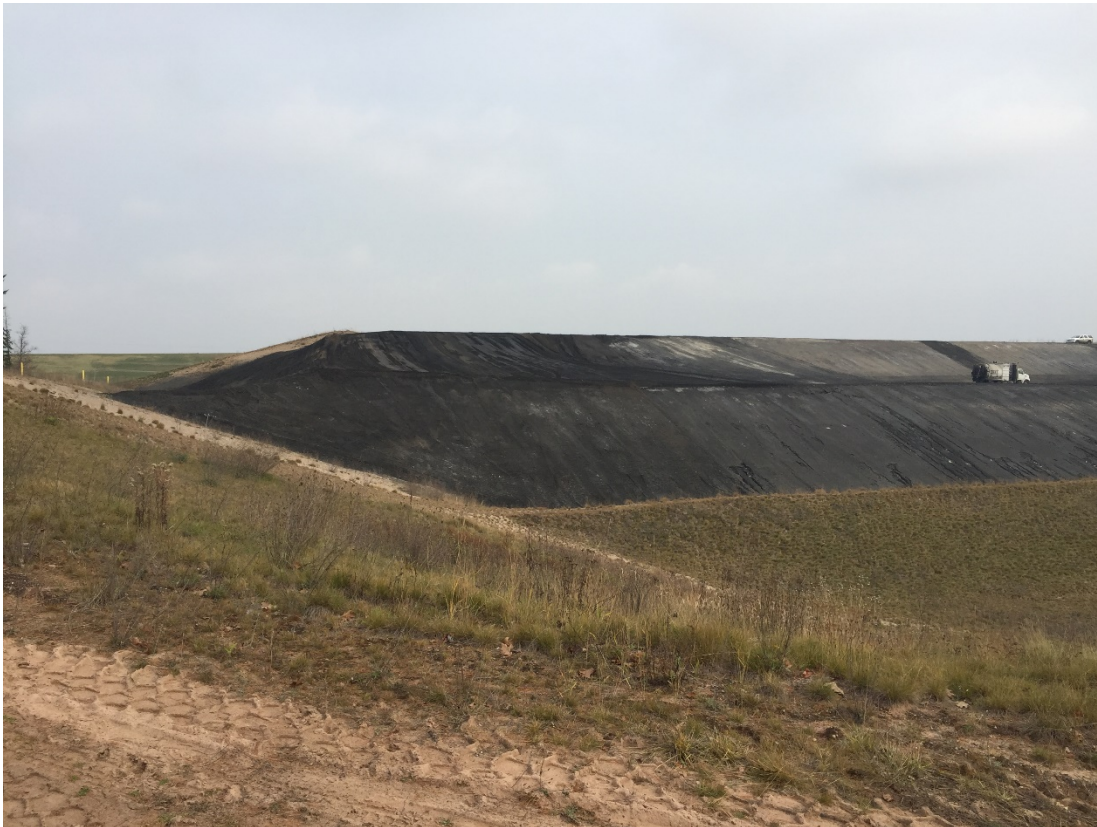
Photo 17 - View of west side of Cell 2 from south.

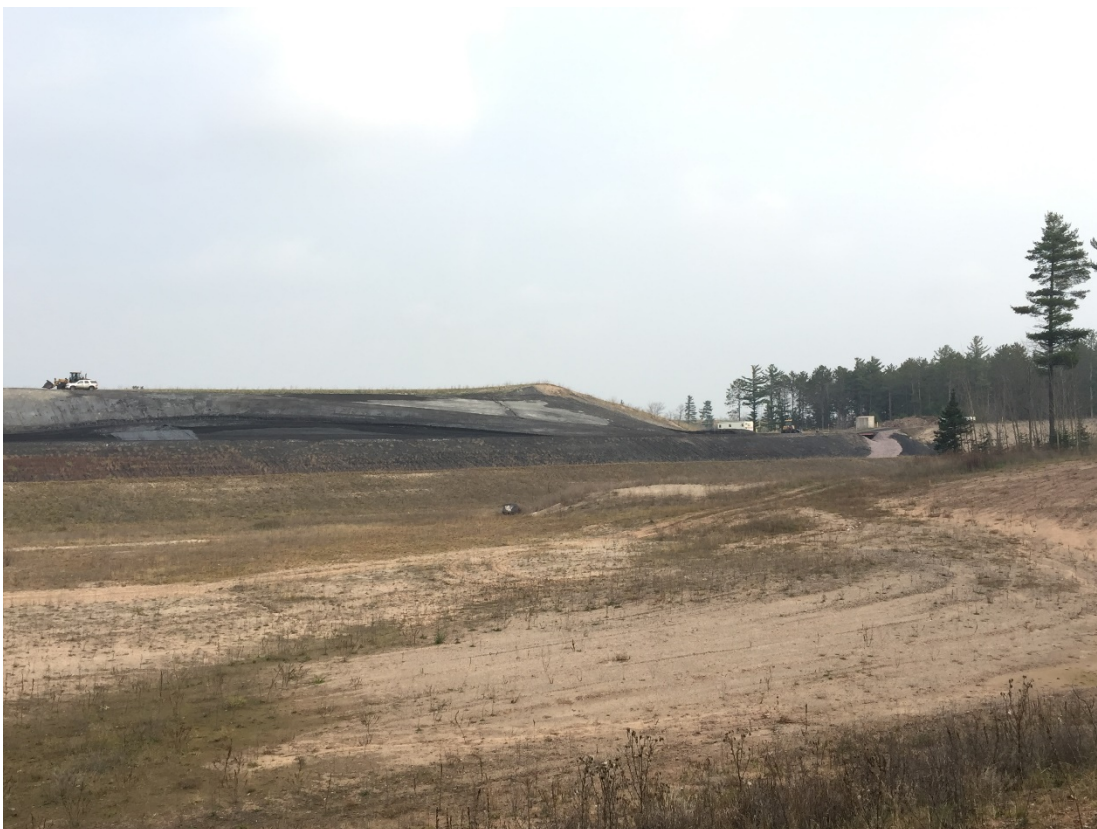
Photo 18 - View of east side of Cell 2 from south..

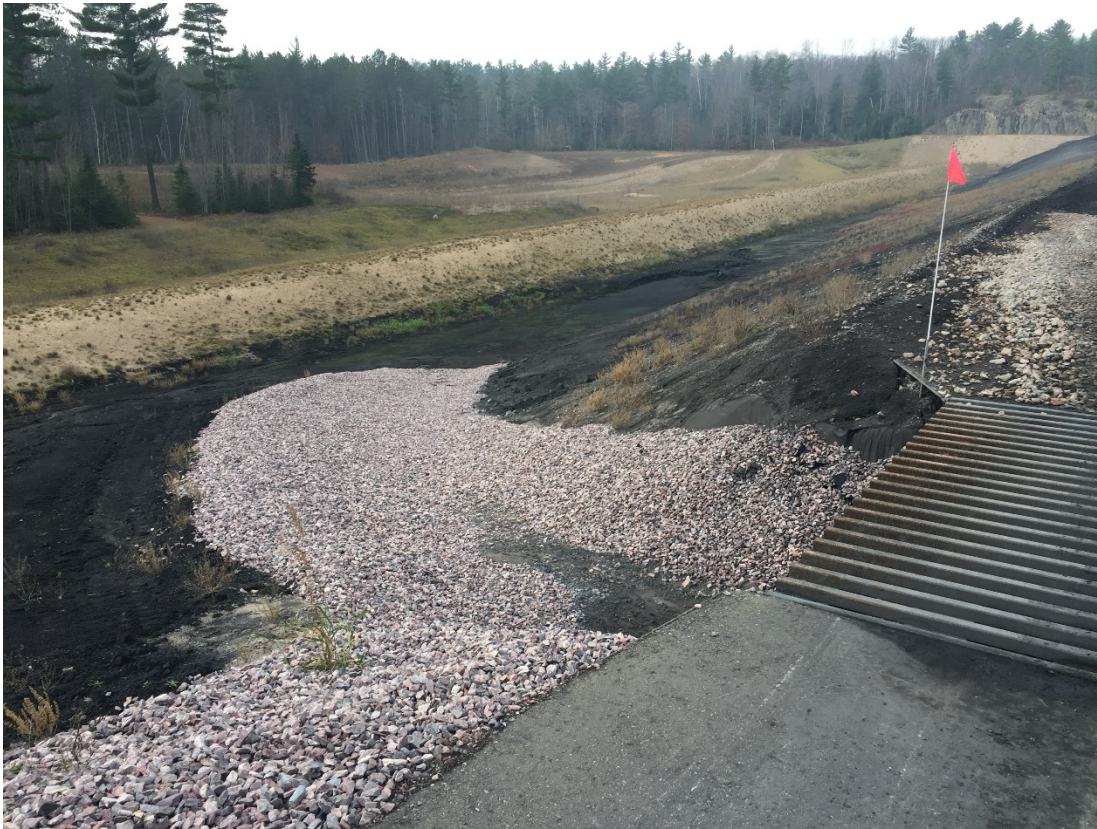
Photo 19 – View of temporary erosion protection installed to protect cell entrance road and cattle guard.

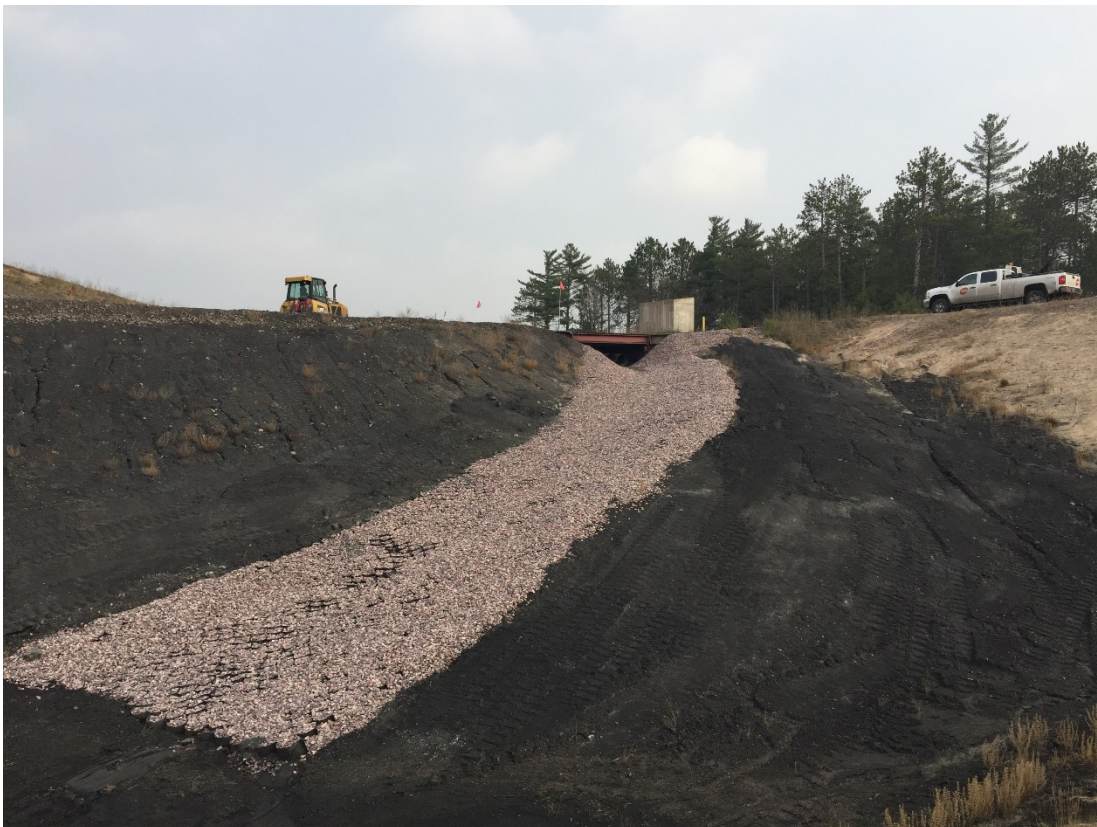
Photo 20 – View of temporary erosion protection of ash at cell entrance and cattle guard.
