December 15, 2017

GEI Project No. 1610536

**Re: Landfill Inspection Report for the We Energies Presque Isle Power Plant Landfill No. 3
Marquette Township, Michigan**

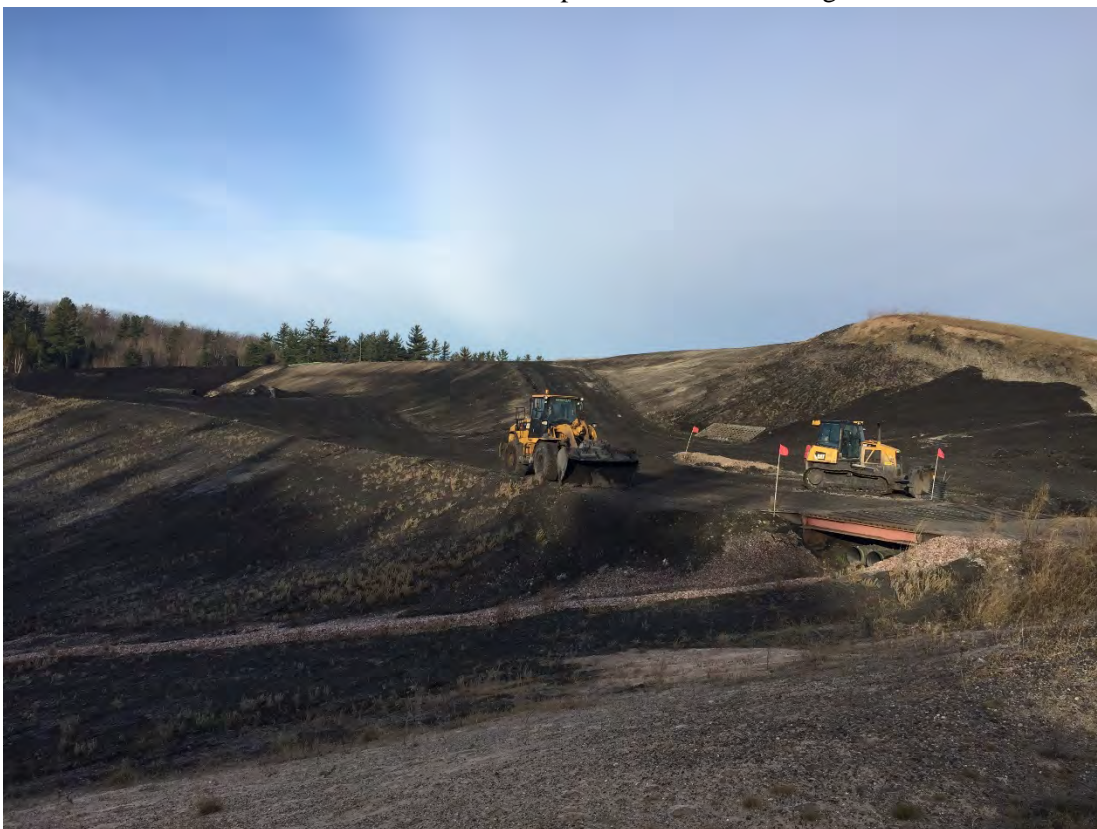
Photo 4 - Landfill No. 3 Cell Entrance looking Northwest.

Following the meeting with the operation personnel, GEI performed a site walk and inspection of the landfill. Overall the landfill appeared to be in very good condition. The all-weather access road was in good condition. The entrance into the landfill slopes to a cattle-crossing that is used to prevent contact water from escaping the landfill cell. The cattle guard also functions as a rumble strip helping to prevent the tracking of ash out of the landfill on the wheels of the haul trucks. The storm water control ditch and containment area appear to be in good condition and properly graded for winter operations.

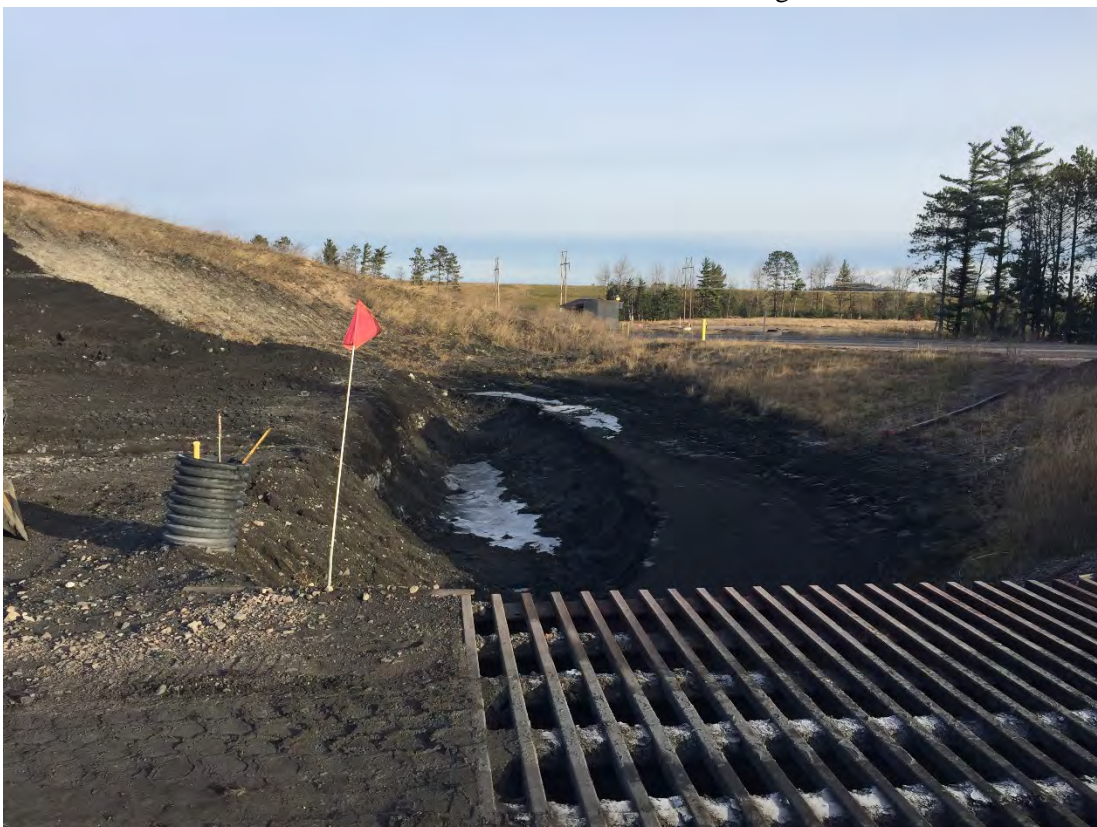
Photo 6 - Entrance into Cell 2 looking north at storm water containment area.

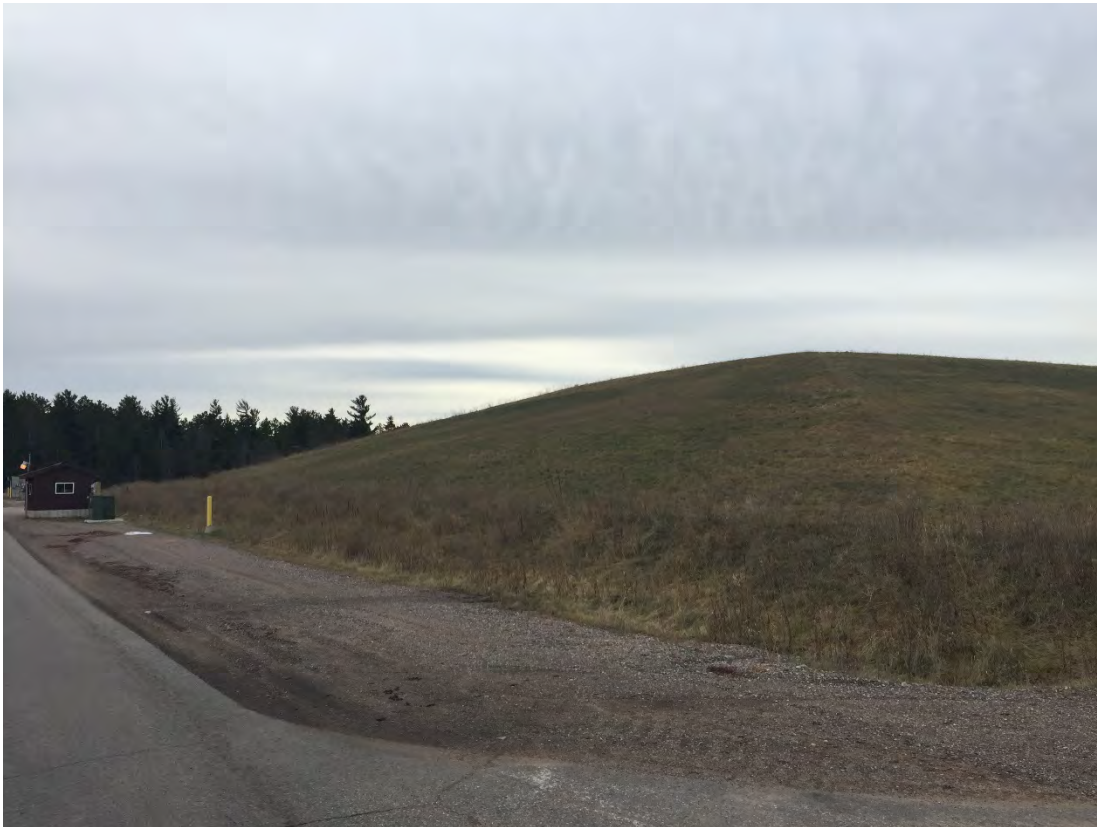
Photo 7 – East slope of Cell 1 from the north access road.

The perimeter slopes of Cell 1 that were closed in 2014 appeared to be in good condition. The vegetation appeared to be well established with no observed bare spots, no significant erosion, no woody vegetation, no animal burrows, and no areas of instability.

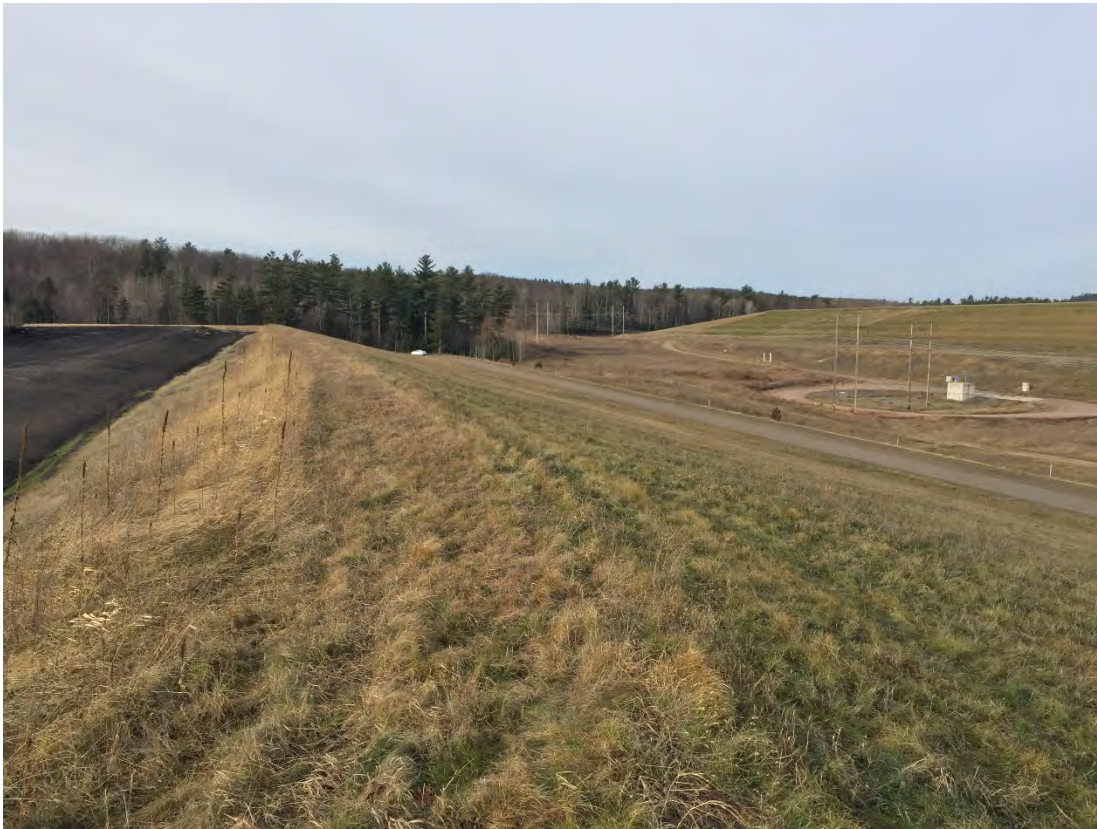
Photo 9 - North slope of Cell 1 looking to the west. Slope is in very good condition..
