December 19, 2018

GEI Project No. 1610536

**Re: Landfill Inspection Report
We Energies Presque Isle Power Plant Landfill No. 3
Marquette Township, Michigan**

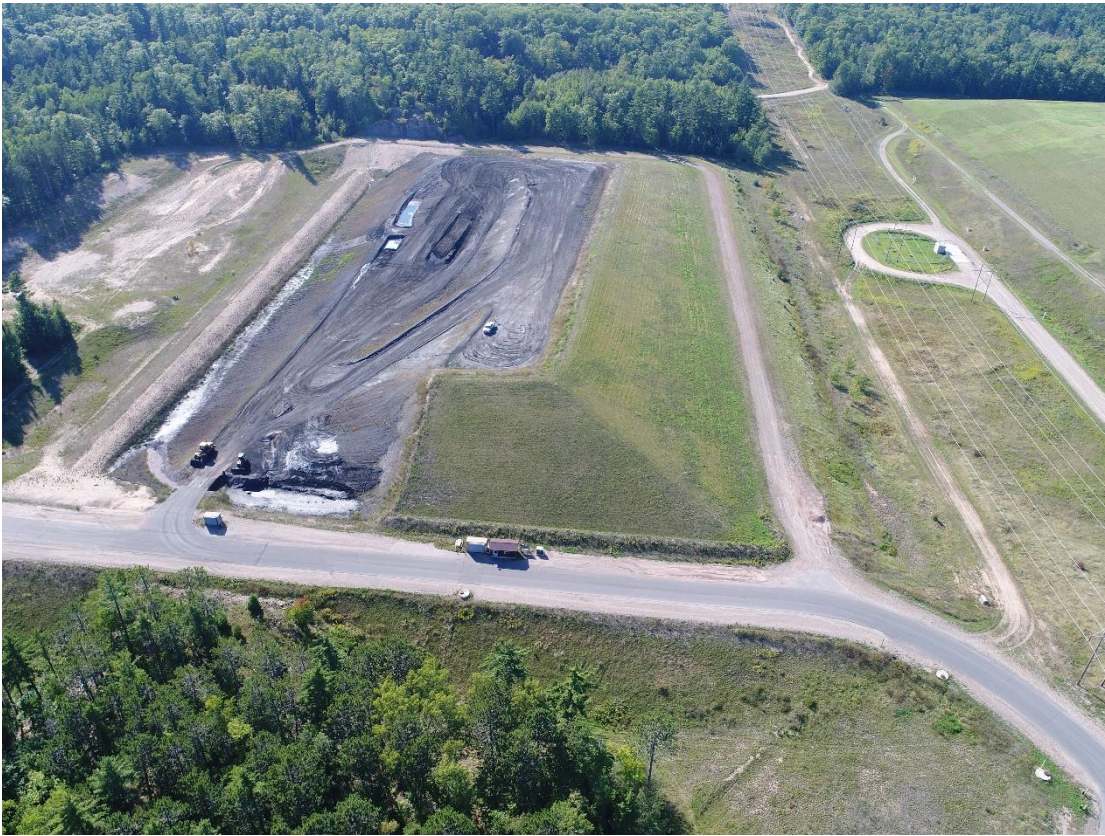
Photo 1 – Landfill No.3 Looking west 09/13/2018.

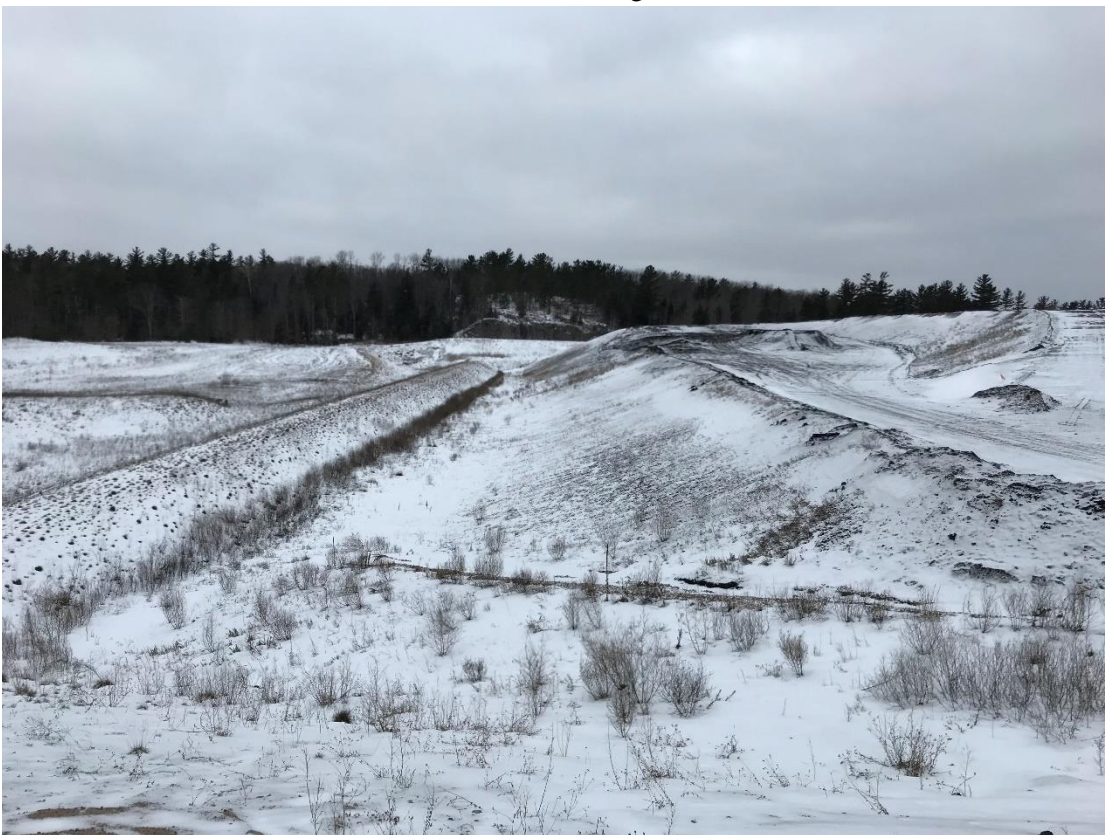
Photo 2 - Landfill No. 3 South perimeter berm looking West.

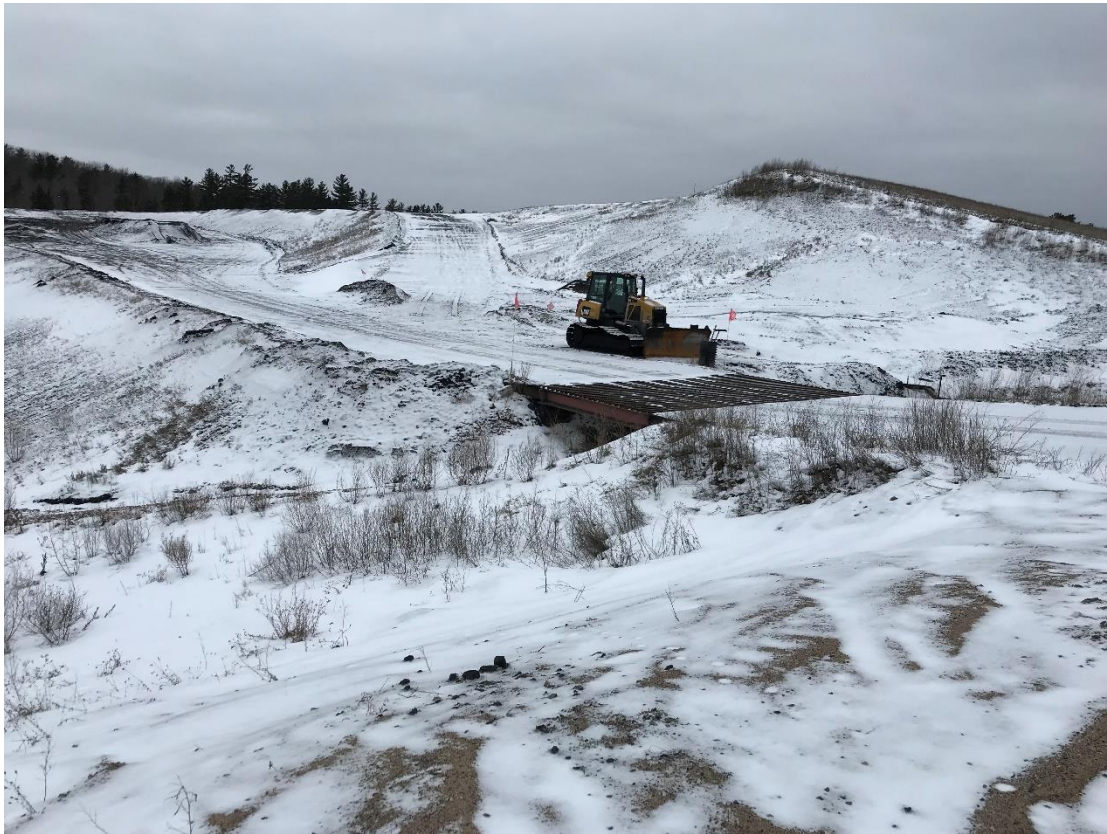
Photo 3 – Landfill No. 3 Cell Entrance looking Northwest.

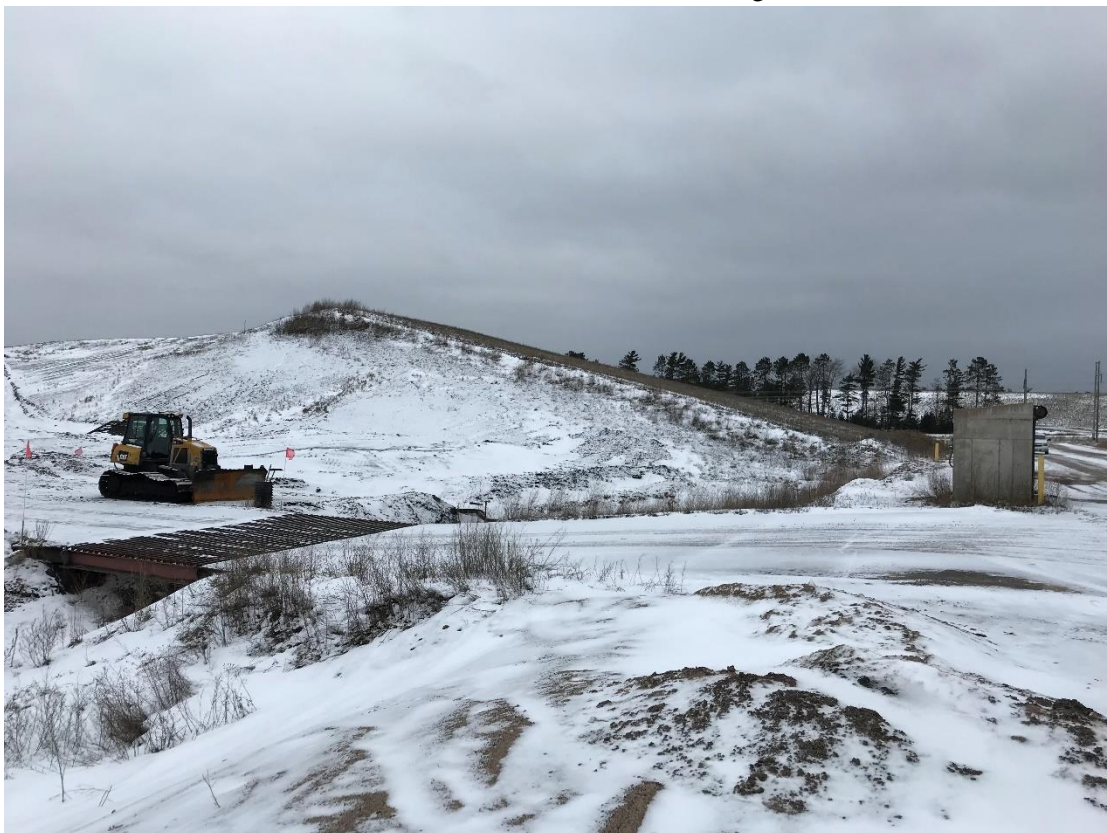
Photo 4 - Landfill No. 3 Cell Entrance looking north towards storm water containment area.

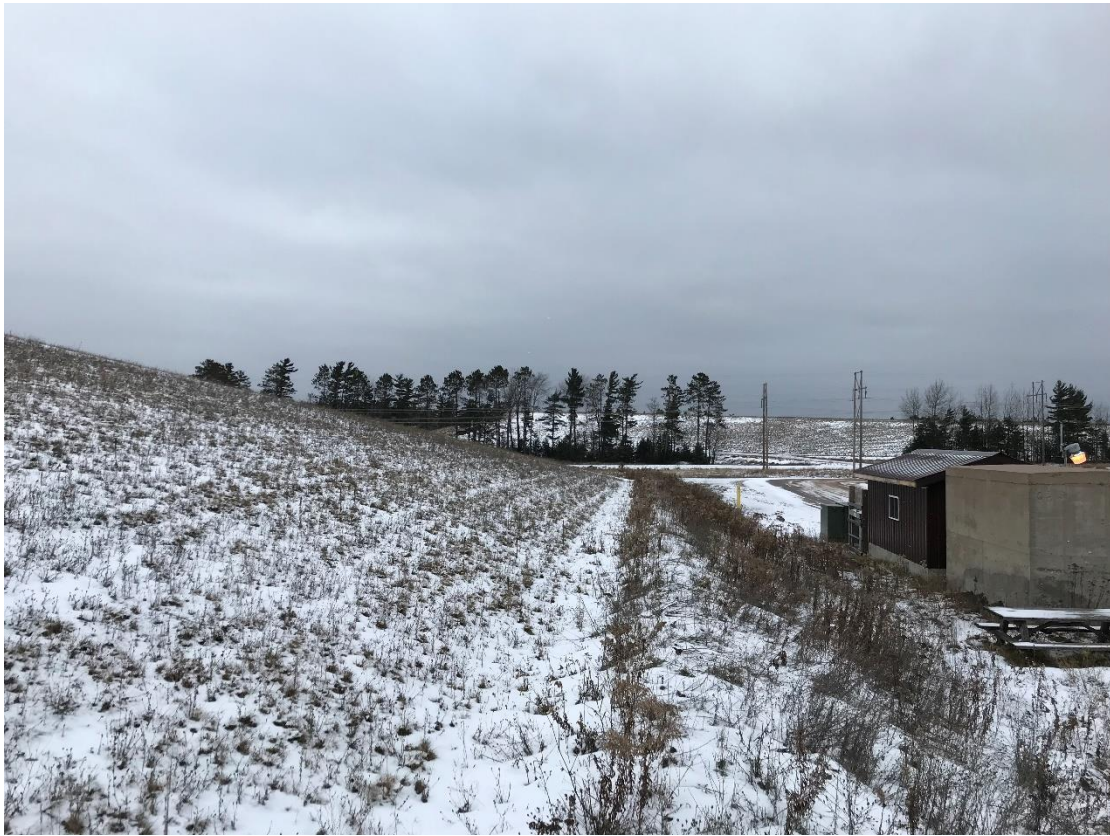
Photo 5 – East slope of Cell 1 from the north access road.

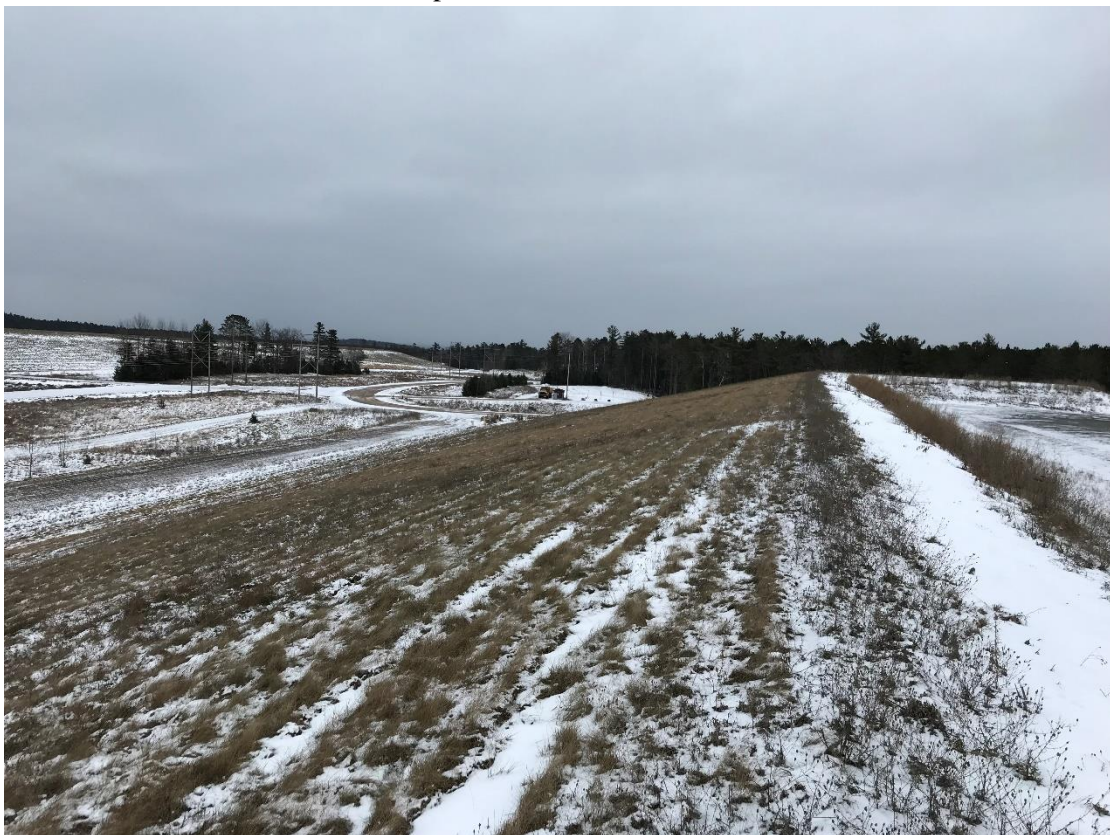
Photo 6- North slope of Cell 1.

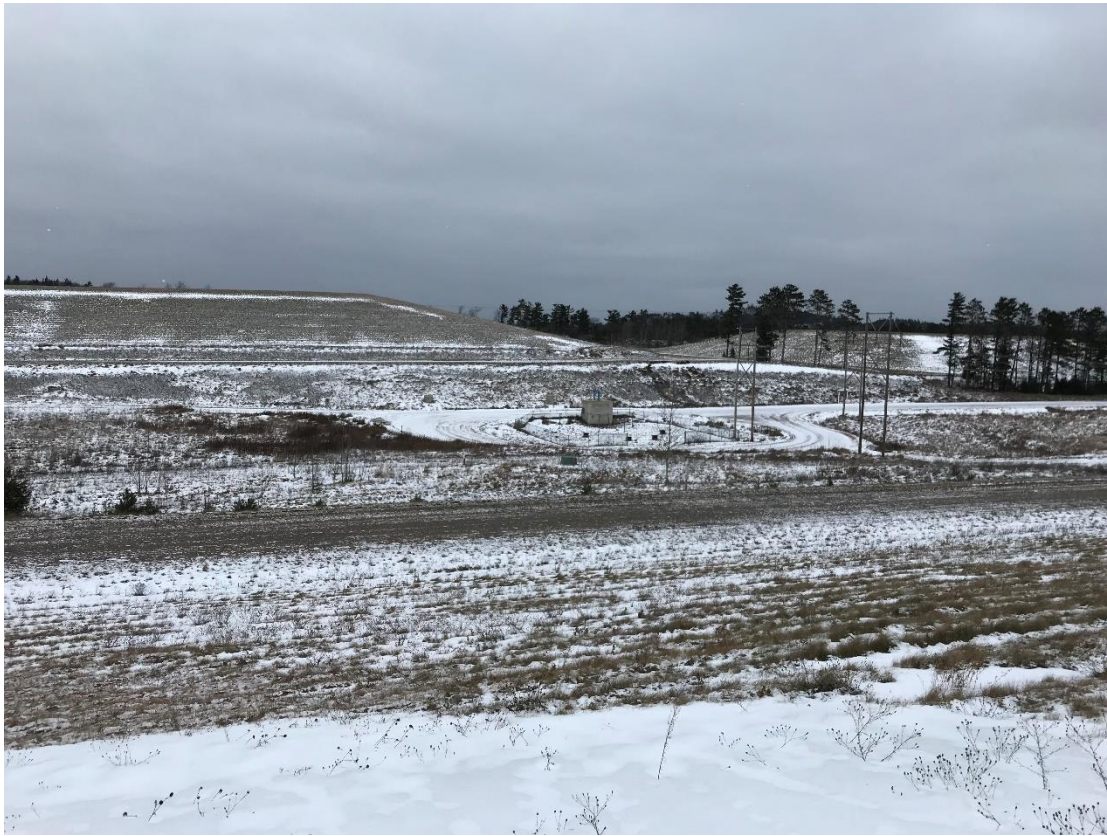
Photo 7 - North slope of Cell 1 looking to the north. Slope is in very good condition.

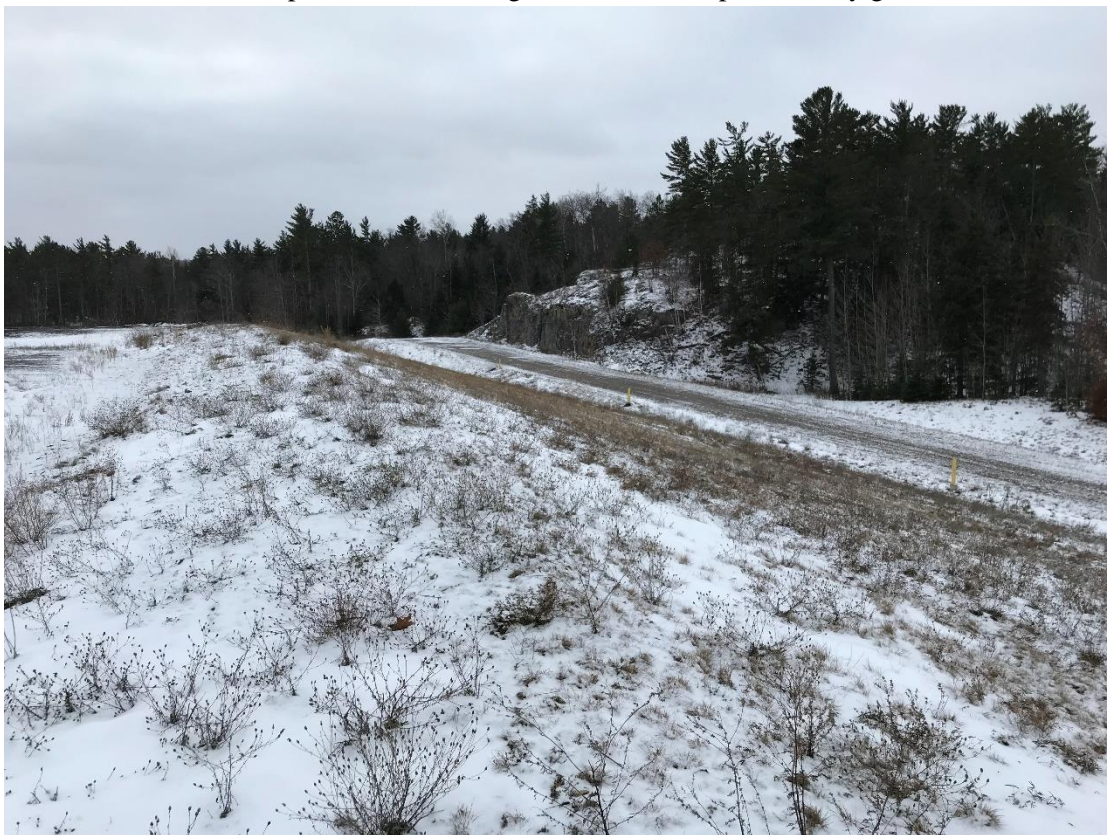
Photo 8 - West slope of Cell 1 looking south.

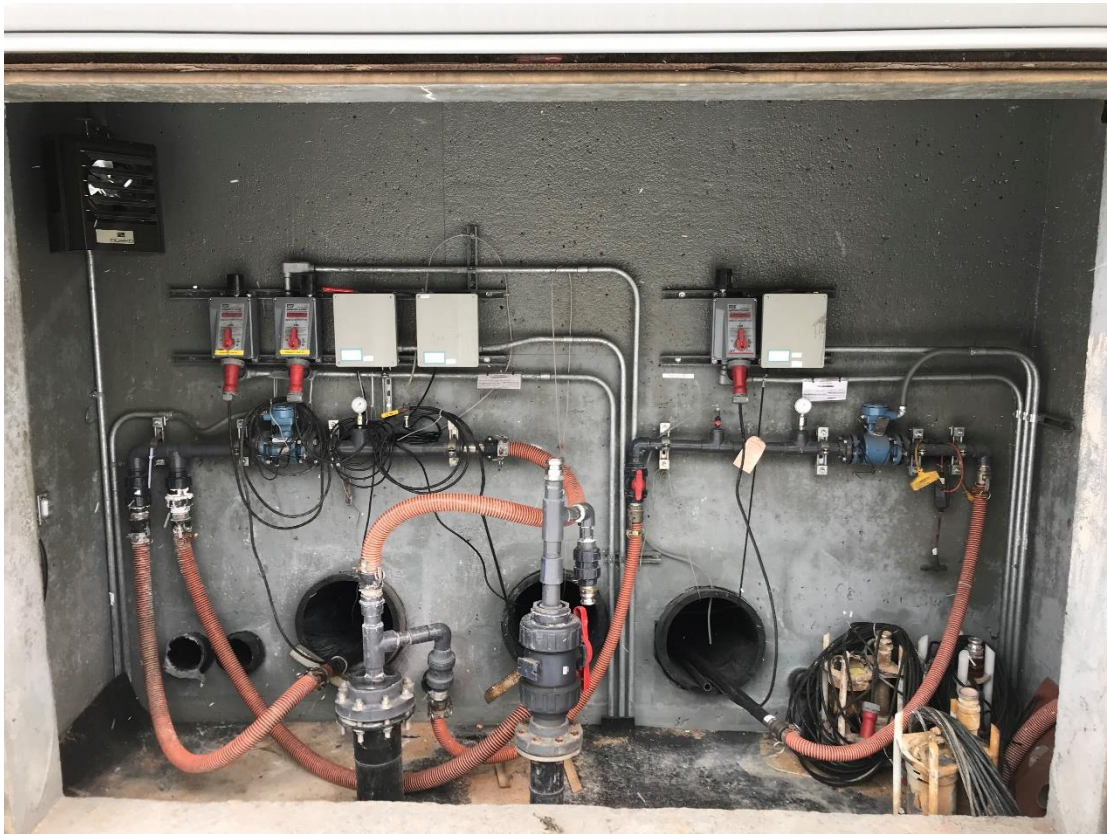
Photo 9 – Cell 1 side slope riser vault.

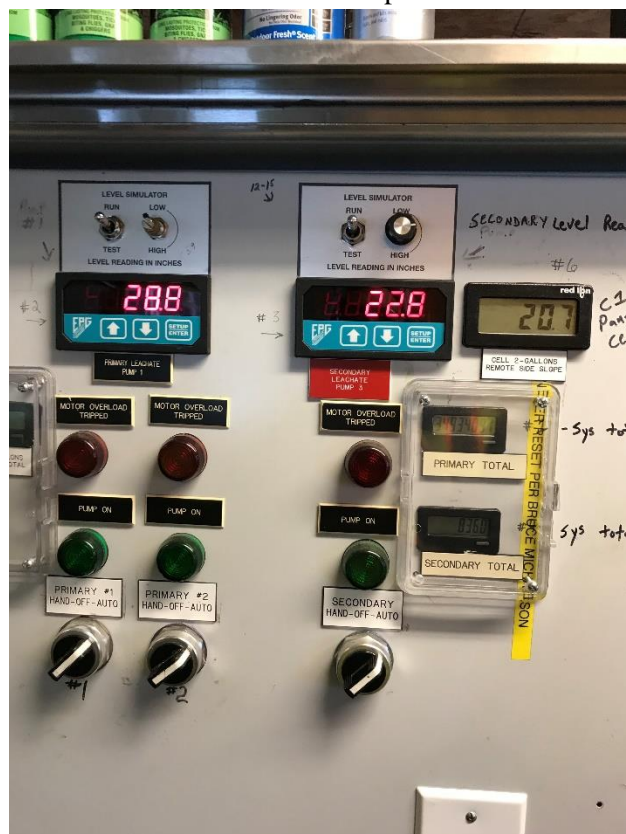
Photo 10 – Cell 1 leachate pump controls.

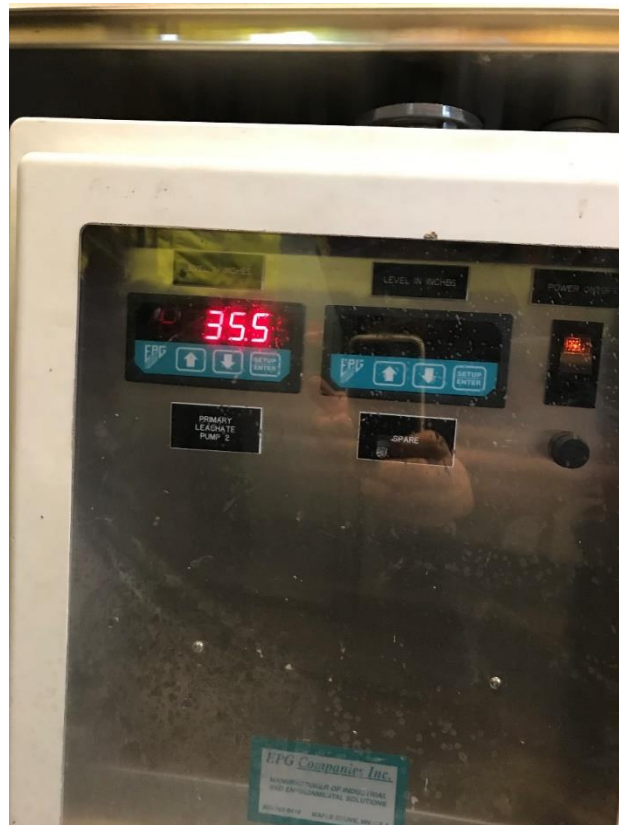
Photo 11 – Cell 1 leachate pump controls.

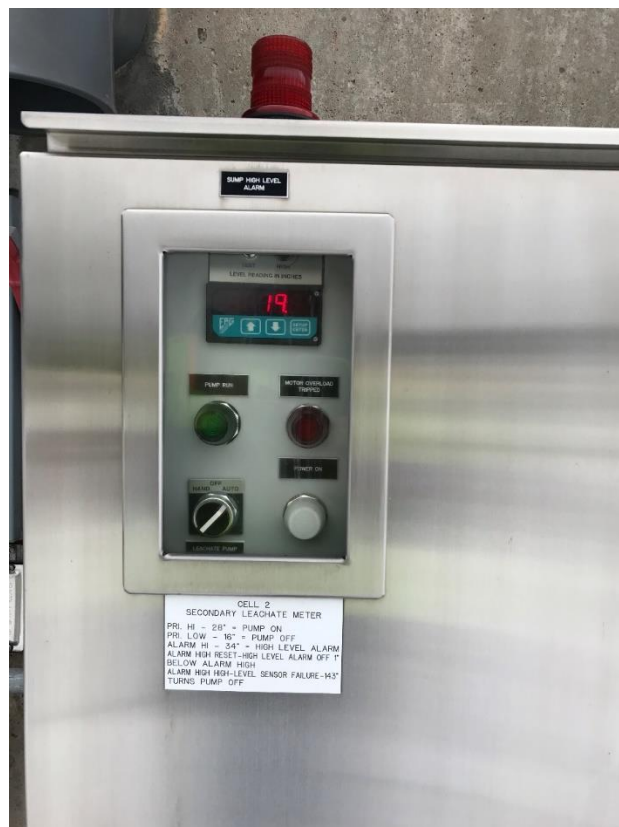
Photo 12 – Cell 2 leachate pump controls.

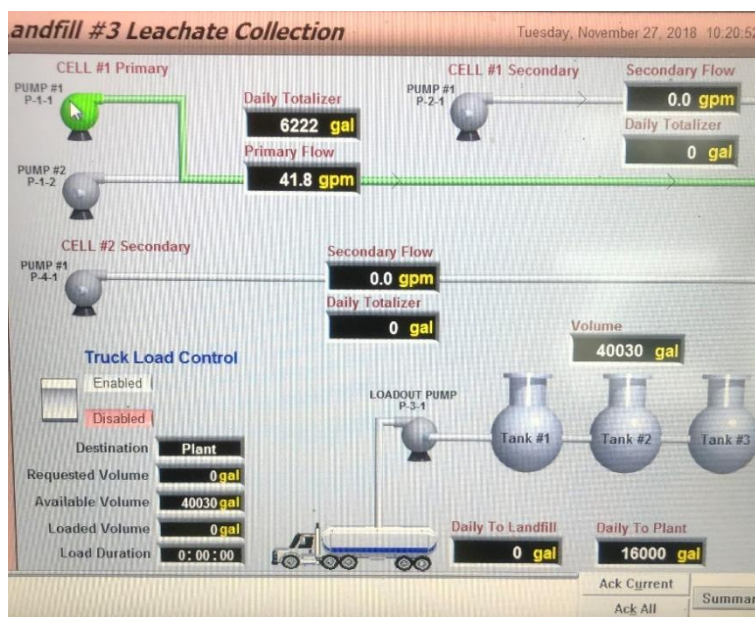
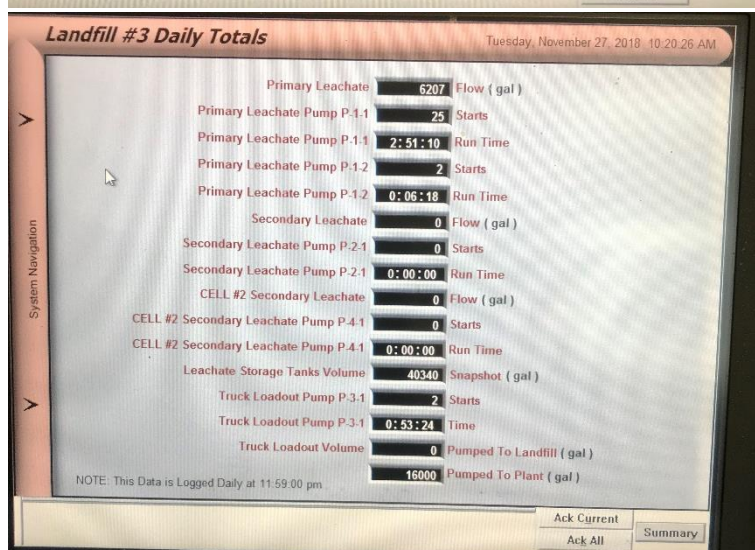
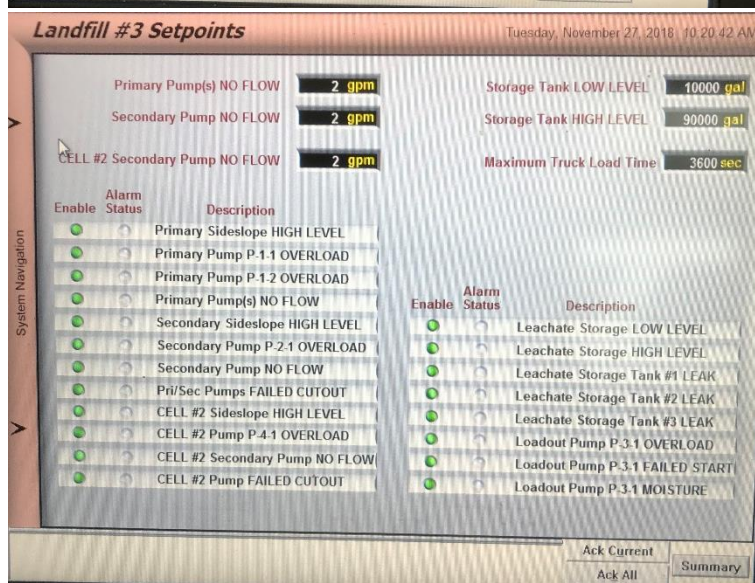
Photo 13 – Landfill No. 3 leachate collection system controls screens.
