December 19, 2020

GEI Project No. 2003564

**Re: Landfill Inspection Report  
We Energies Presque Isle Power Plant Landfill No. 3  
Marquette Township, Michigan**

# WEC PIPP LF 3 Final Cover Inspection

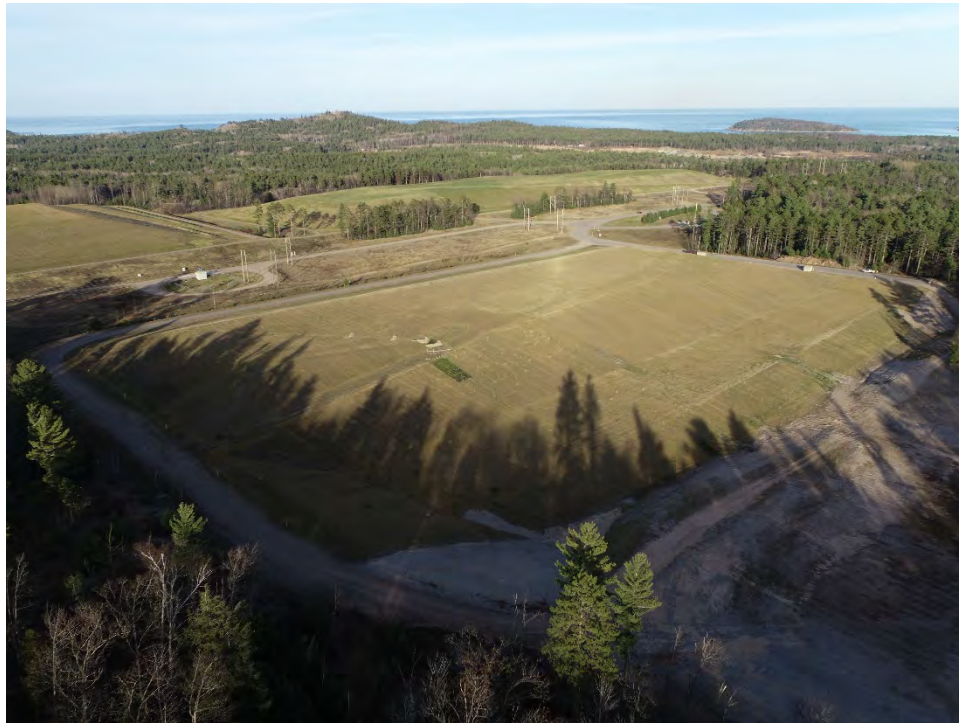
Photo No. 1: Aerial photo of PIPP Landfill No. 3 looking northeast 11/6/2020

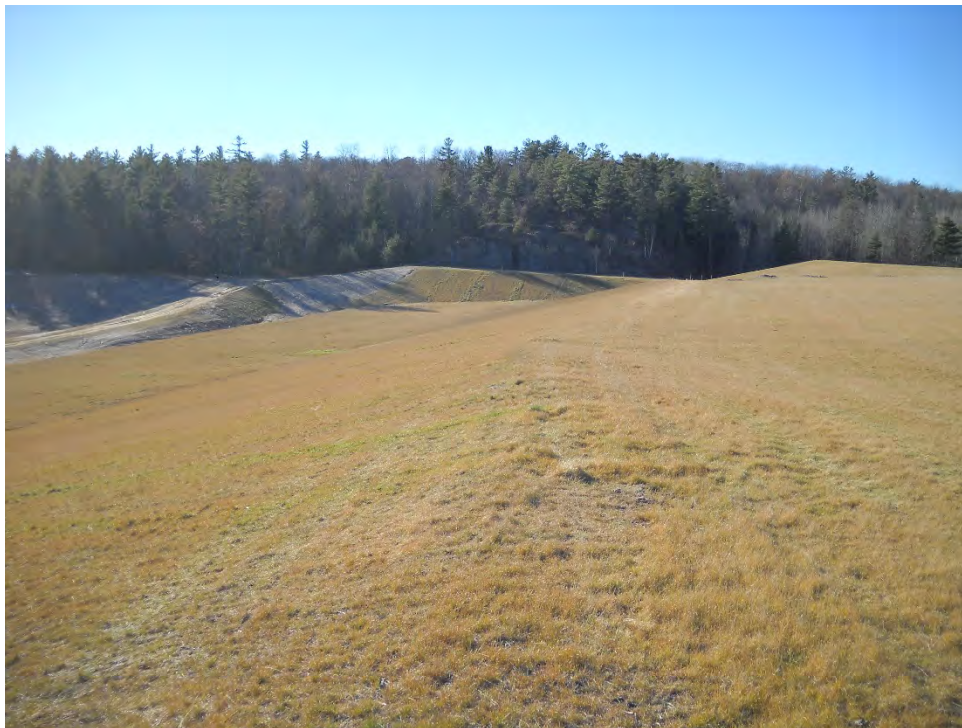
Photo No. 2: South slope of the PIPP Landfill No. 3 looking west 11/4/2020

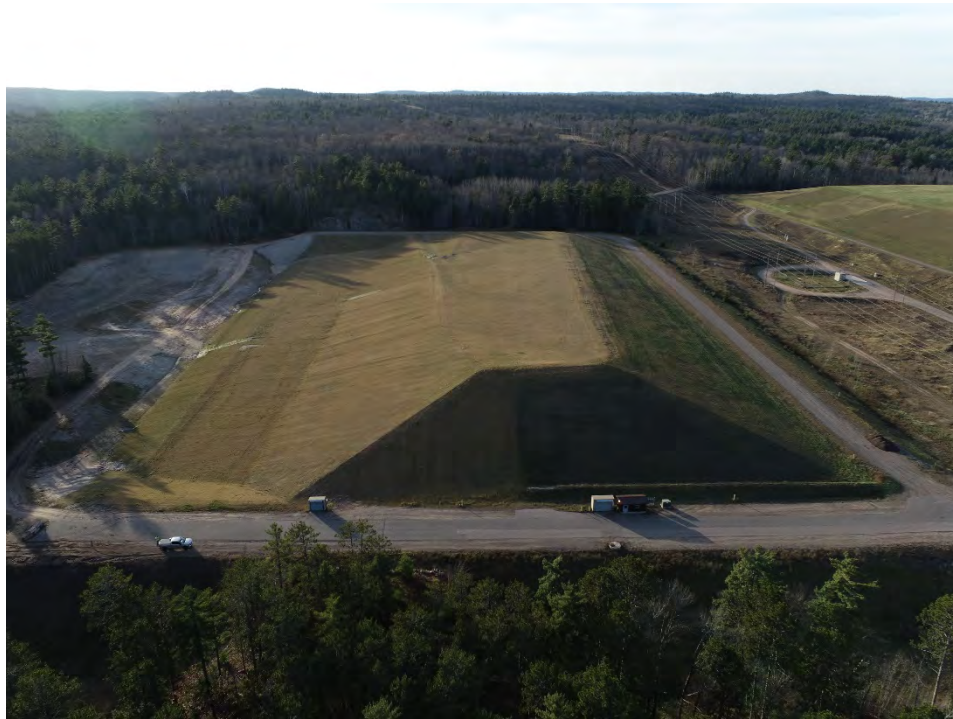
Photo No. 3: East slope of the PIPP Landfill No. 3 looking west 11/6/2020

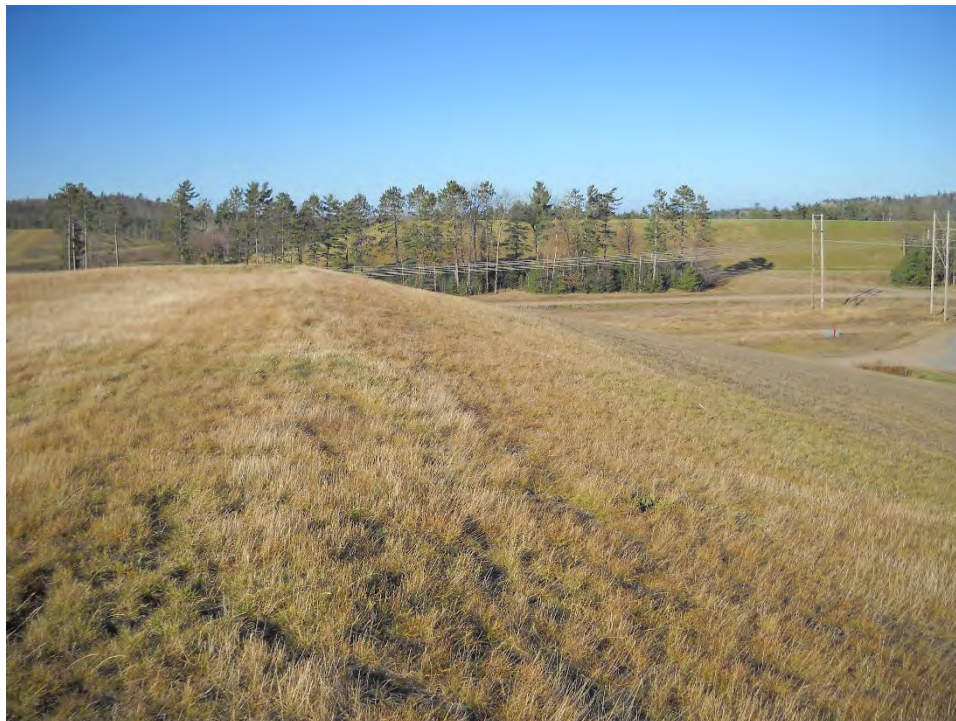
Photo No. 4: East slope of the PIPP Landfill No. 3 looking north 11/4/2020

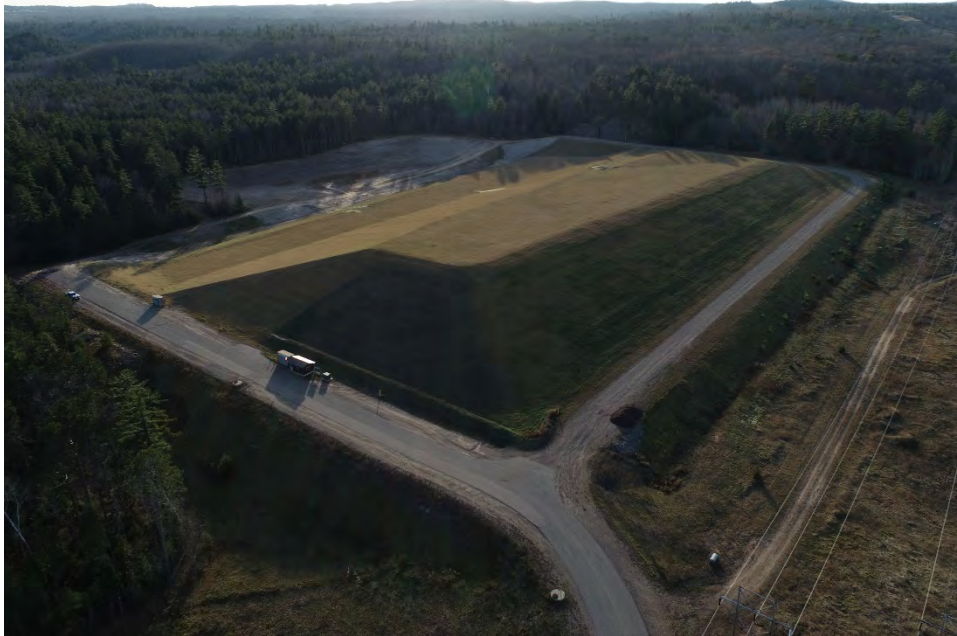
Photo No. 5: East and north slopes of the PIPP Landfill No. 3 looking southwest 11/6/2020

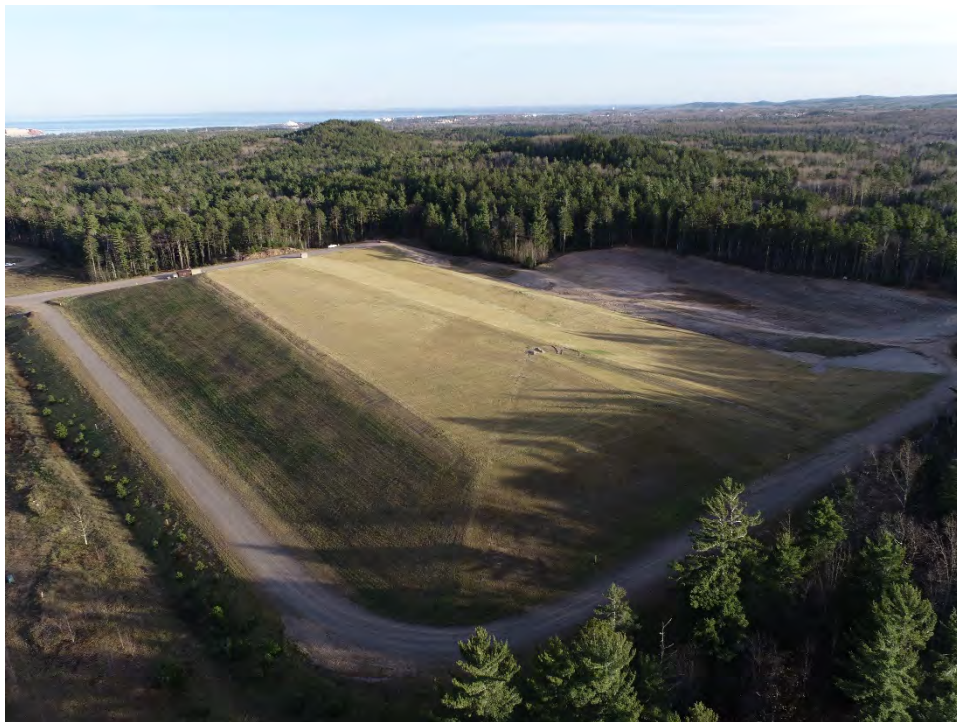
Photo No. 6: East and north slopes of the PIPP Landfill No. 3 looking southwest 11/6/2020

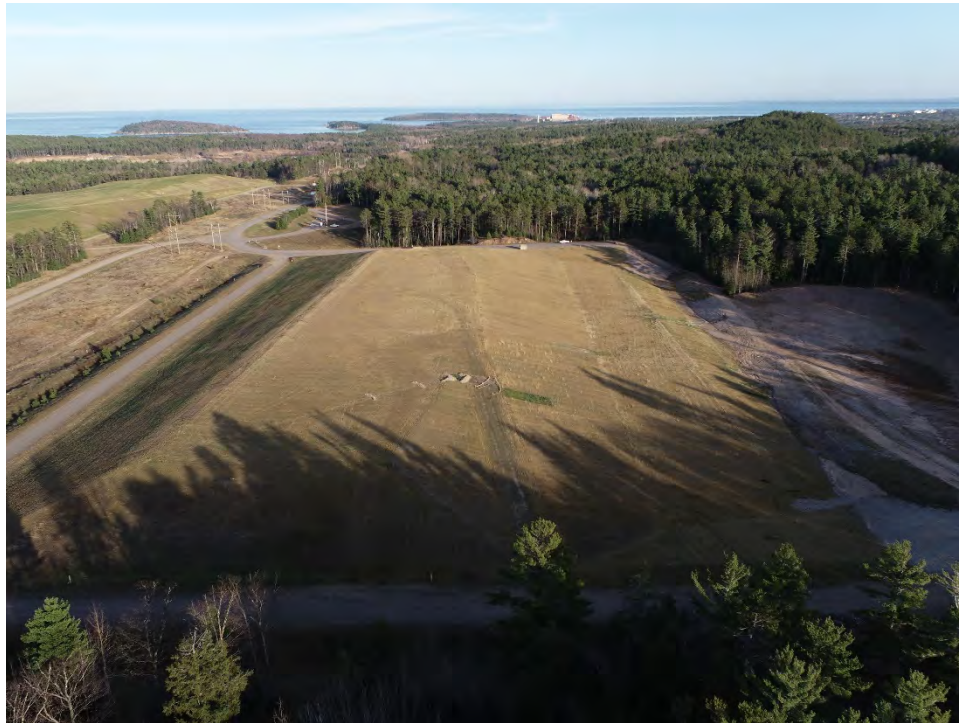
Photo No. 7: West slope of the PIPP Landfill No. 3 looking east 11/6/2020

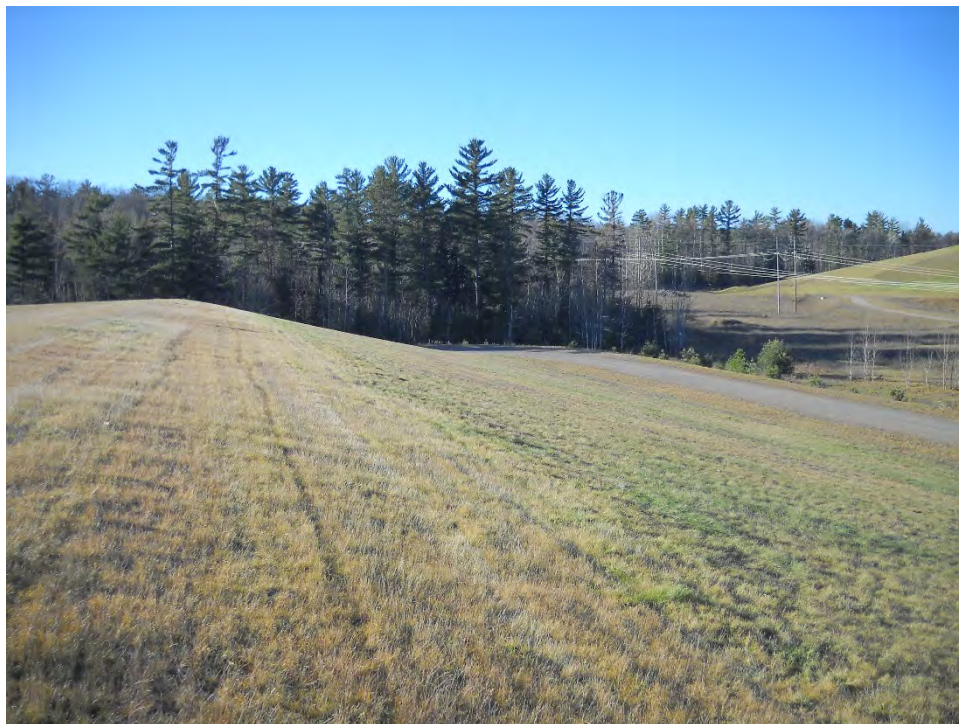
Photo No. 8: North slope of the PIPP Landfill No. 3 looking west 11/4/2020
