December 19, 2021  
Project 2103683

**Re: Landfill Inspection Report  
We Energies Presque Isle Power Plant Landfill No. 3  
Marquette Township, Michigan**

# WEC PIPP LF 3 Final Cover Inspection

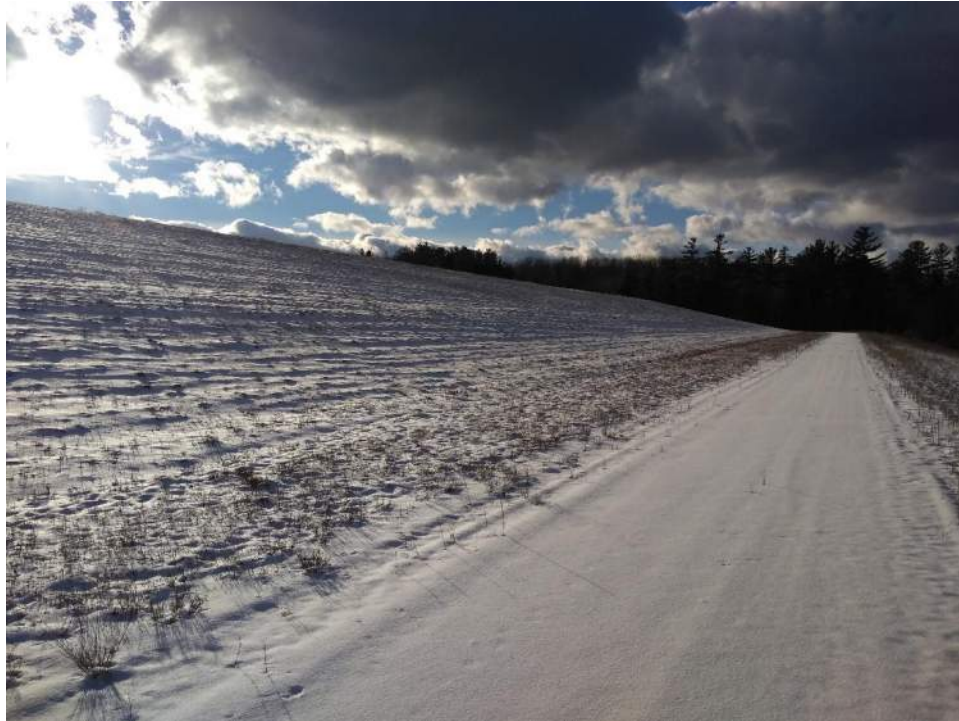
Photo No. 1: Toe of north slope of the PIPP Landfill No. 3, looking west.

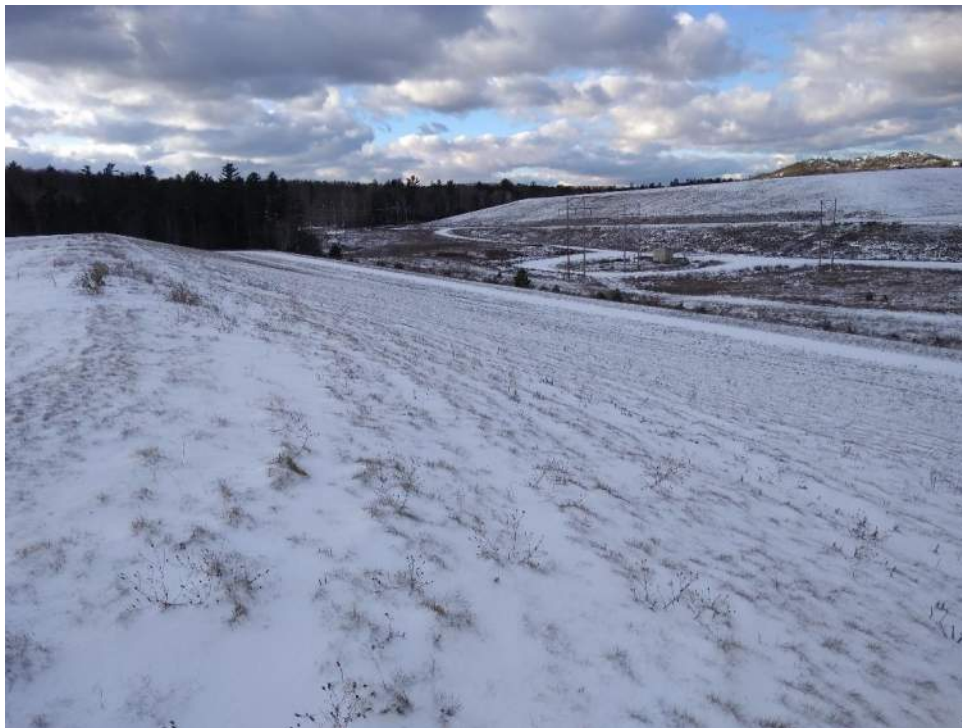
Photo No. 2: Top of north slope, looking northwest

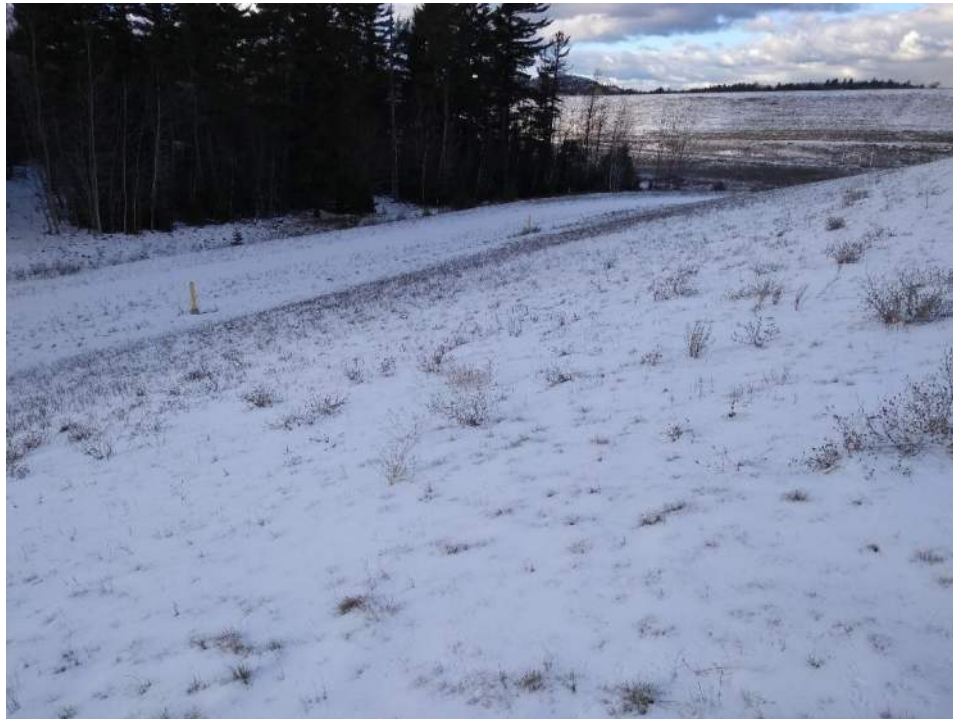
Photo No. 3: West slope of the PIPP Landfill No. 3 looking north.

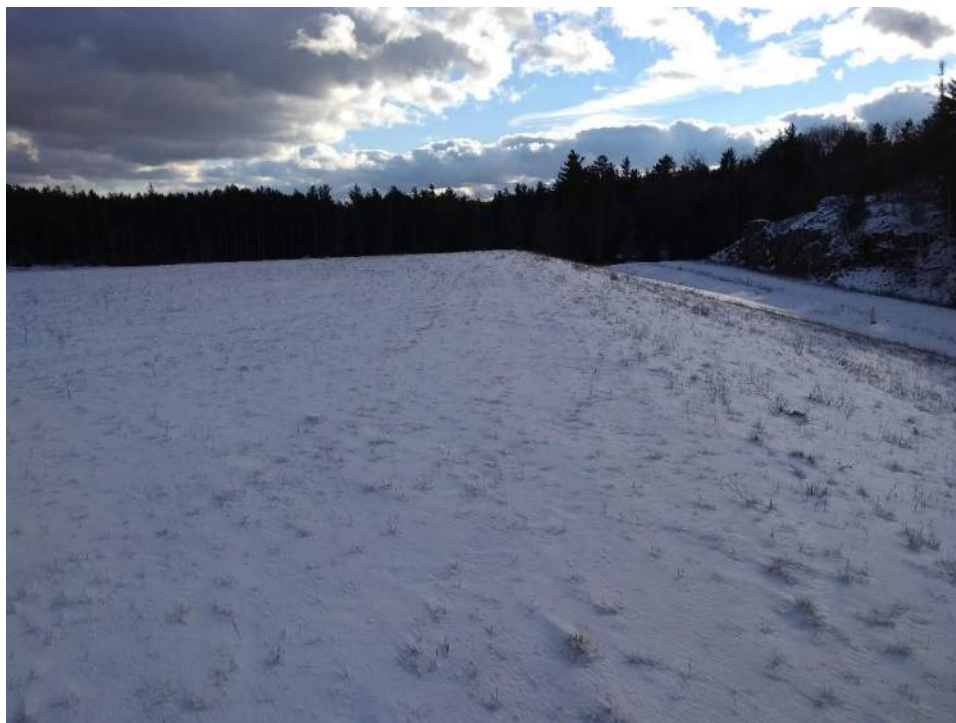
Photo No. 4: Crest of the west slope at the PIPP Landfill No. 3, looking south.

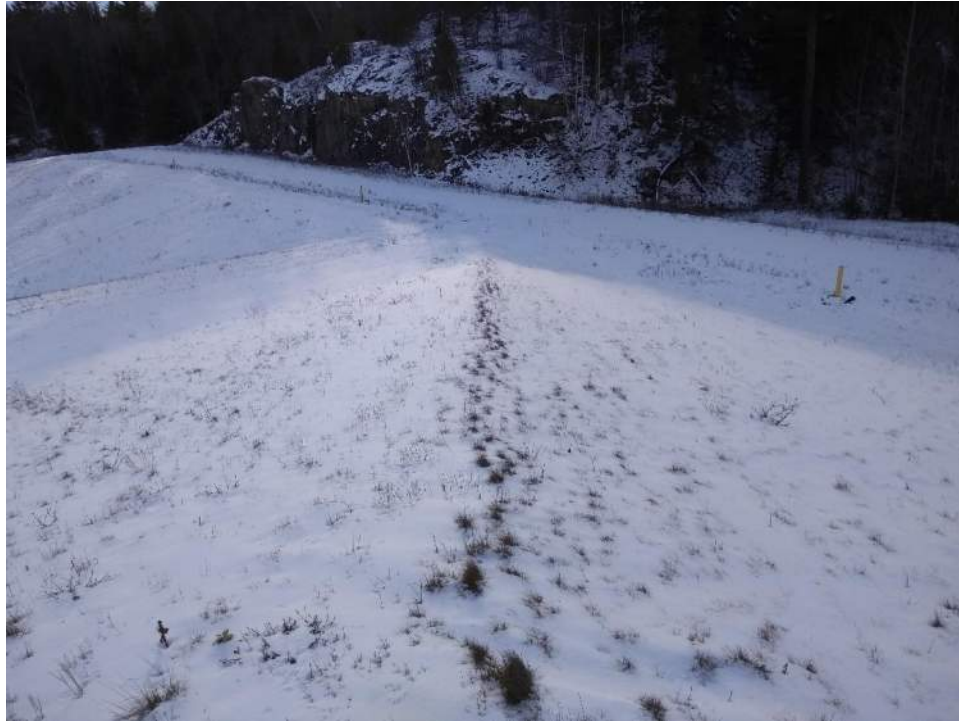
Photo No. 5: Corner of the west and south slope at the PIPP Landfill No. 3, looking southwest.

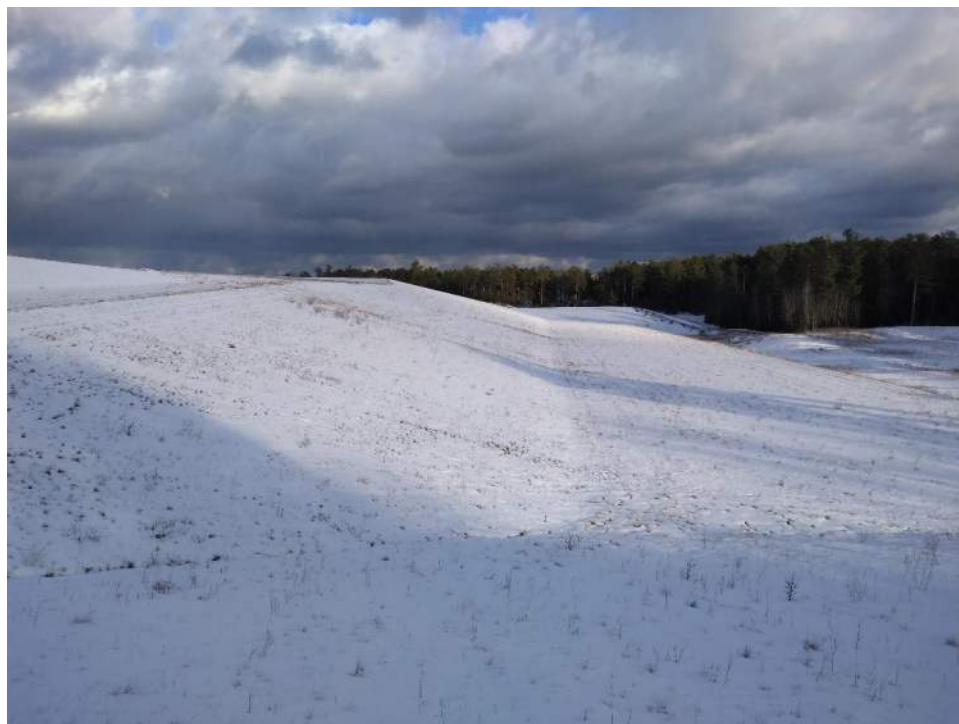
Photo No. 6: South slope of the PIPP Landfill No. 3 looking east.

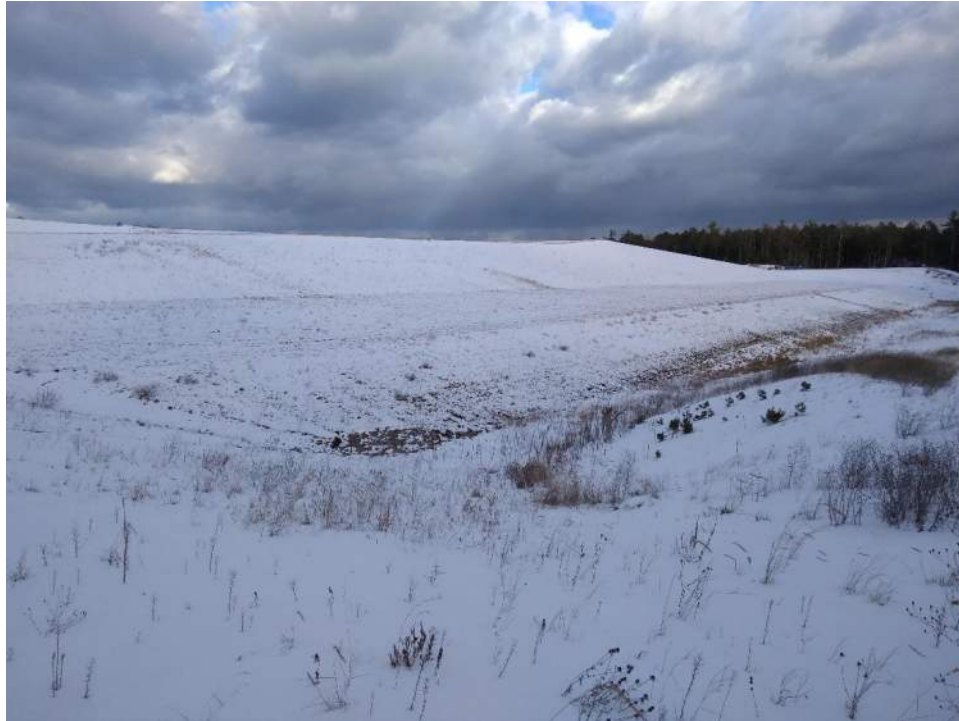
Photo No. 7: South slope of the PIPP Landfill No. 3 looking northeast.

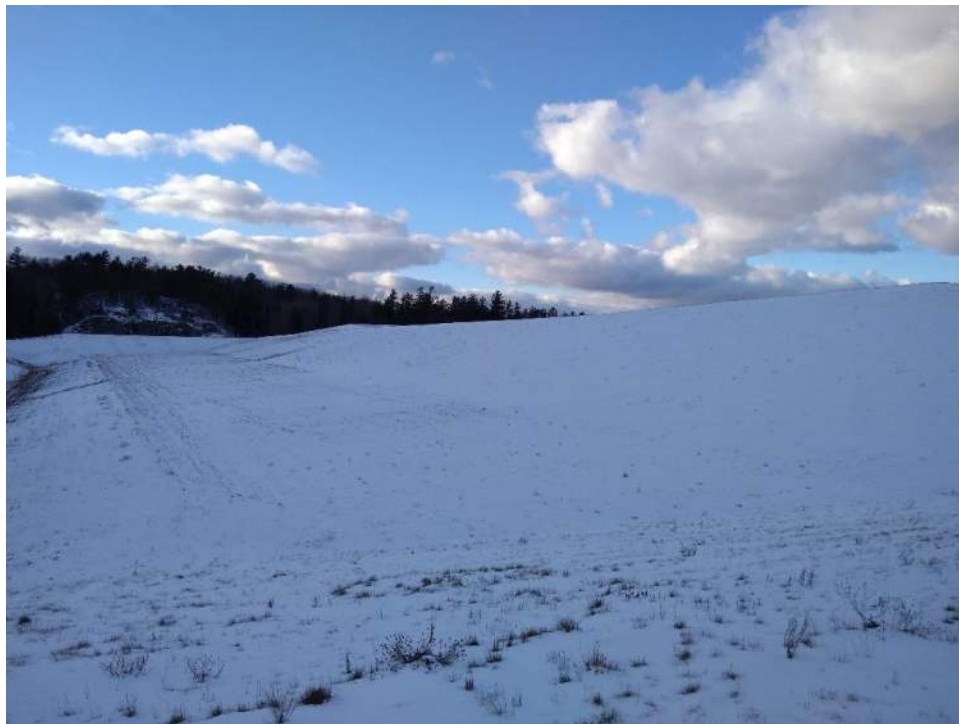
Photo No. 8: South slope of the PIPP Landfill No. 3 looking west.

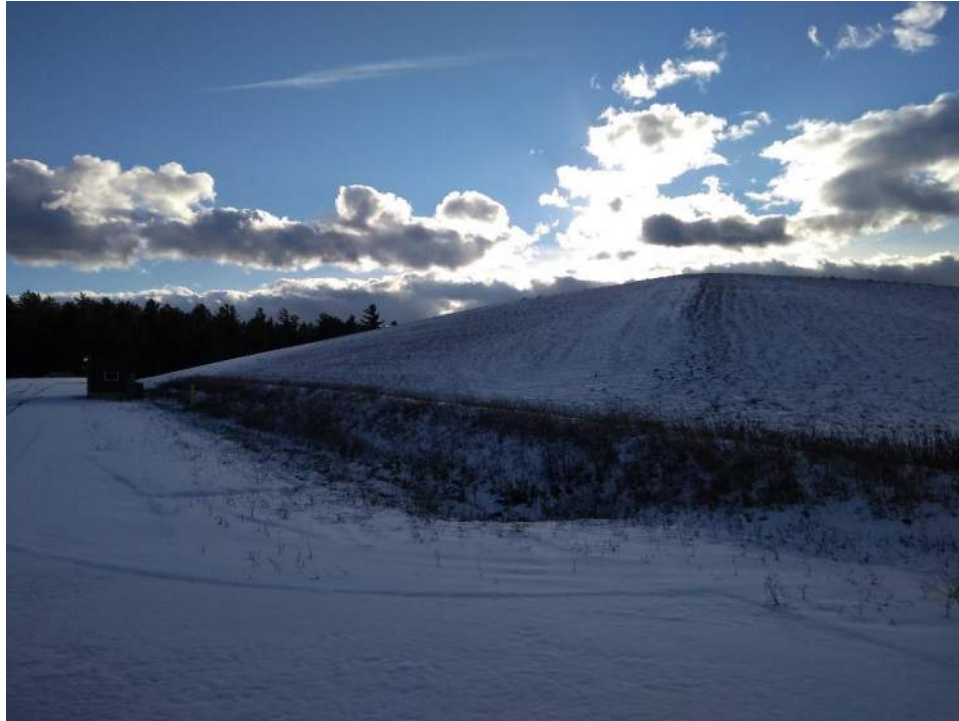
Photo No. 9: East slope of the PIPP Landfill No. 3 looking south.

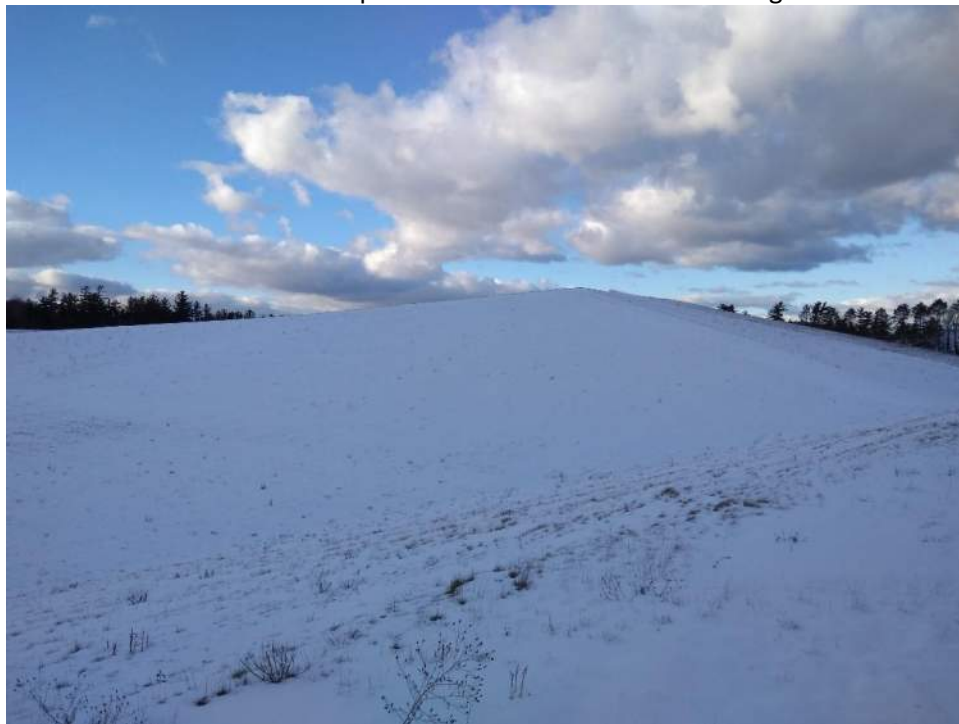
Photo No. 10: East slope of the PIPP Landfill No. 3 looking northwest.

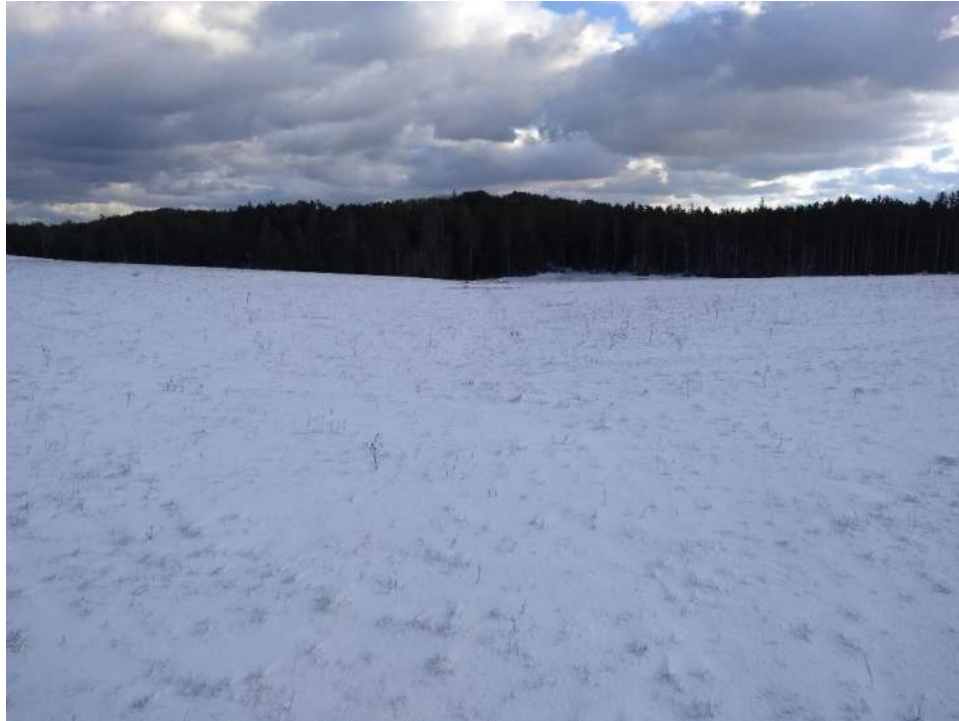
Photo No. 11: Top of the PIPP Landfill No. 3 looking west.

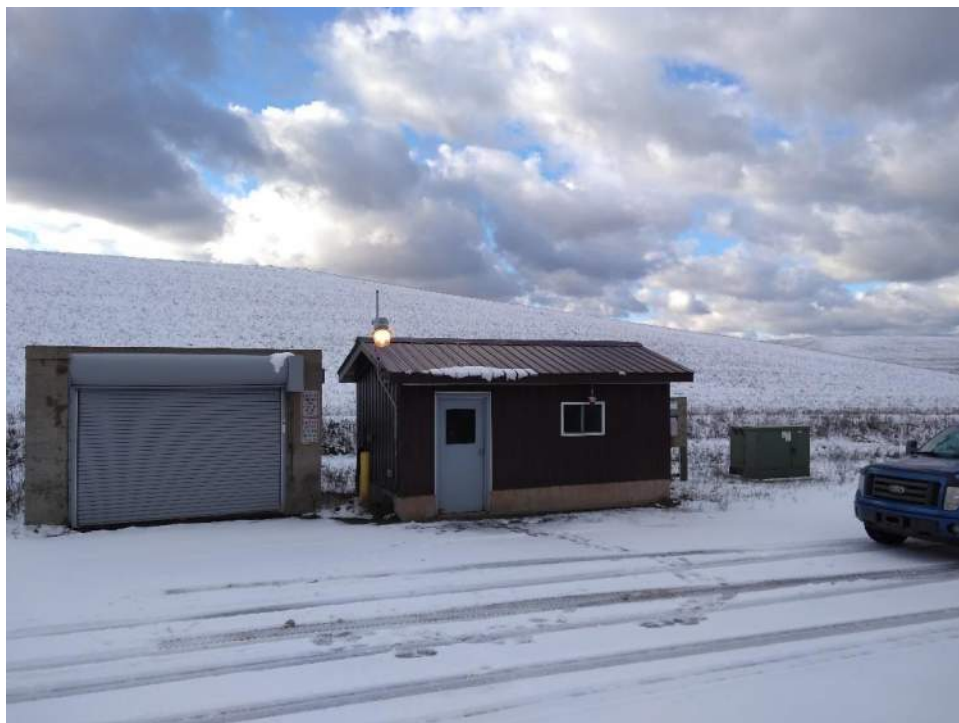
Photo No. 12: Leachate control box shed on the east side of the PIPP Landfill No. 3.
