December 19, 2021  
Project 2103683

**Re: 2022 Landfill Inspection Report  
We Energies Presque Isle Power Plant Landfill No. 3  
Marquette Township, Michigan**

# Photographic Log

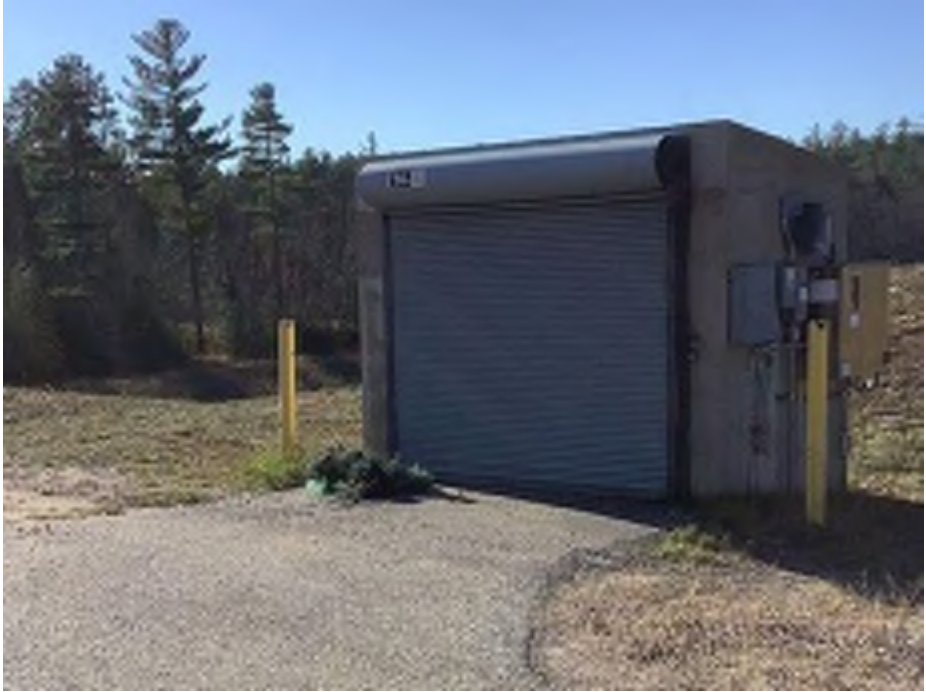
<b>PHOTOGRAPH NO: 3</b>	<b>DATE:</b> November 3, 2022	<b>LATITUDE:</b> 46.5844632790012	<b>LONGITUDE:</b> -87.4715185981357
<b>SITE LOCATION:</b> PRESQUE ISLE, MARQUETTE TOWNSHIP, MICHIGAN			
<b>DESCRIPTION:</b>  Cell 2 Riser Vault Building

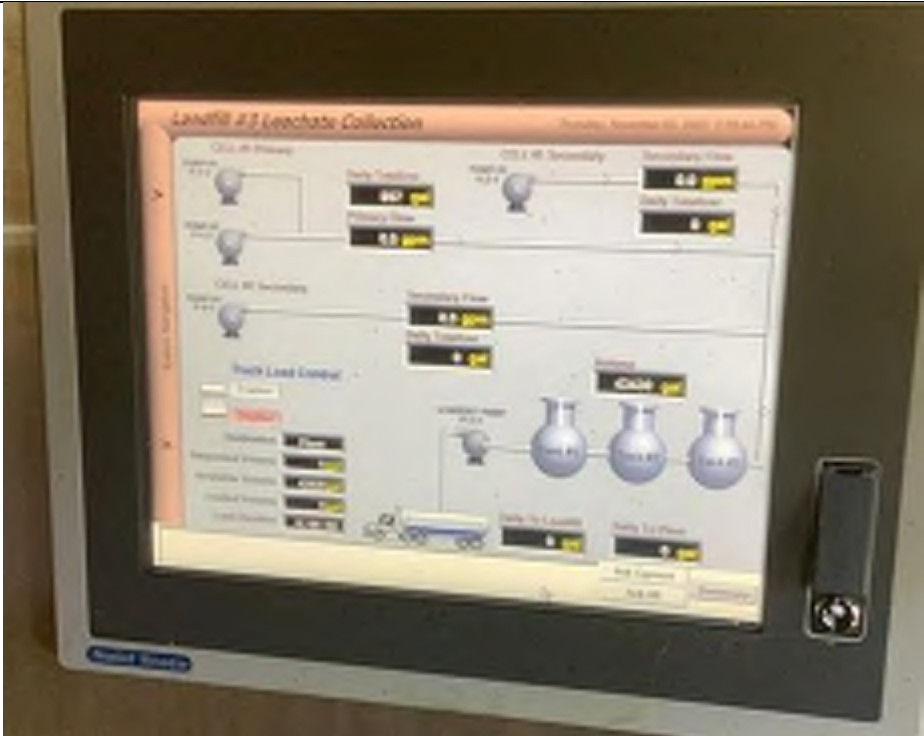
<b>PHOTOGRAPH NO: 6</b>	<b>DATE:</b> November 3, 2022	<b>LATITUDE:</b> 46.5857106515525	<b>LONGITUDE:</b> -87.4700236162765
<b>SITE LOCATION:</b> PRESQUE ISLE, MARQUETTE TOWNSHIP, MICHIGAN			
<b>DESCRIPTION:</b>  Loadout station L/F 3

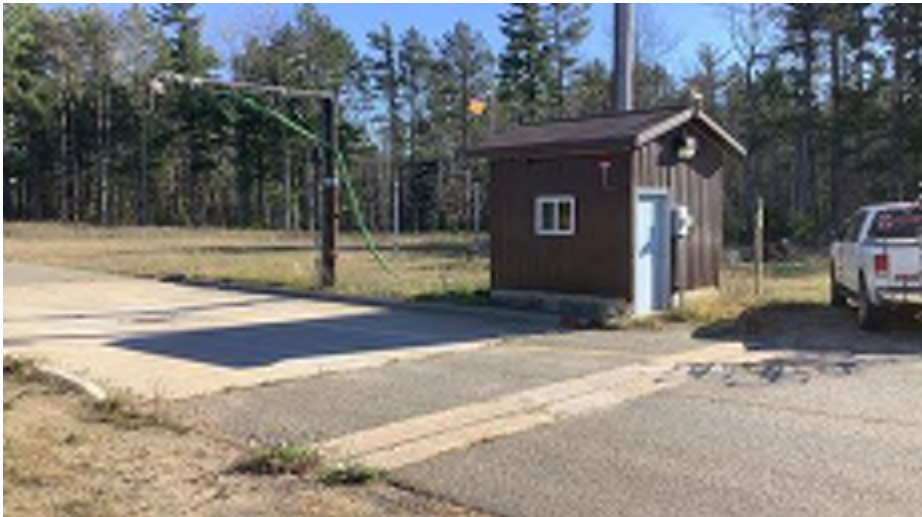
<b>PHOTO BY:</b>  BILL BUTLER			
<b>PHOTOGRAPH No: 8</b>	<b>DATE:</b> November 3, 2022	<b>LATITUDE:</b> 46.5857964190534	<b>LONGITUDE:</b> -87.4700132382054
<b>SITE LOCATION:</b> PRESQUE ISLE, MARQUETTE TOWNSHIP, MICHIGAN			
<b>DESCRIPTION:</b>  Leachate loadout building

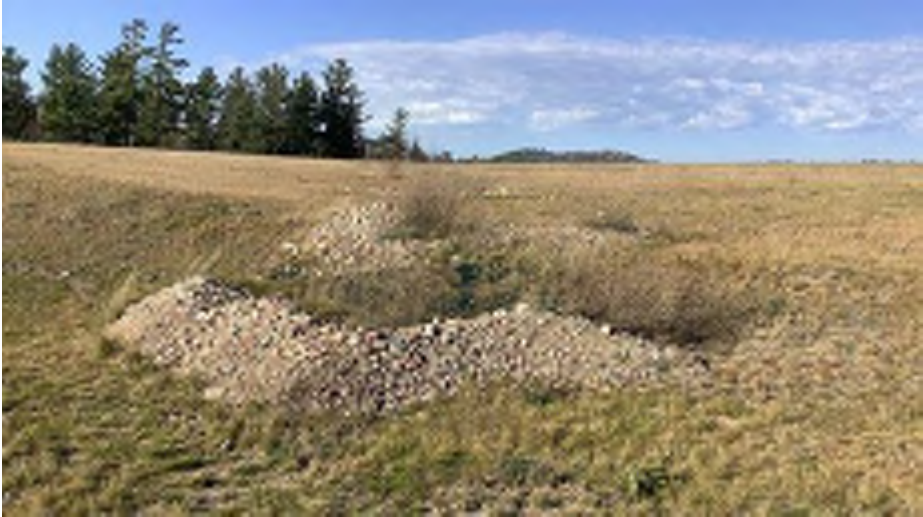
PHOTOGRAPH No: 9	DATE: November 3, 2022	LATITUDE: 46.5846299567449	LONGITUDE: -87.474458073161
<b>SITE LOCATION:</b> PRESQUE ISLE, MARQUETTE TOWNSHIP, MICHIGAN			
<b>DESCRIPTION:</b>  Cover erosion control berms

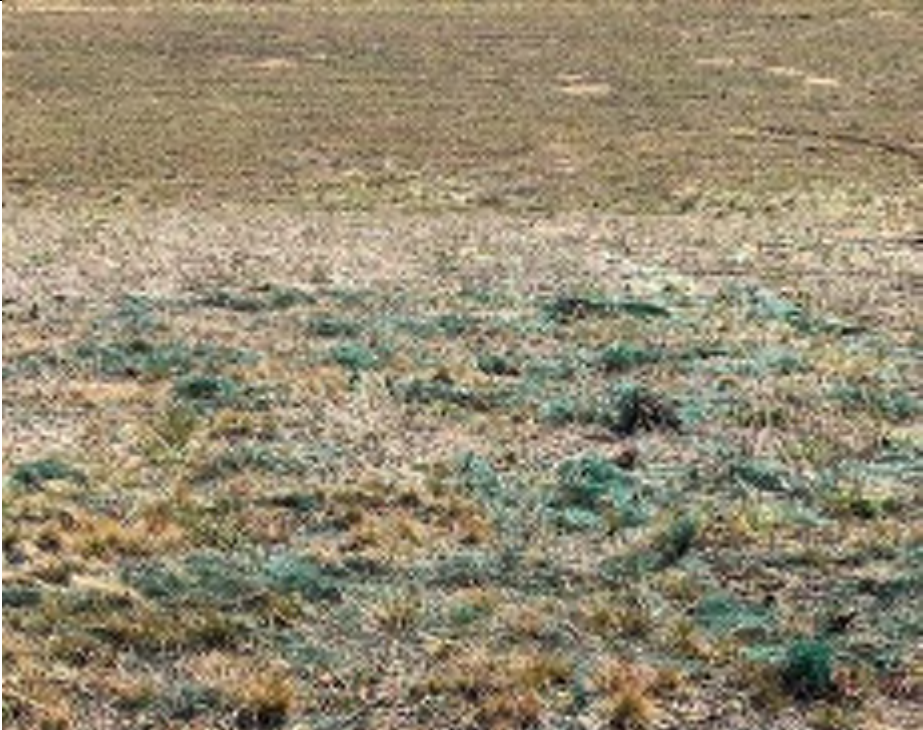
<b>PHOTO BY:</b>  BILL BUTLER			
PHOTOGRAPH No: 10	DATE: November 3, 2022	LATITUDE: 46.5846185413905	LONGITUDE: -87.4745029428592
<b>SITE LOCATION:</b> PRESQUE ISLE, MARQUETTE TOWNSHIP, MICHIGAN			
<b>DESCRIPTION:</b>  North slope erosion repair area

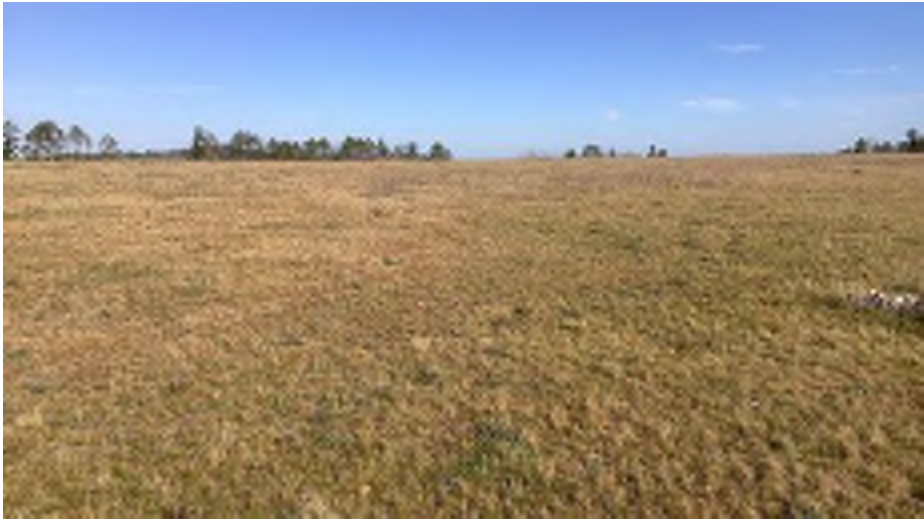
<b>PHOTOGRAPH No: 11</b>	<b>DATE:</b> November 3, 2022	<b>LATITUDE:</b> 46.5847195337031	<b>LONGITUDE:</b> -87.4747668821404
<b>SITE LOCATION:</b> PRESQUE ISLE, MARQUETTE TOWNSHIP, MICHIGAN			
<b>DESCRIPTION:</b>  L/F 3 crest good vegetation

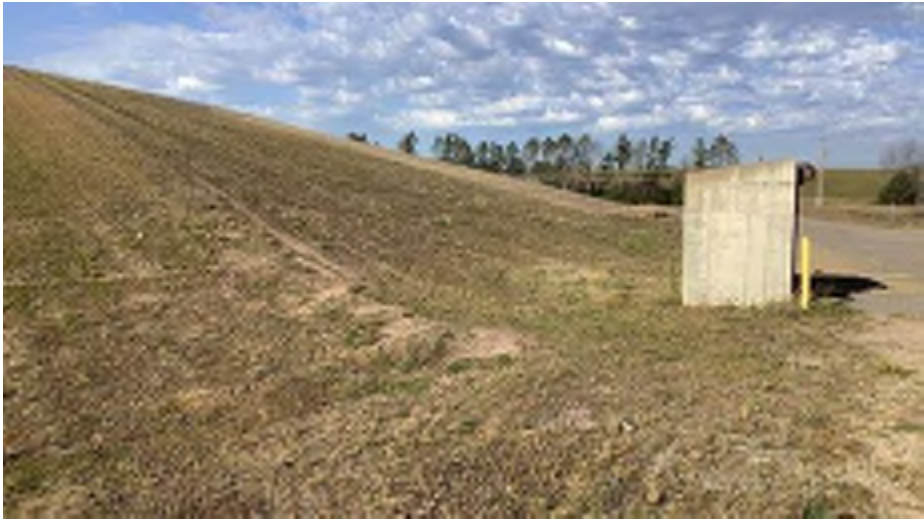
<b>PHOTOGRAPH No: 15</b>	<b>DATE:</b> November 3, 2022	<b>LATITUDE:</b> 46.5857062346019	<b>LONGITUDE:</b> -87.4716494688739
<b>SITE LOCATION:</b> PRESQUE ISLE, MARQUETTE TOWNSHIP, MICHIGAN			
<b>DESCRIPTION:</b>  L/F 3 east slope

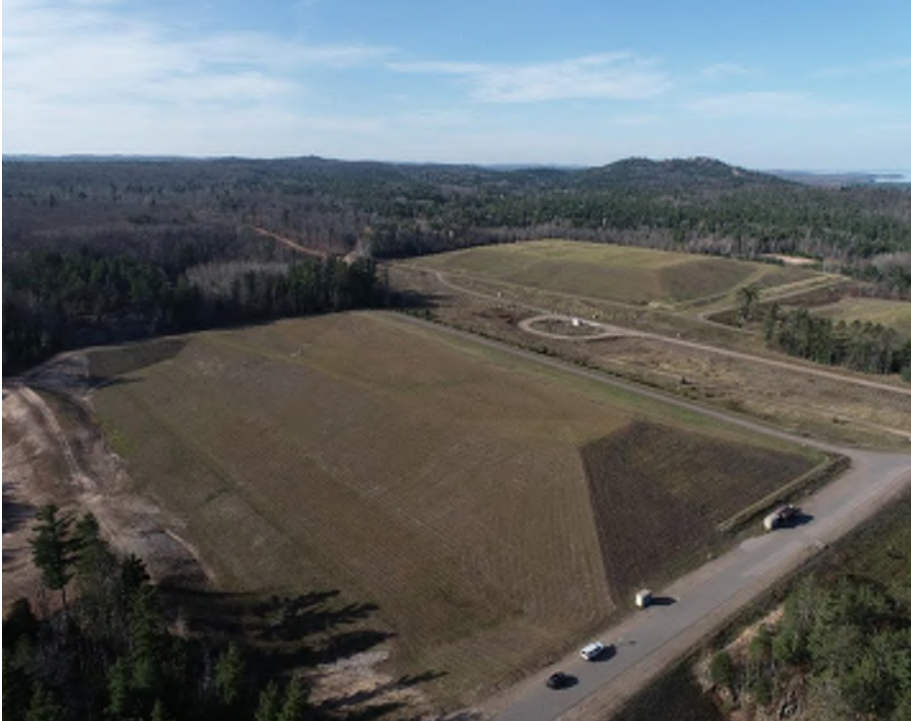
<b>PHOTO BY:</b>  BILL BUTLER			
<b>PHOTOGRAPH No: 16</b>	<b>DATE:</b> November 3, 2022	<b>LATITUDE:</b> 46.5857062346019	<b>LONGITUDE:</b> -87.4716494688739
<b>SITE LOCATION:</b> PRESQUE ISLE, MARQUETTE TOWNSHIP, MICHIGAN			
<b>DESCRIPTION:</b>  L/F 3 Looking Northwest

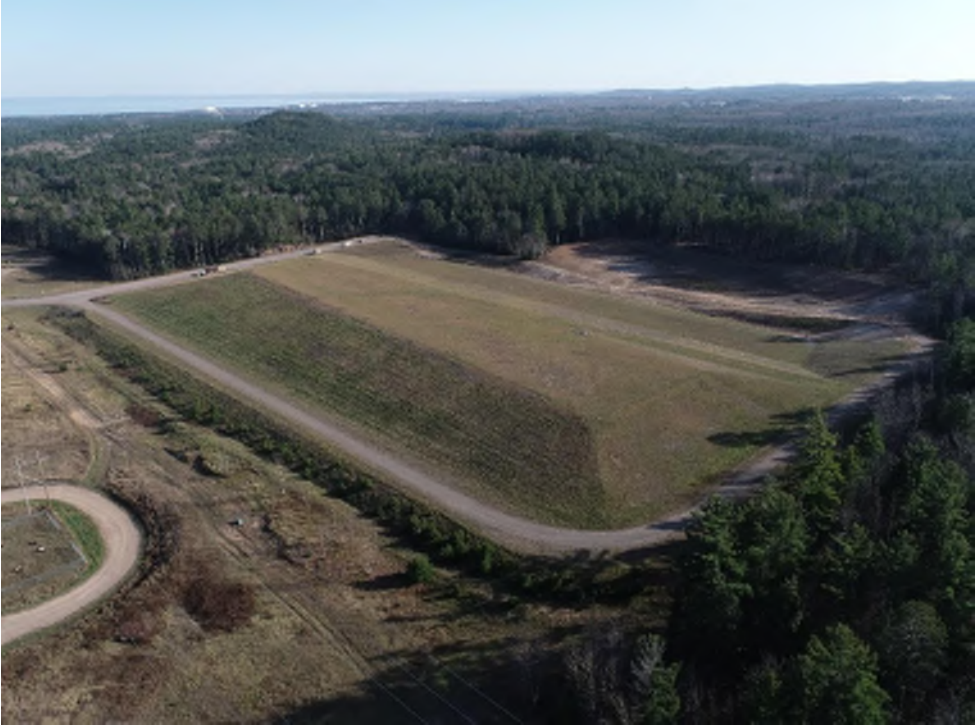
<b>PHOTOGRAPH No: 17</b>	<b>DATE:</b> November 3, 2022	<b>LATITUDE:</b> 46.5857062346019	<b>LONGITUDE:</b> -87.4716494688739
<b>SITE LOCATION:</b> PRESQUE ISLE, MARQUETTE TOWNSHIP, MICHIGAN			
<b>DESCRIPTION:</b>  L/F 3 Looking Southeast

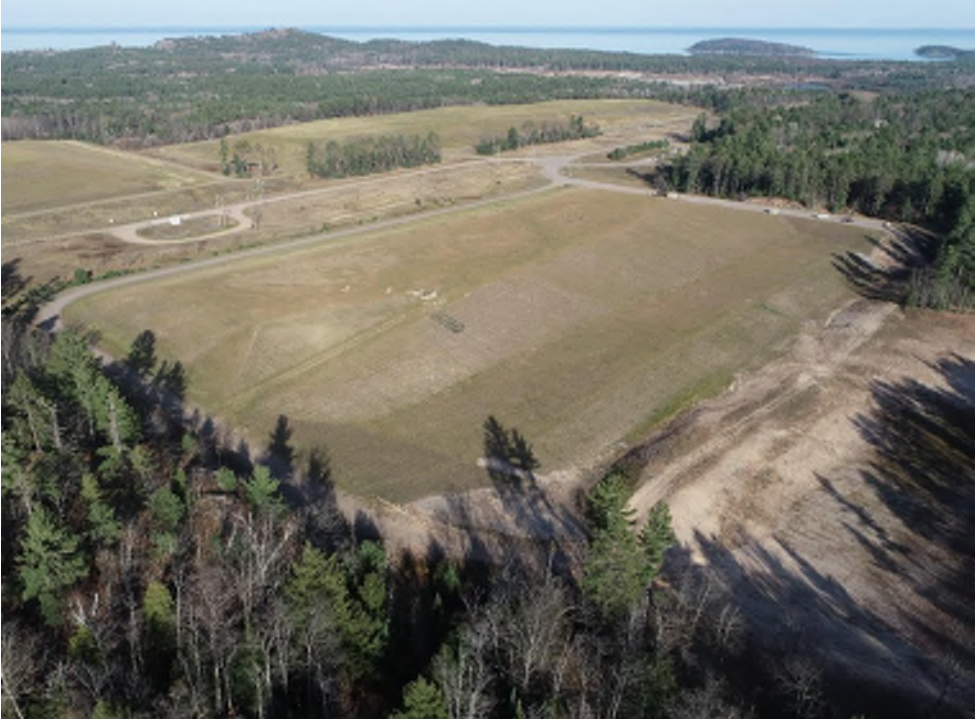
<b>PHOTOGRAPH No: 18</b>	<b>DATE:</b> November 3, 2022	<b>LATITUDE:</b> 46.5857062346019	<b>LONGITUDE:</b> -87.4716494688739
<b>SITE LOCATION:</b> PRESQUE ISLE, MARQUETTE TOWNSHIP, MICHIGAN			
<b>DESCRIPTION:</b>  L/F 3 Looking Northeast
