December 19, 2023
Project 2103683

**Re: 2023 Landfill Inspection Report
Presque Isle Power Plant Ash Landfill No. 3
We Energies
Marquette Township, Michigan**

Presque Isle Power Plant Ash Landfill No. 3 CCR Inspection – Photo Log

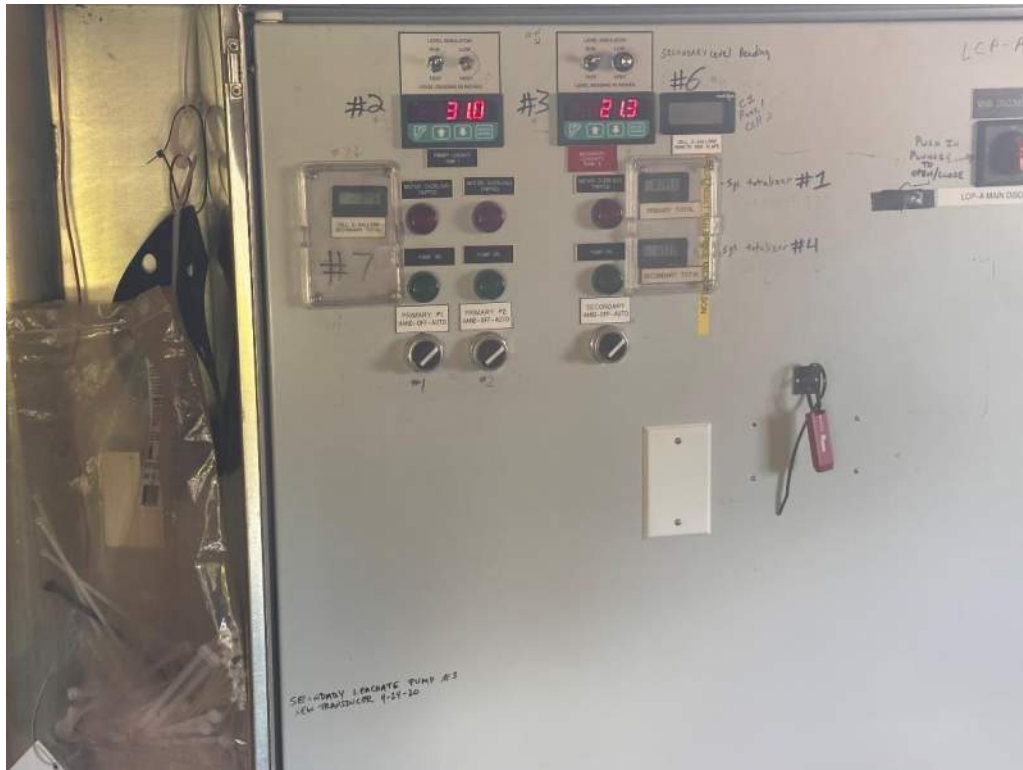
Photo No. 1 – Leachate sump master board readings.

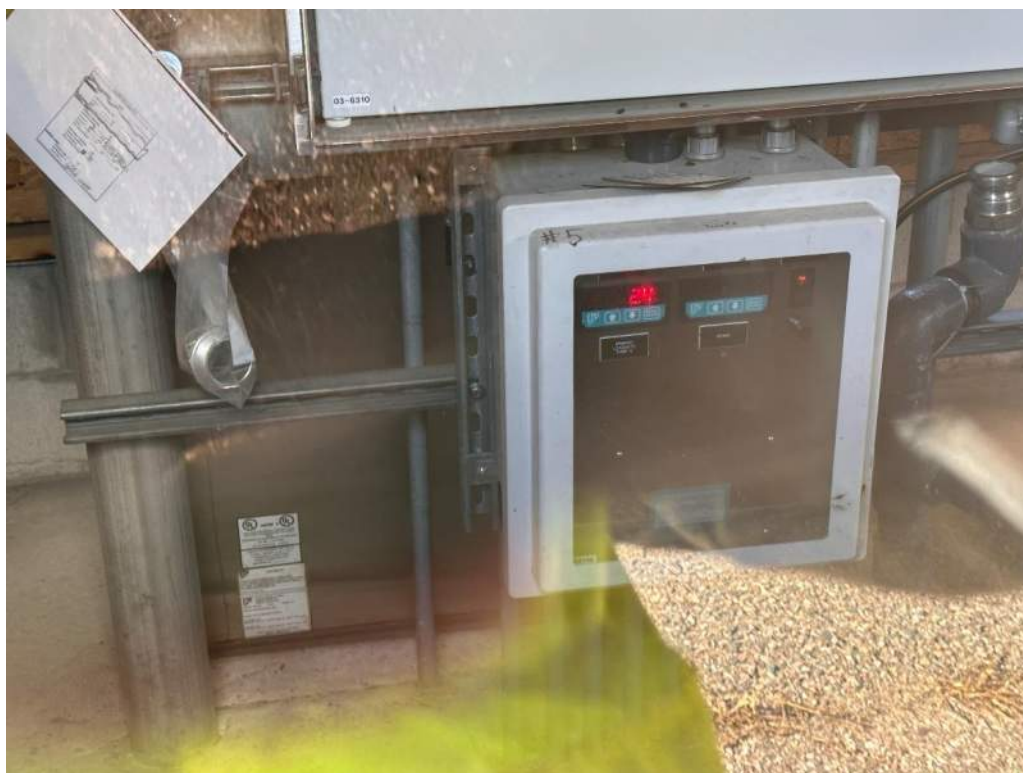
Photo No. 2 – Primary Leachate pump #1-2.

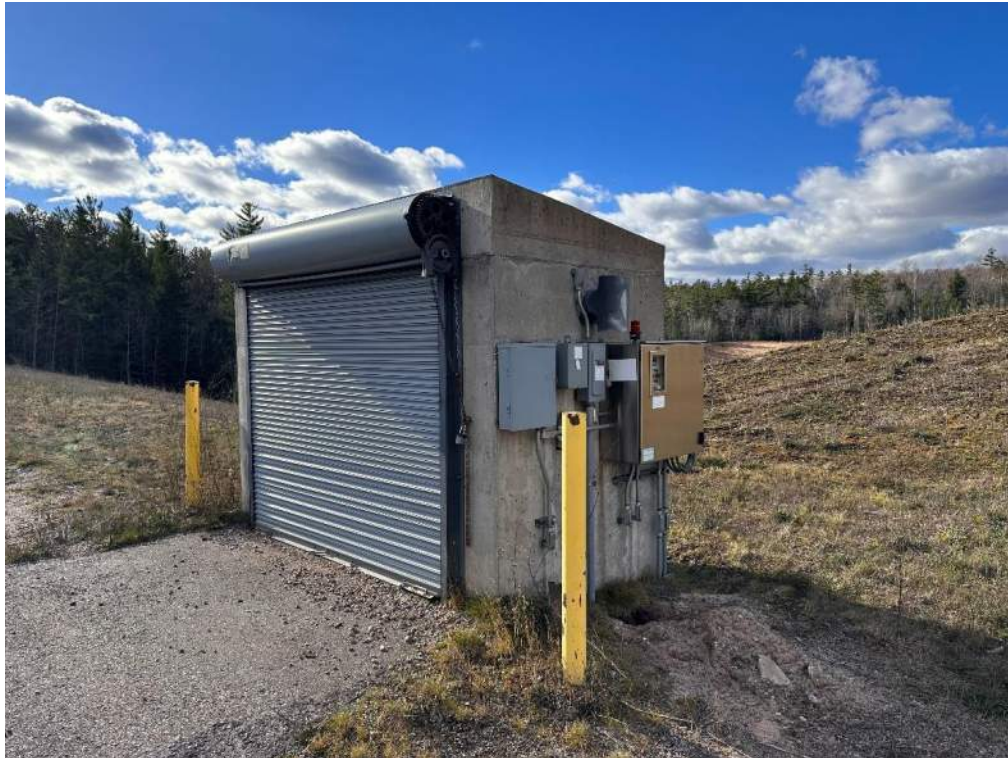
Photo No. 3 – Cell 2 riser vault building

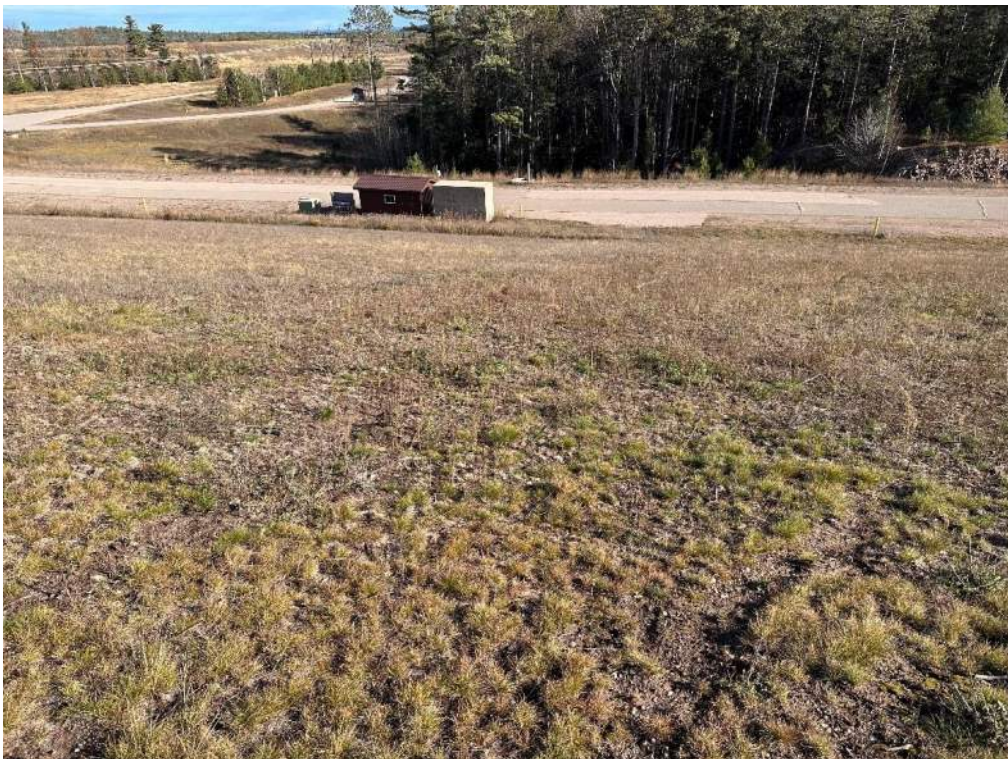
Photo No. 4 – Cell 1 east slope and riser vault building.

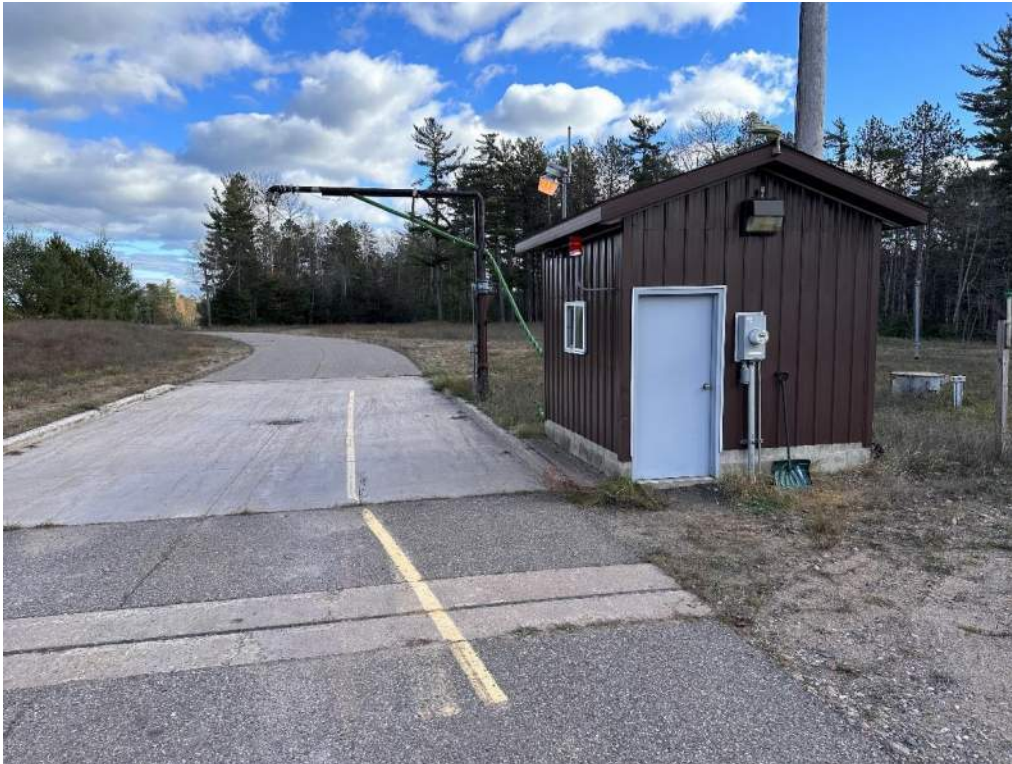
Photo No. 5 – Landfill No. 3 leachate loadout facility.

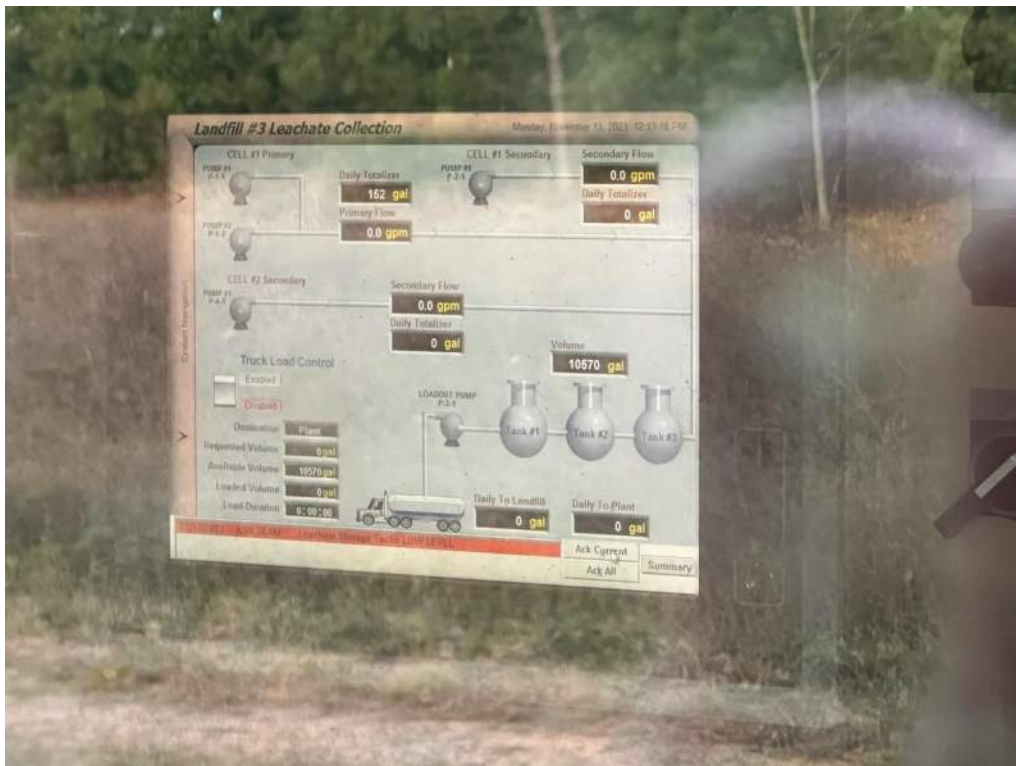
Photo No. 6 – Landfill No. 3 leachate loadout facility screen.

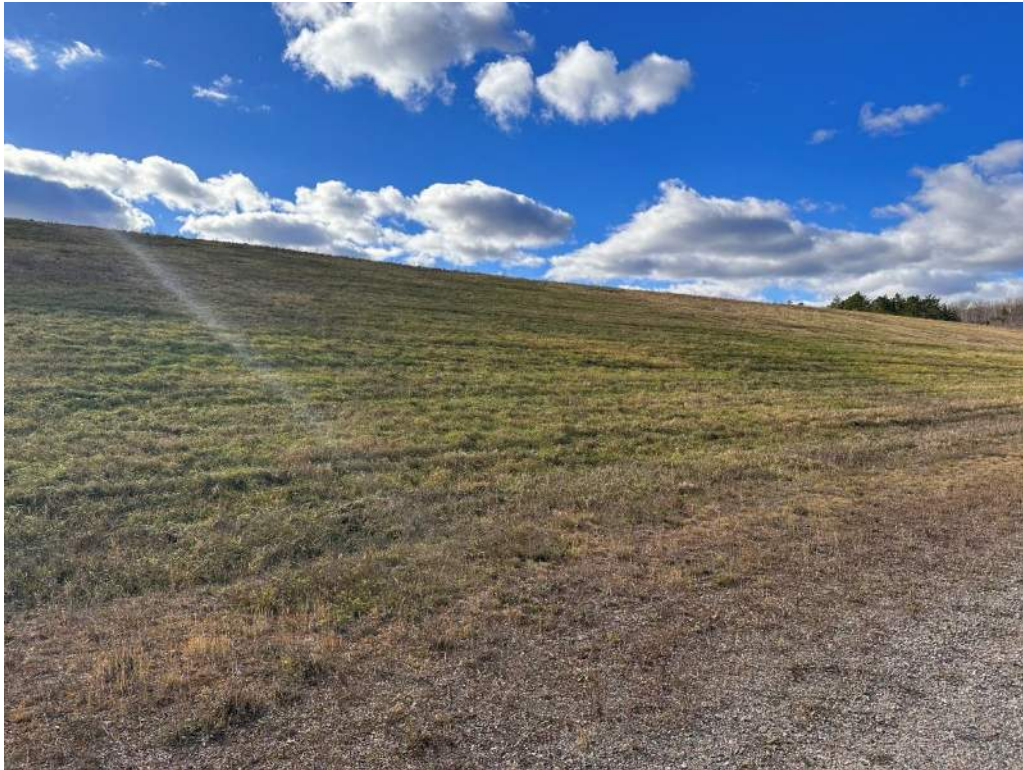
Photo No. 7 – North slope of Landfill No. 3, looking south.

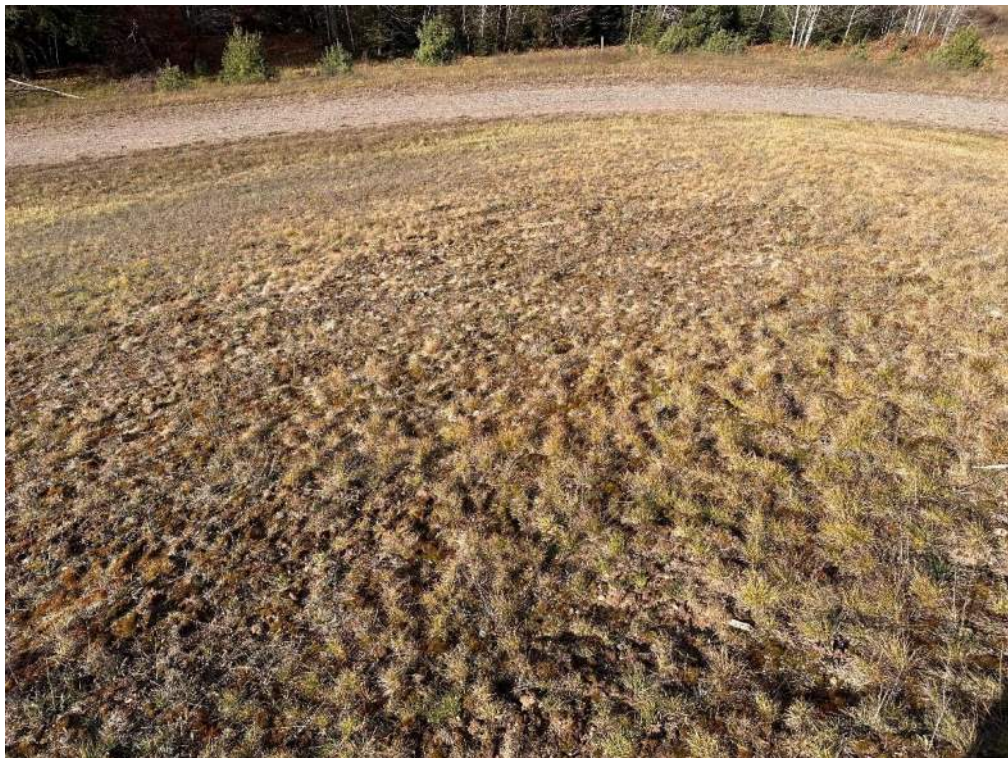
Photo No. 8 – Northwest corner of Landfill No. 3.

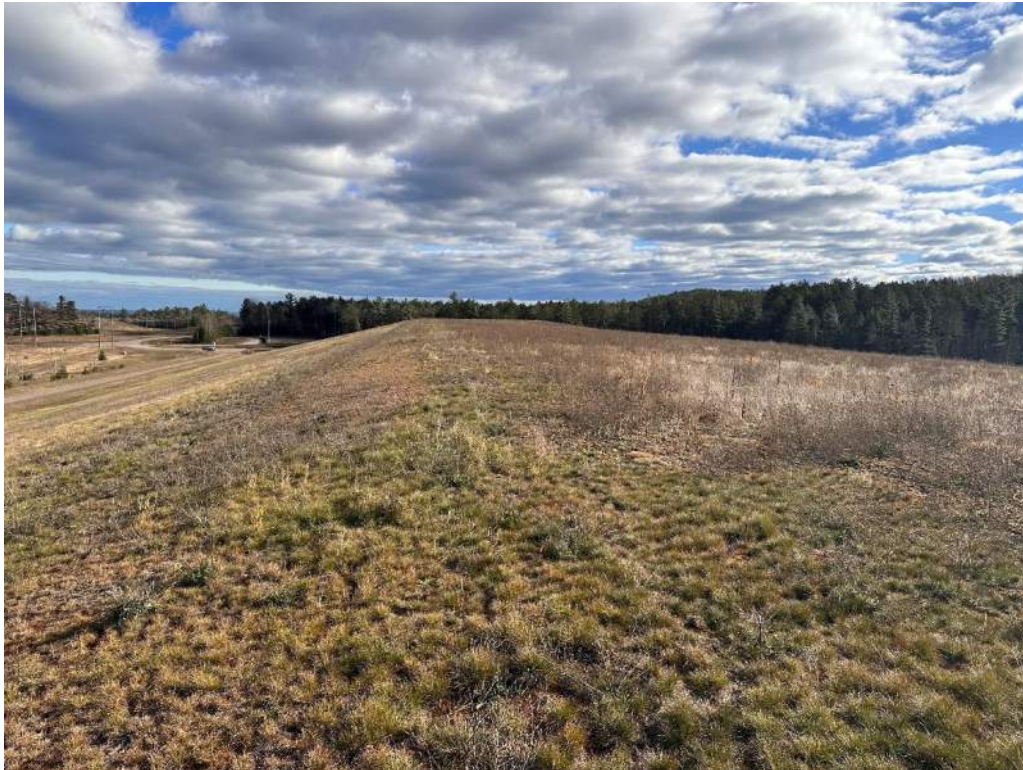
Photo No. 9 – Top of Landfill No. 3, looking east.

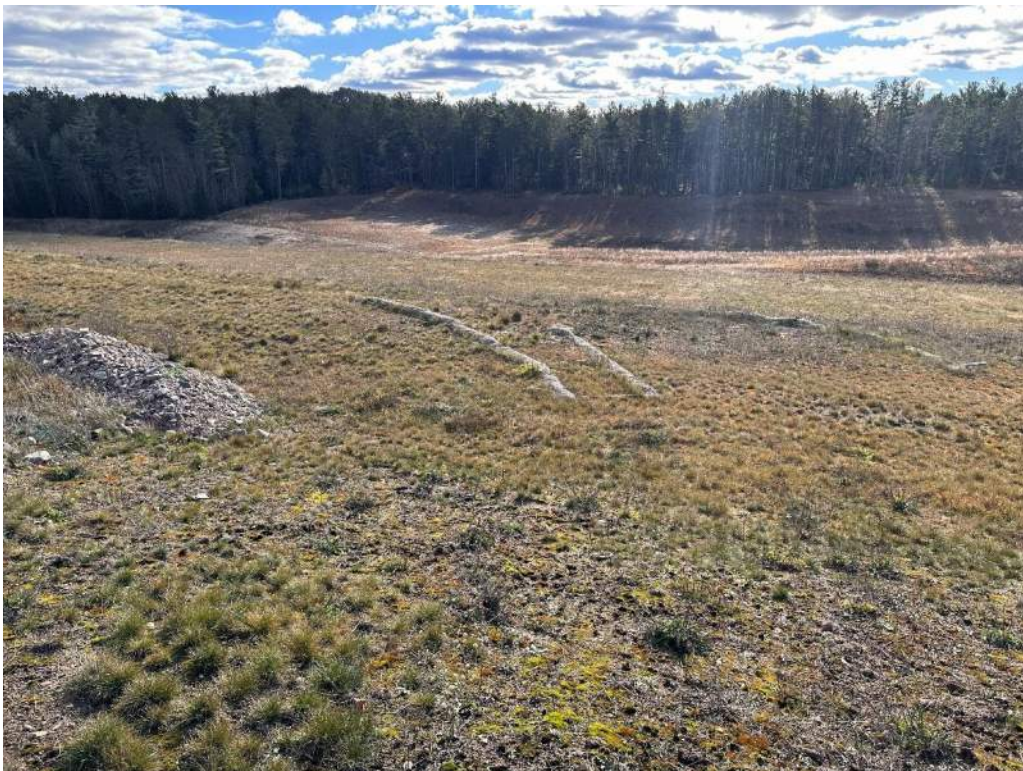
Photo No. 10 – Cover erosion control berms.

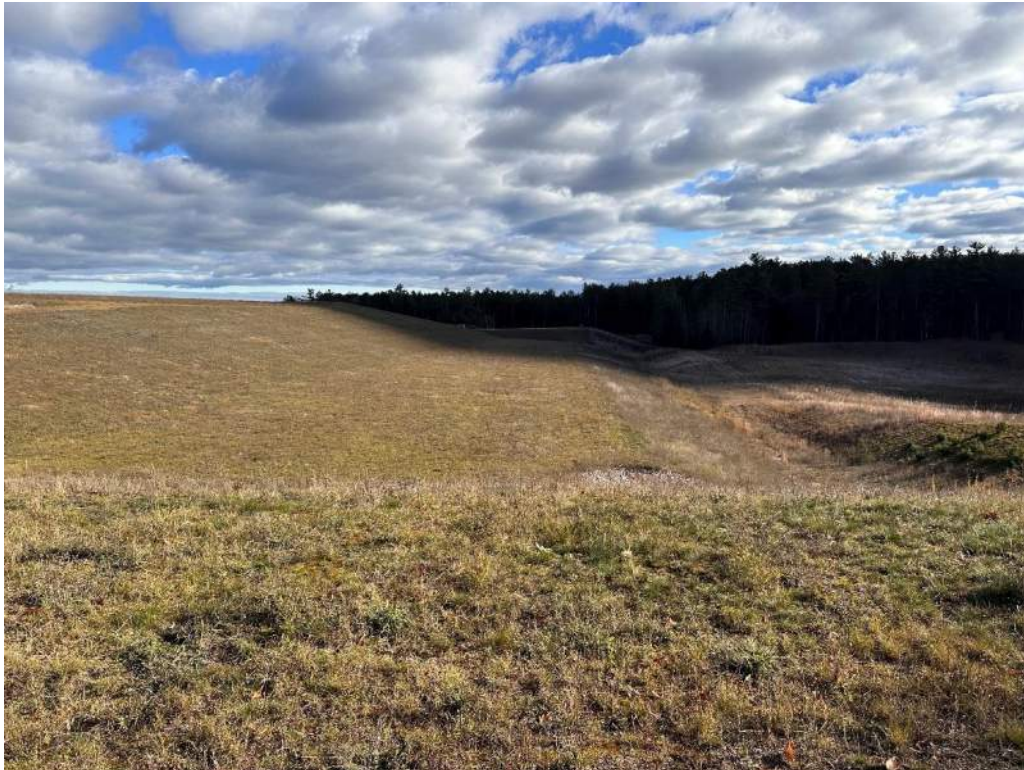
Photo No. 11 – South slope of Landfill No. 3, looking east.

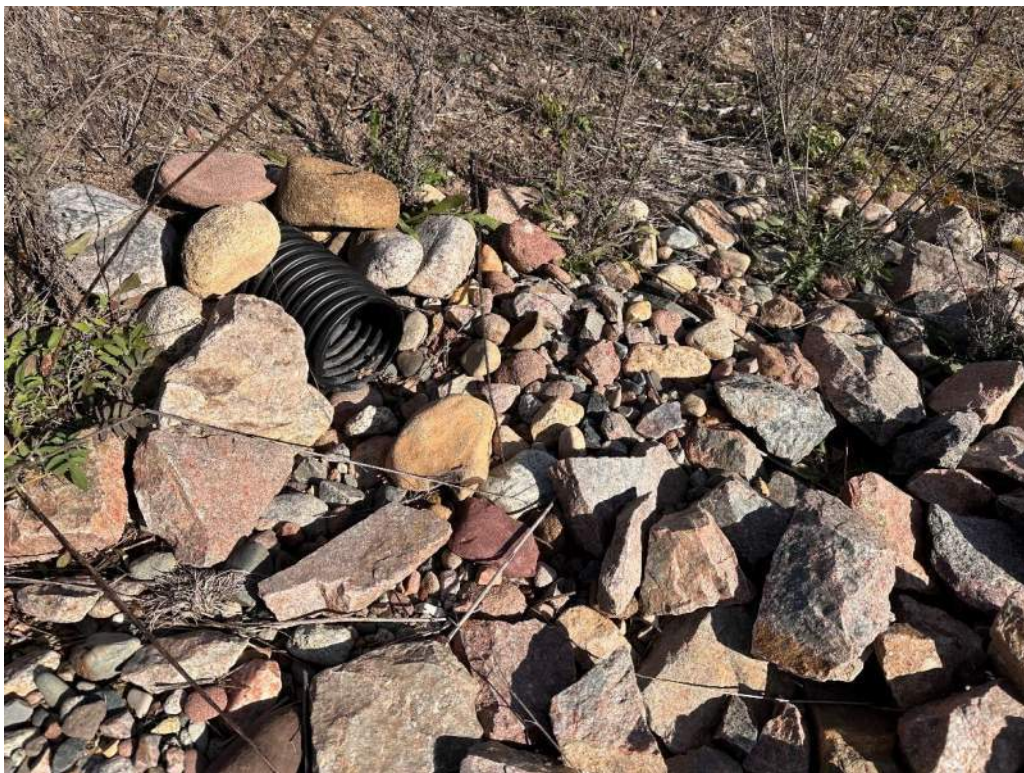
Photo No. 12 – Cover drain outlet located in the borrow area.

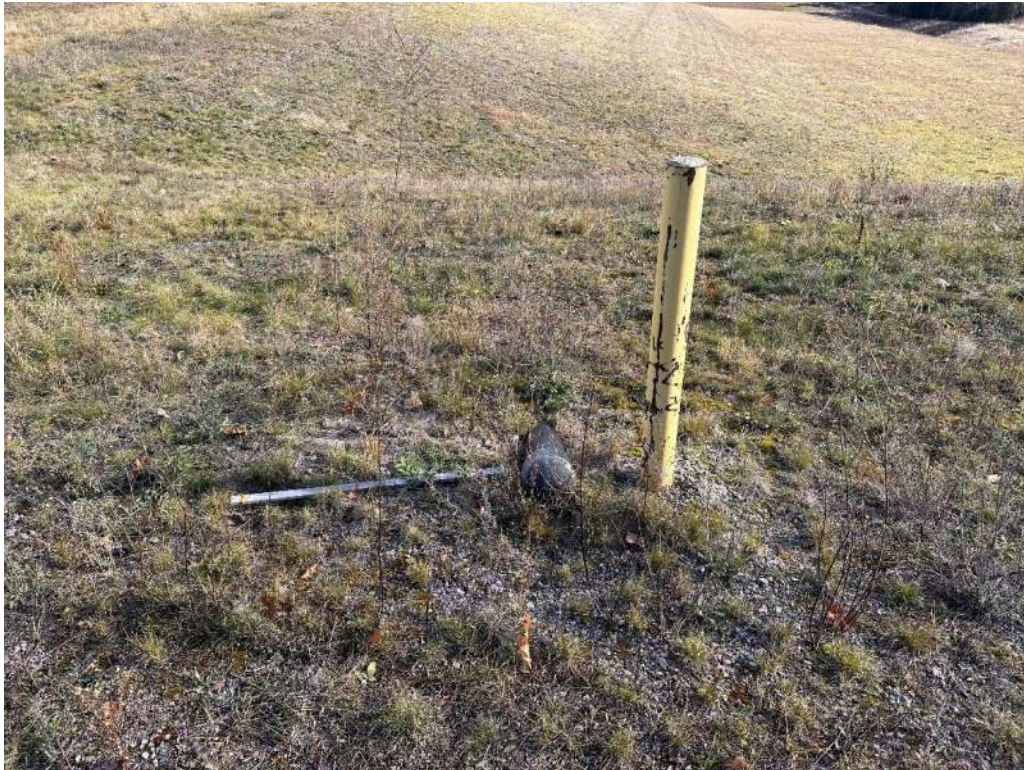
Photo No. 13 – Leachate cleanout on the west side of Landfill No. 3.

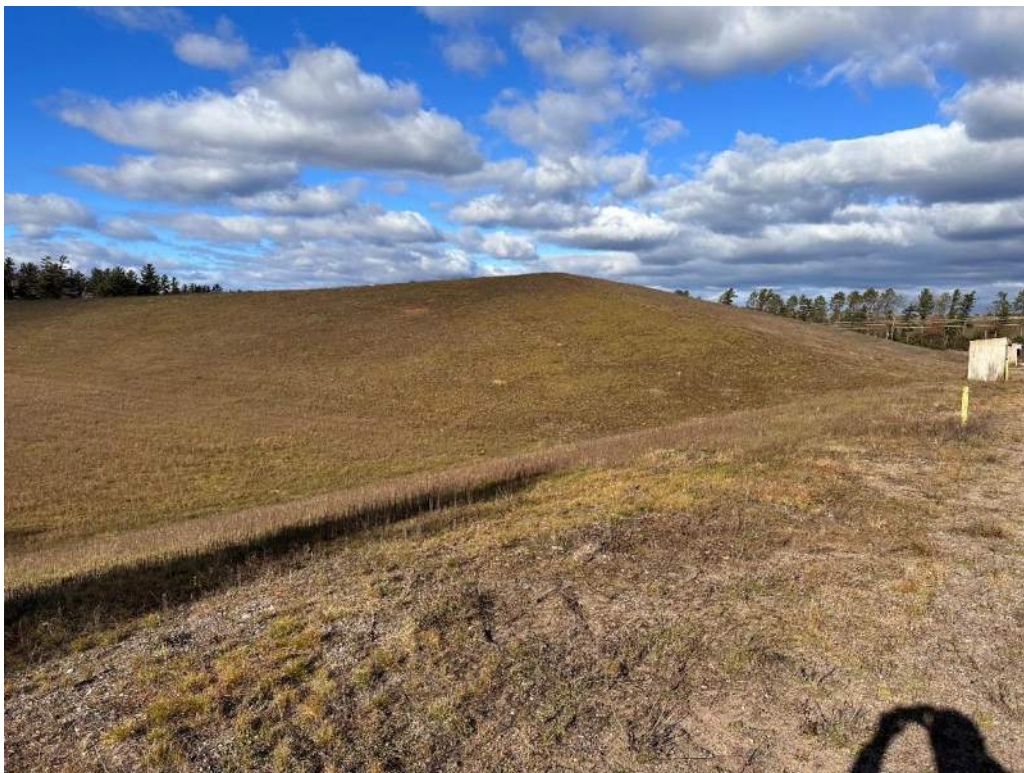
Photo No. 14 – South and east slopes of Landfill No. 3A, looking northwest.

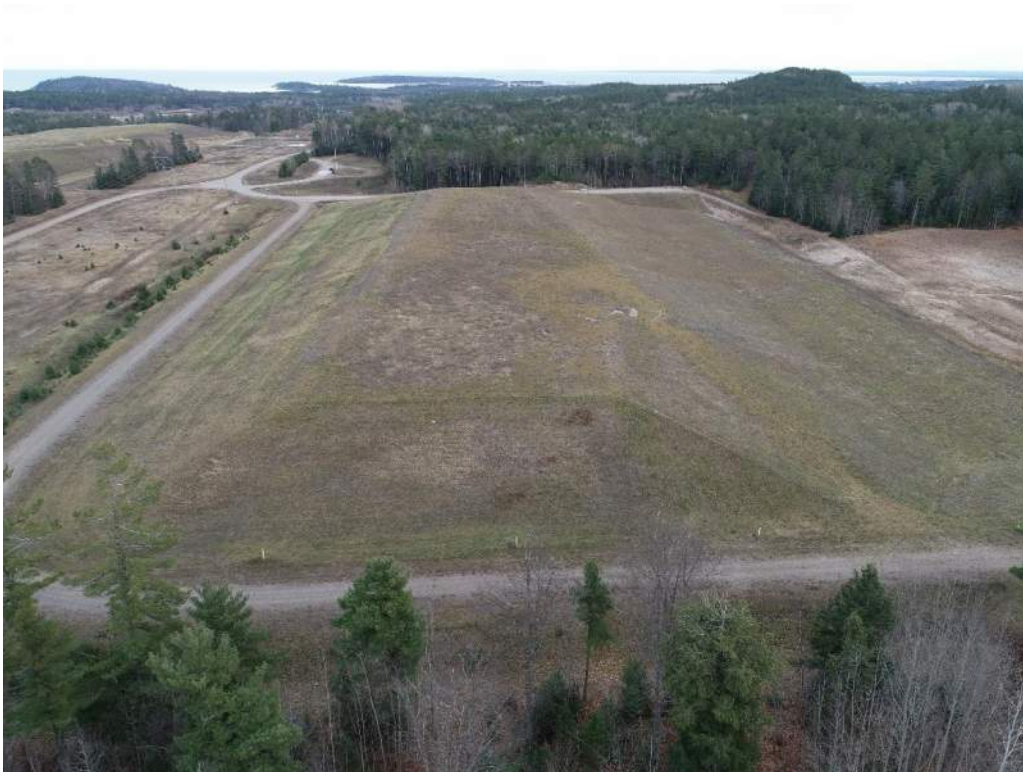
Photo No. 15 – Landfill No. 3, looking east.

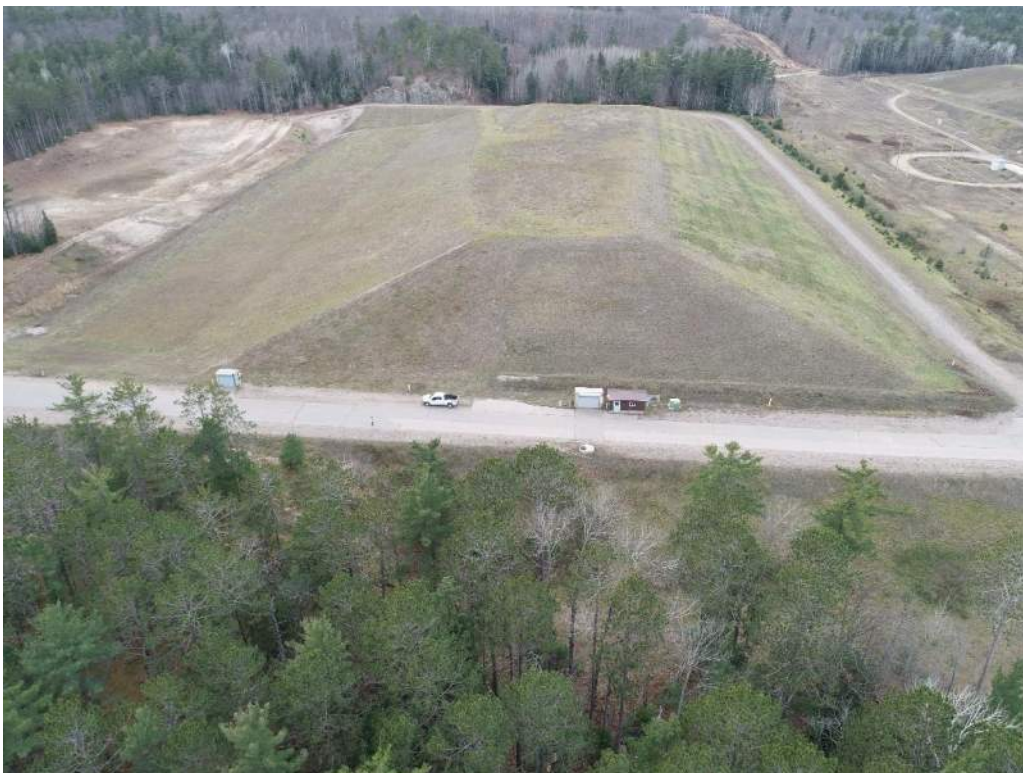
Photo No. 16 – Landfill No. 3, looking west.

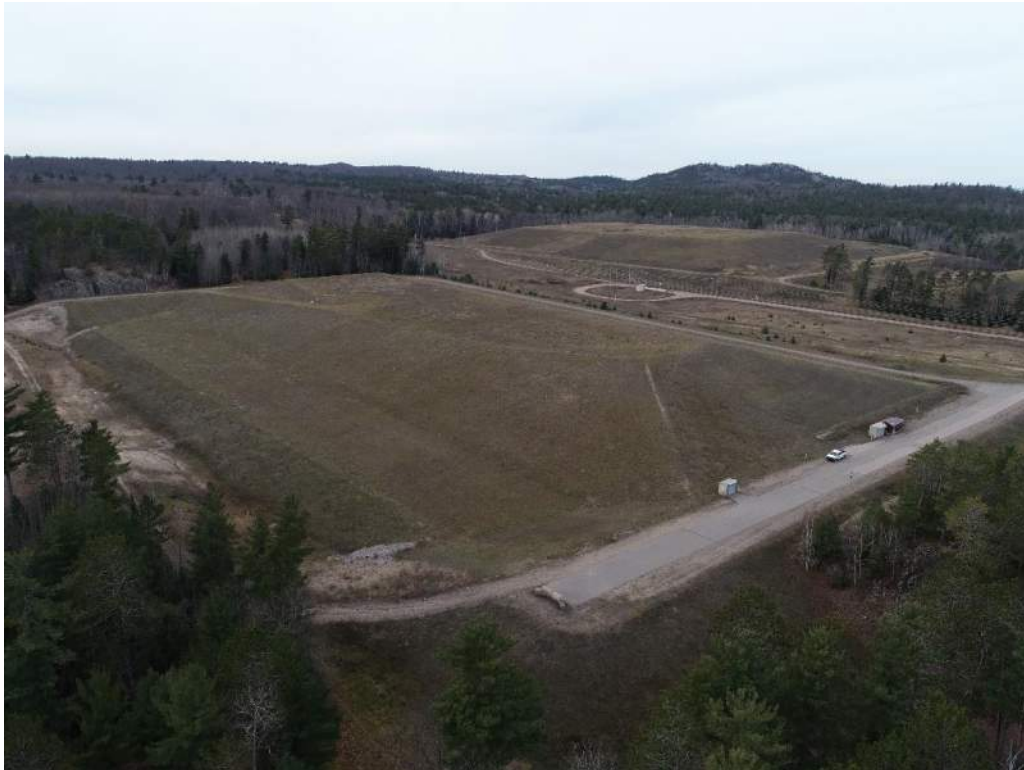
Photo No. 17 – Landfill No. 3, looking northwest.
