December 19, 2025

Project No. 2103683

**Re: 2025 Landfill Inspection Report**  
**Presque Isle Power Plant Ash Landfill No. 3**  
**We Energies**  
**Marquette Township, Michigan**

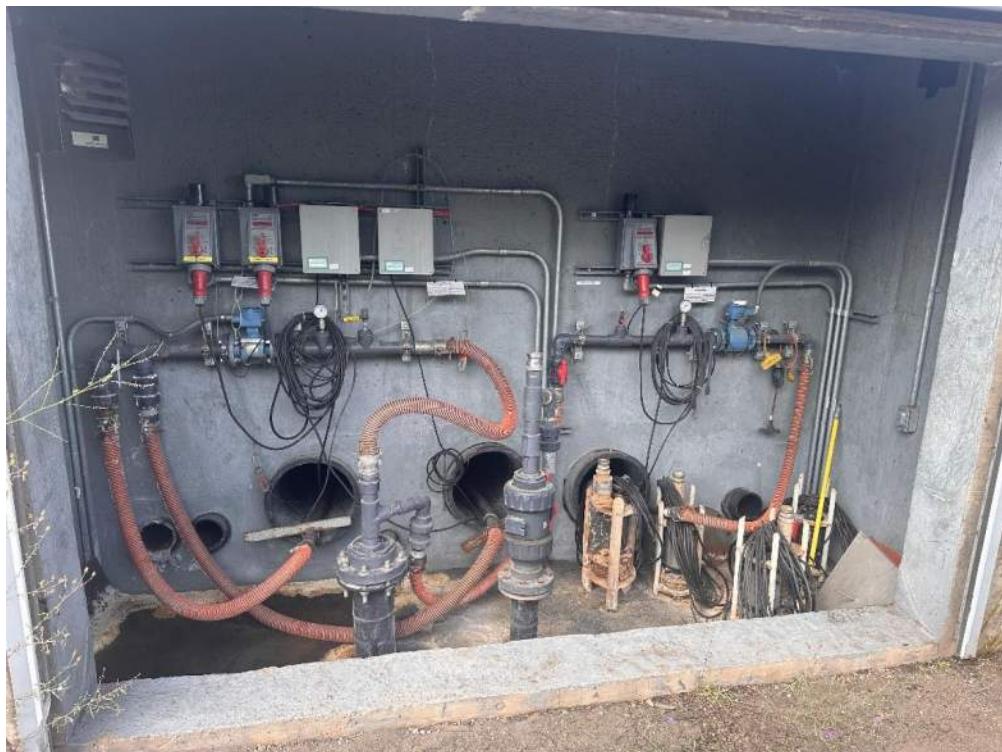
Photo No. 1 – Landfill No. 3, Cell 2 leachate collection riser vault.

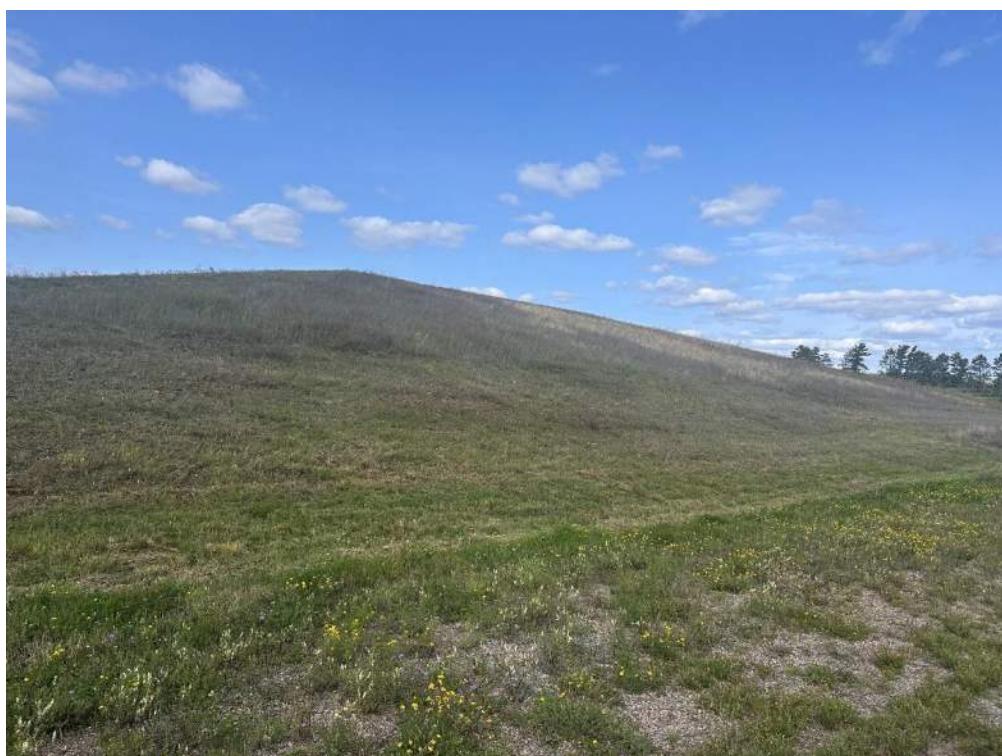
Photo No. 2 – East slope of Landfill No. 3, looking northwest.

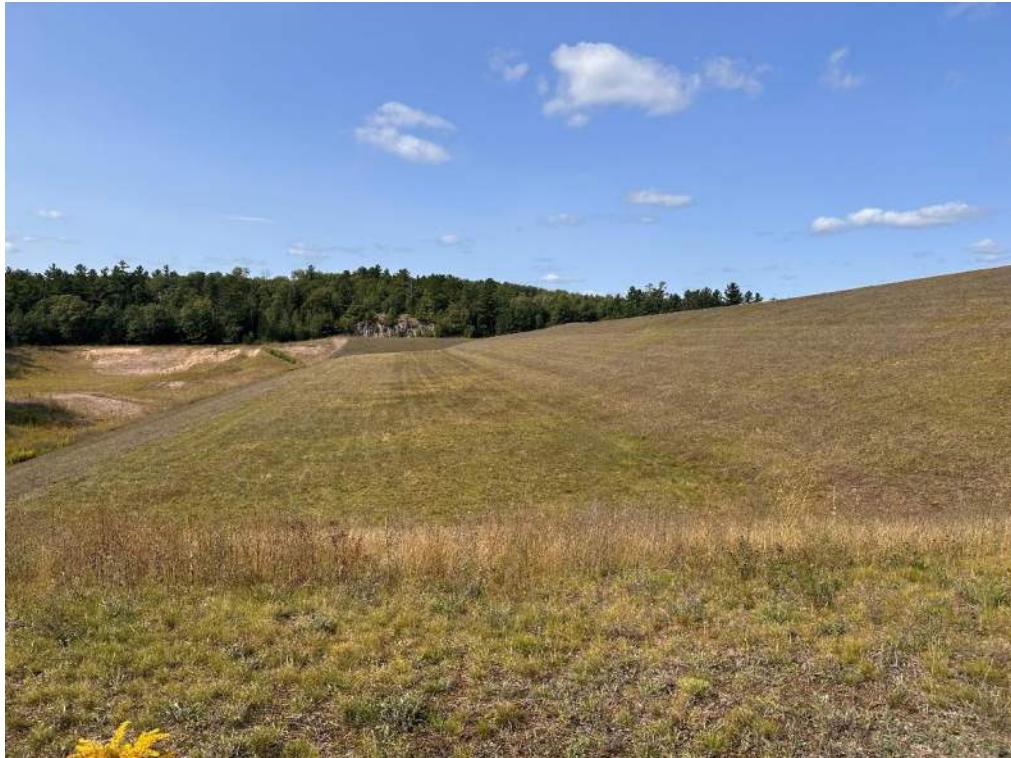
Photo No. 3 – South slope of Landfill No. 3, looking west.

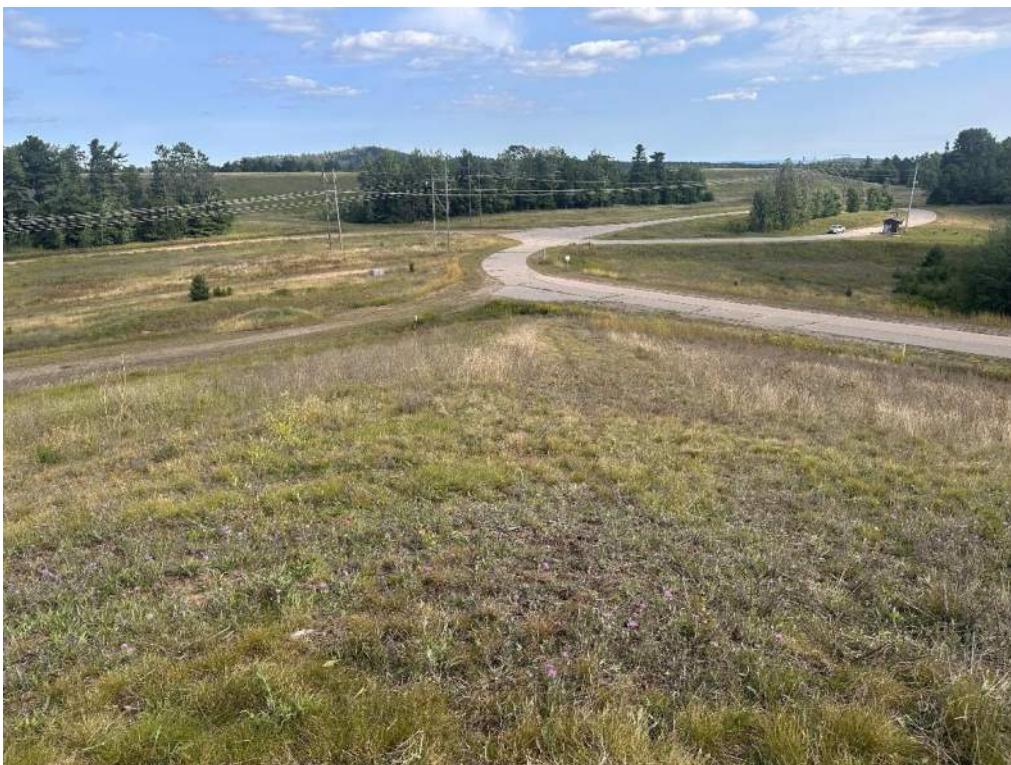
Photo No. 4 – Landfill No. 3 east and north slopes and leachate loadout facility.

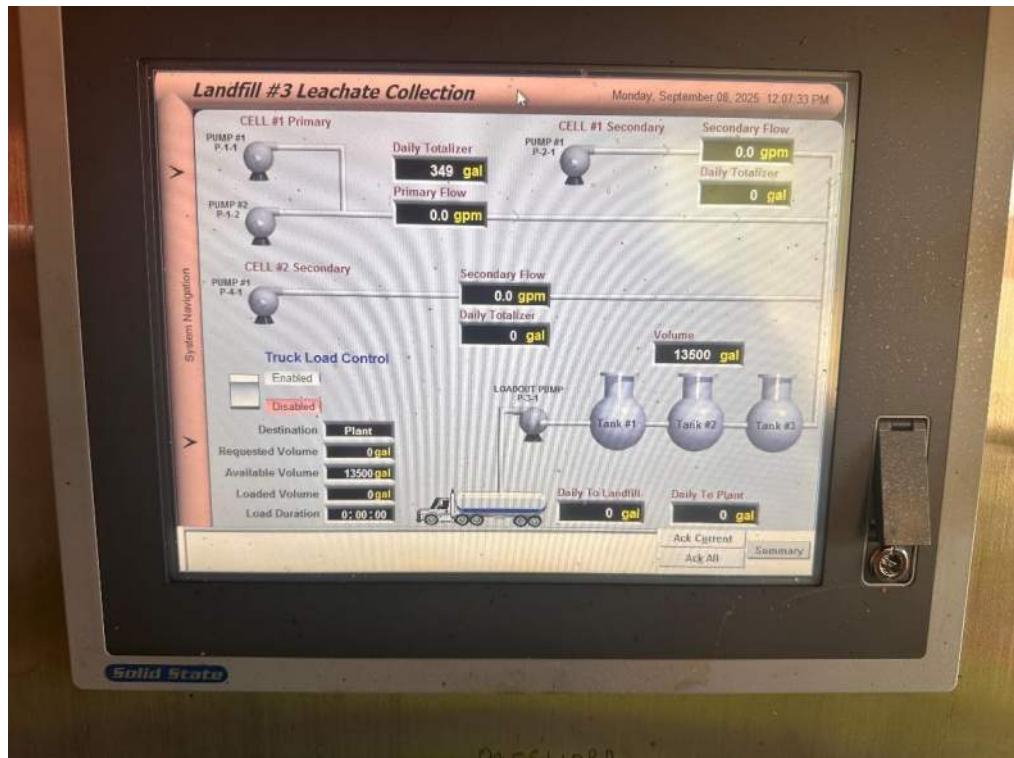
Photo No. 5 – Landfill No. 3 leachate loadout facility screen.

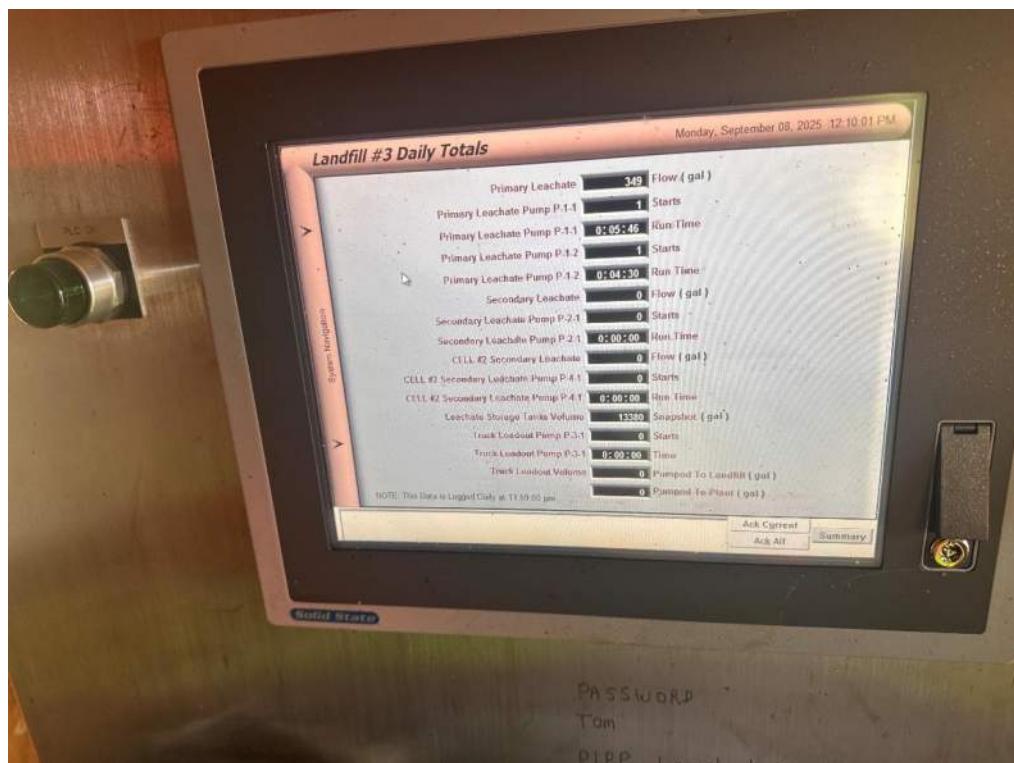
Photo No. 6 – Landfill No. 3 leachate loadout facility screen.

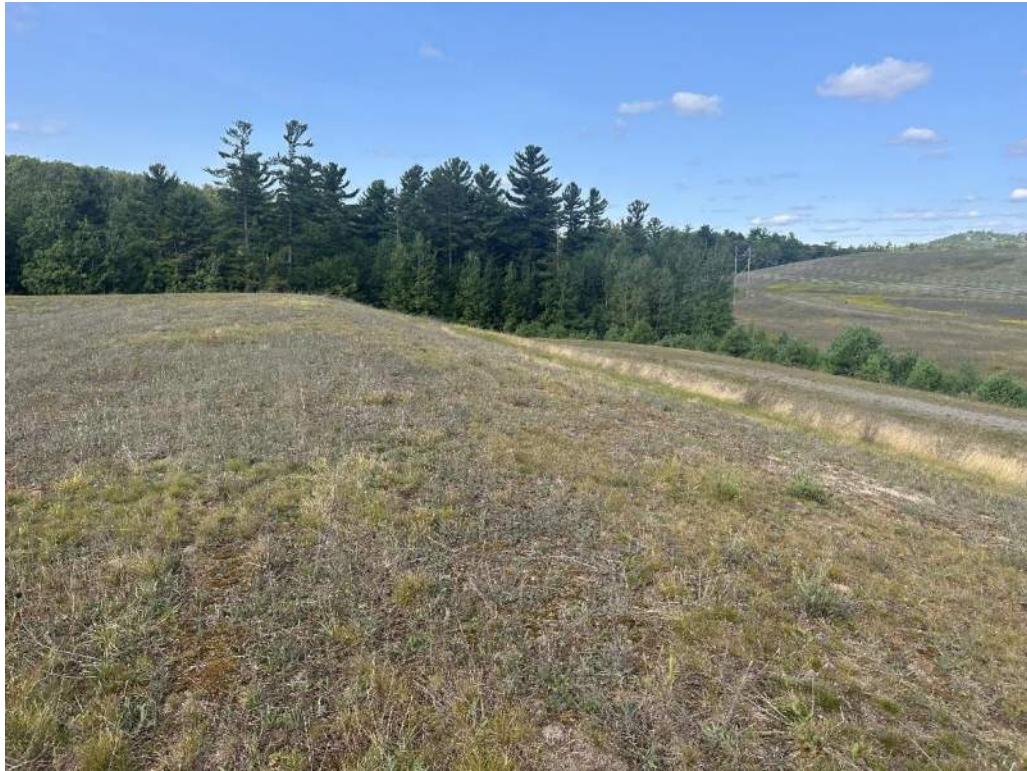
Photo No. 7 – North slope of Landfill No. 3, looking west.

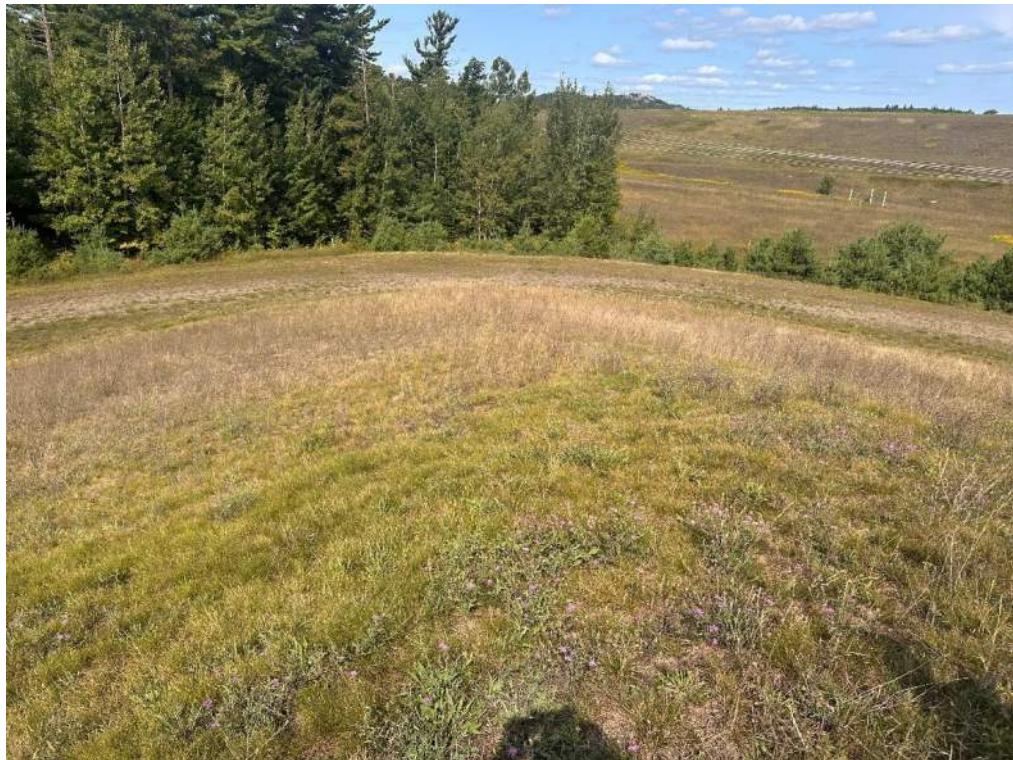
Photo No. 8 – Northwest corner of Landfill No. 3, looking northwest.

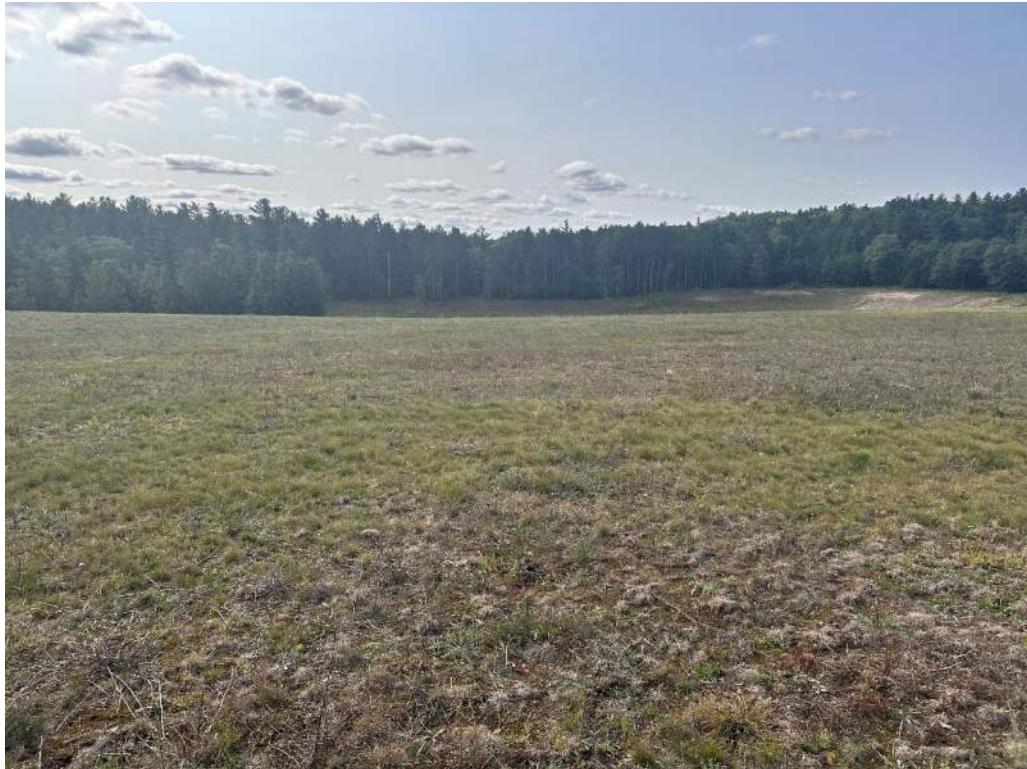
Photo No. 9 – Top of Landfill No. 3, looking south.

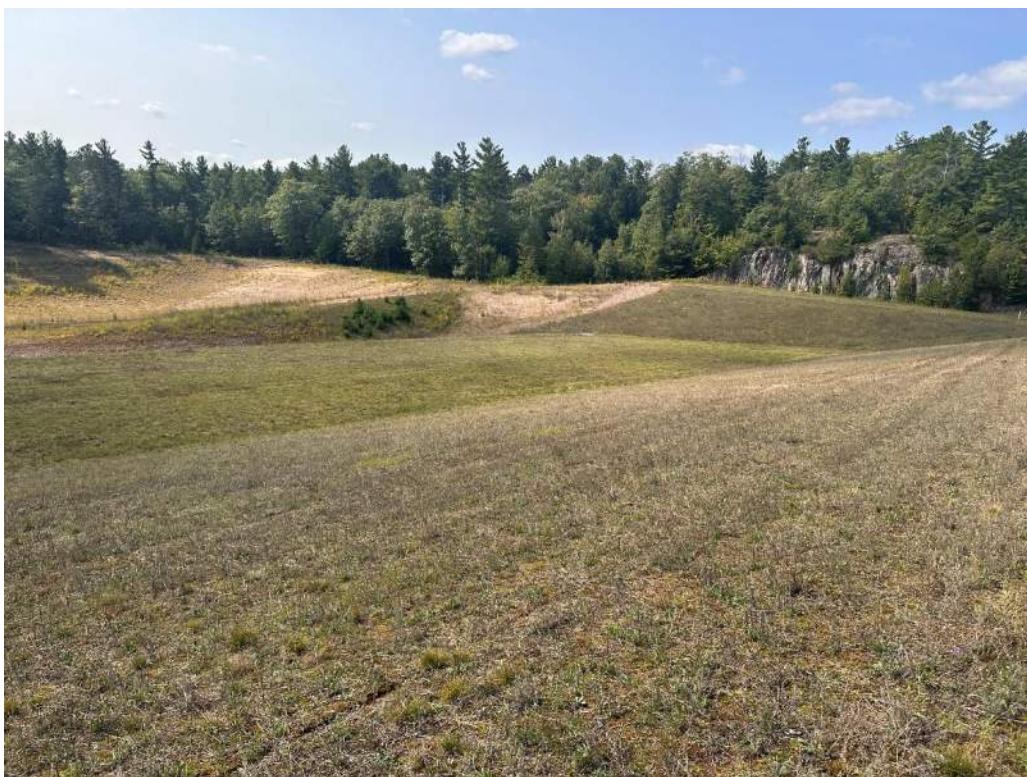
Photo No. 10 – South slope of Landfill No. 3, looking southwest.

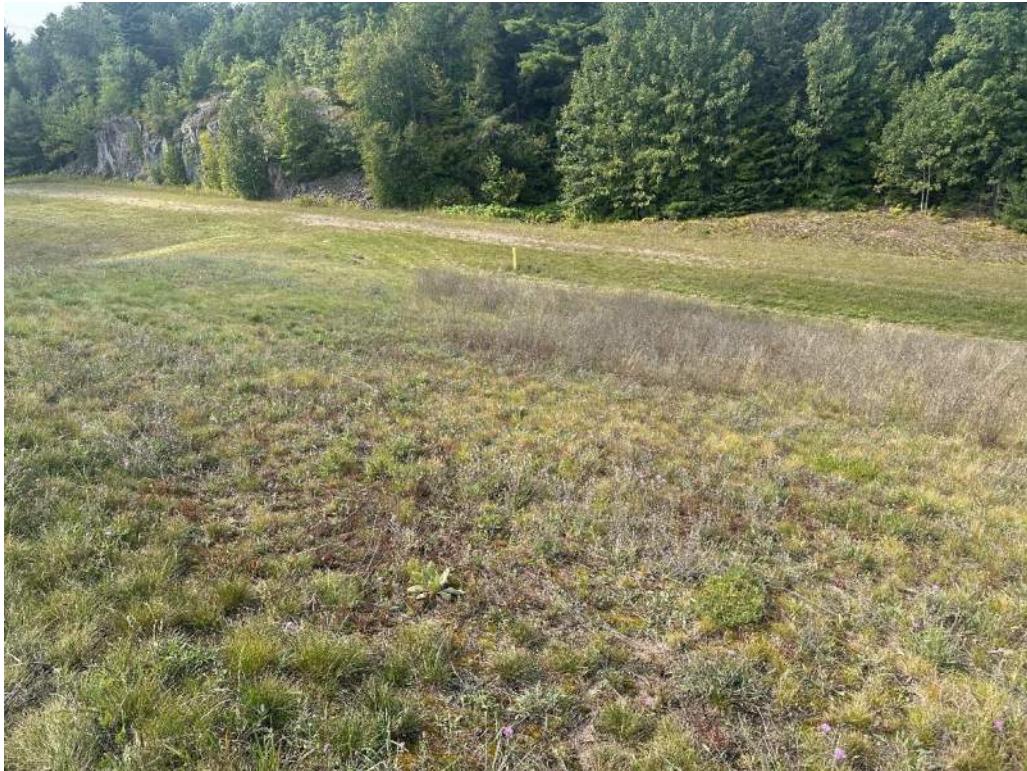
Photo No. 11 – West slope of Landfill No. 3, looking west.

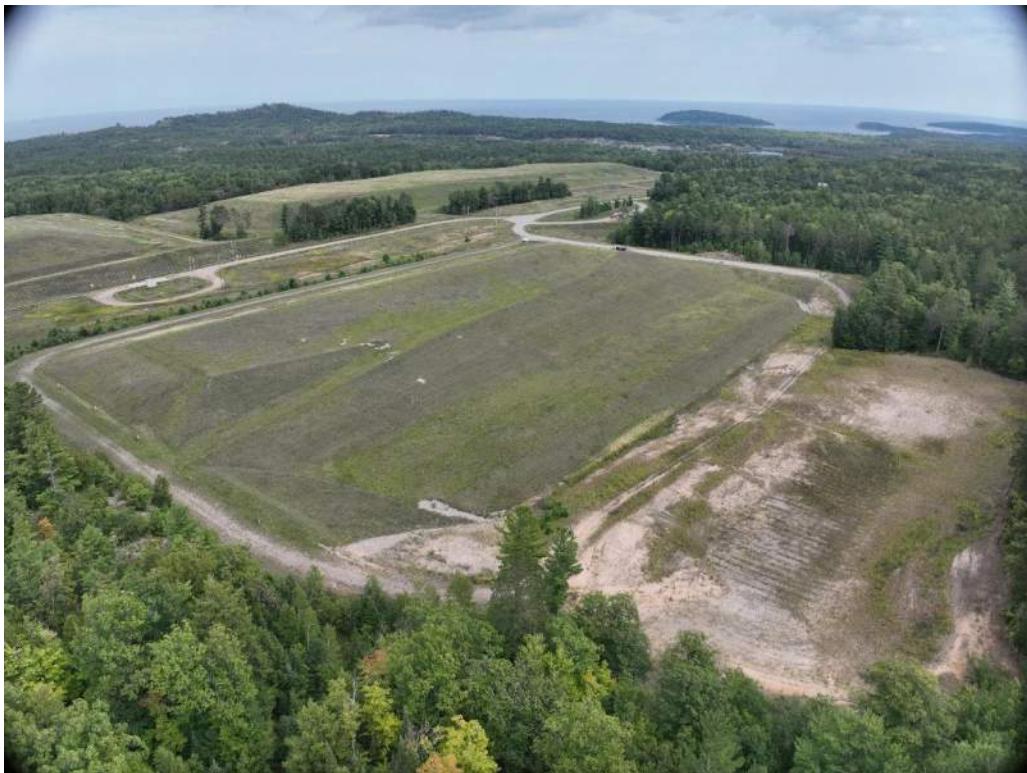
Photo No. 12 – Landfill No. 3, looking northeast.

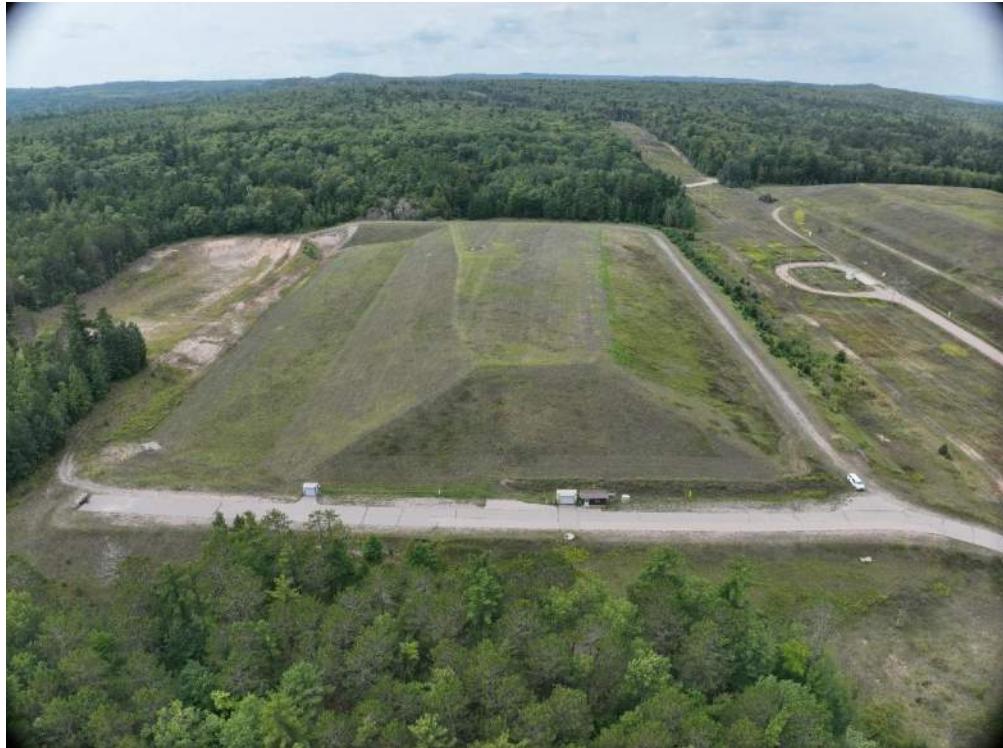
Photo No. 13 – Landfill No. 3, looking west.

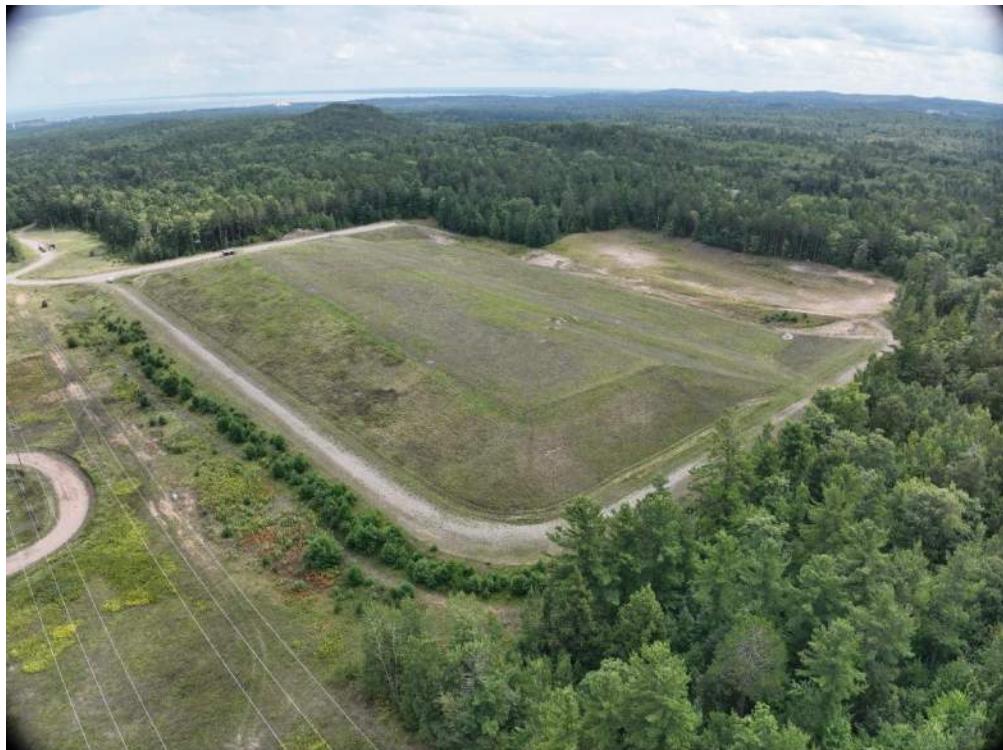
Photo No. 14 – Landfill No. 3, looking southeast.
