January 7, 2016

Project 128980

**Re: Landfill Inspection Report for the Presque Isle Power Plant Landfill No. 3
We Energies
Marquette Township, Michigan**

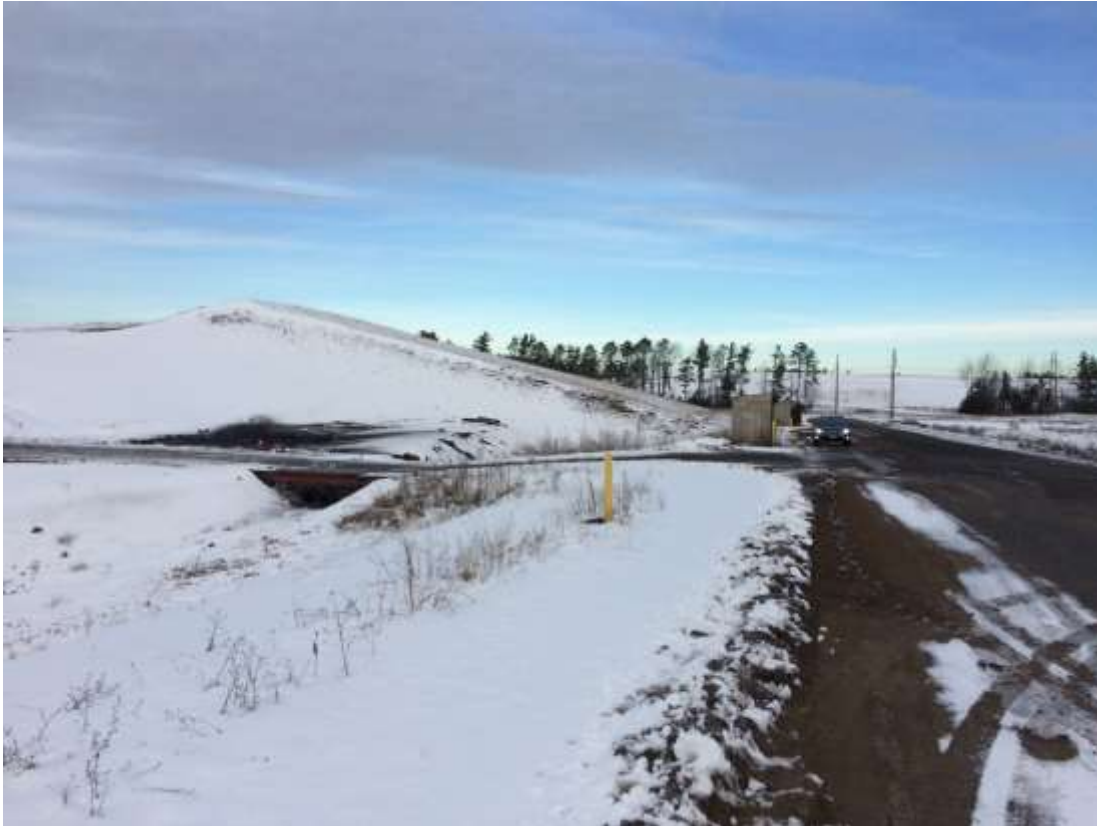
Photo 1- Landfill No. 3 access road and entrance to the landfill, looking north along east perimeter road.

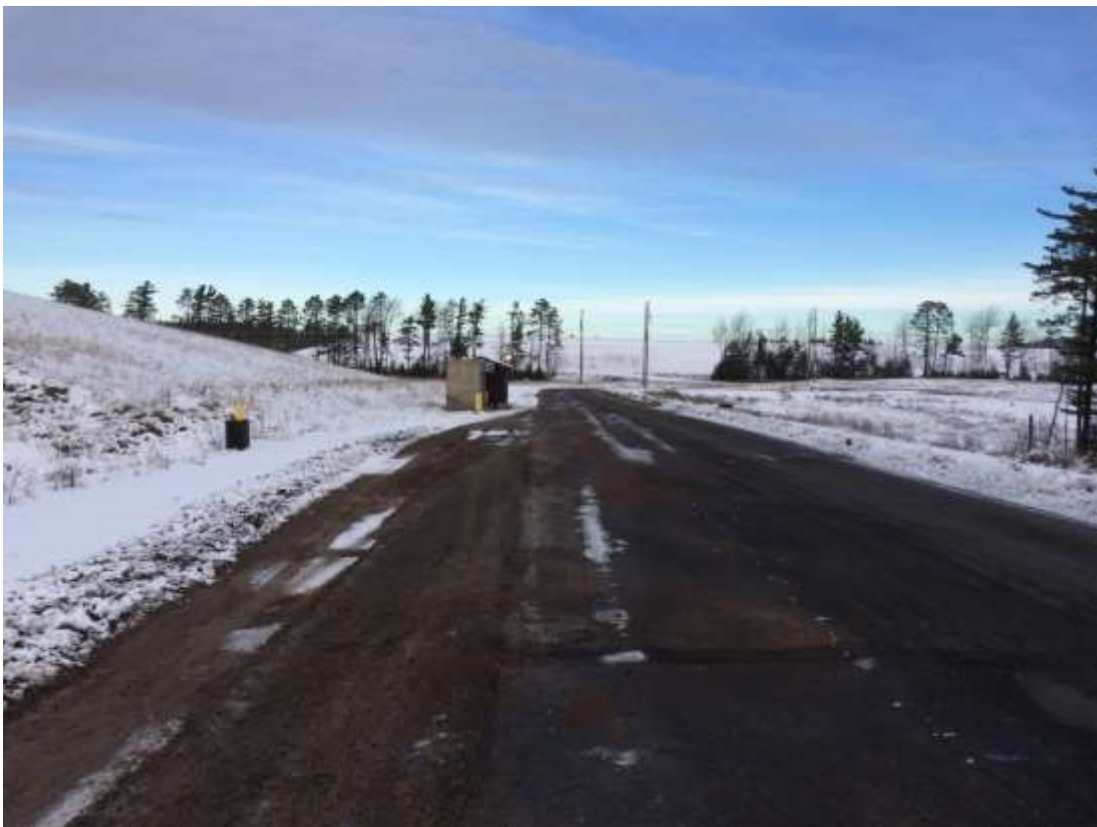
Photo 2- Landfill No. 3 access road and Cell 1 riser vault, looking north along east perimeter road.

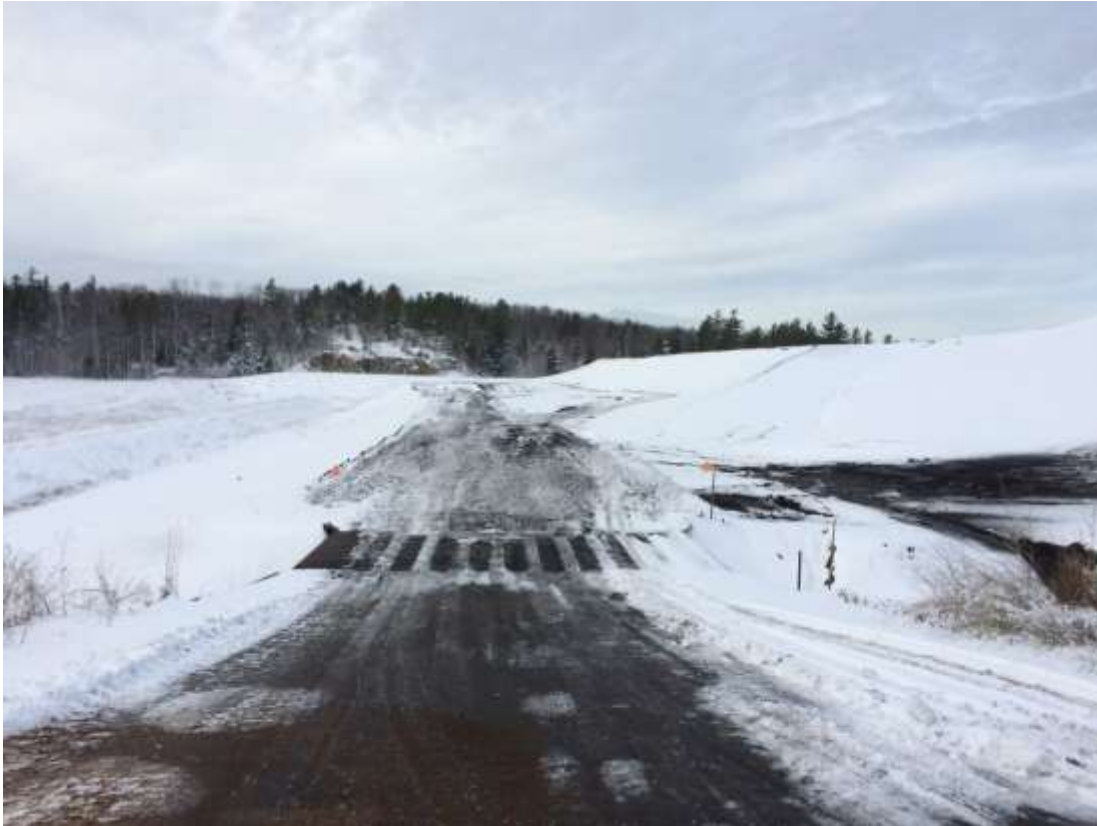
Photo 3- Entrance into Cell 2 looking west at cattle crossing used for storm water and track-out control.

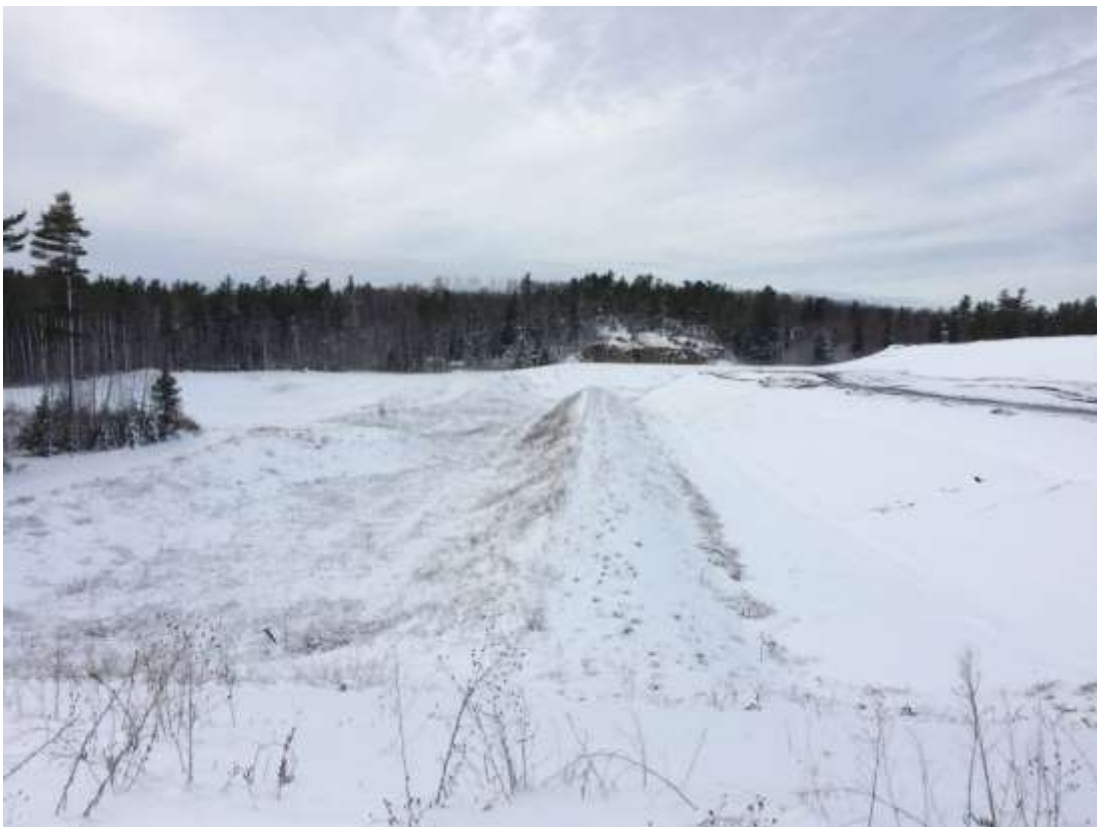
Photo 4- Looking west at the south containment berm and operational storm water containment area. The operational storm water containment area is graded as required by the design.

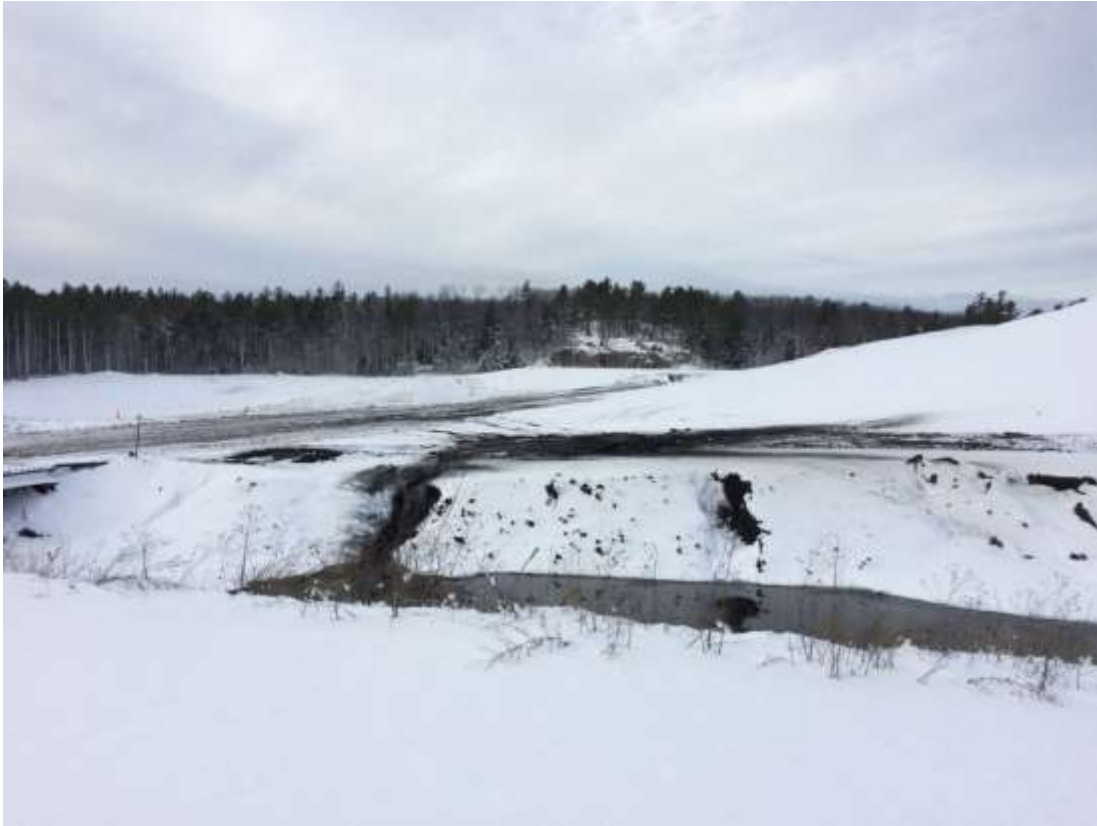
Comments : Final Cover Slopes appear stable with no observed instability, no significant erosion, no woody vegetation, no animal burrows, or concerns regarding the final cover slopes. Ash Slopes appeared to be in good condition with no observed instability or significant erosion. The only observed erosion was small erosion gullies north of the cattle crossing/access road on the interior storm/contact water control ditch.

Photo 5- Operational storm water containment ditch north of the entrance, with some minor erosion. The ditch appears to have adequate capacity for the upcoming winter and eventual spring runoff.

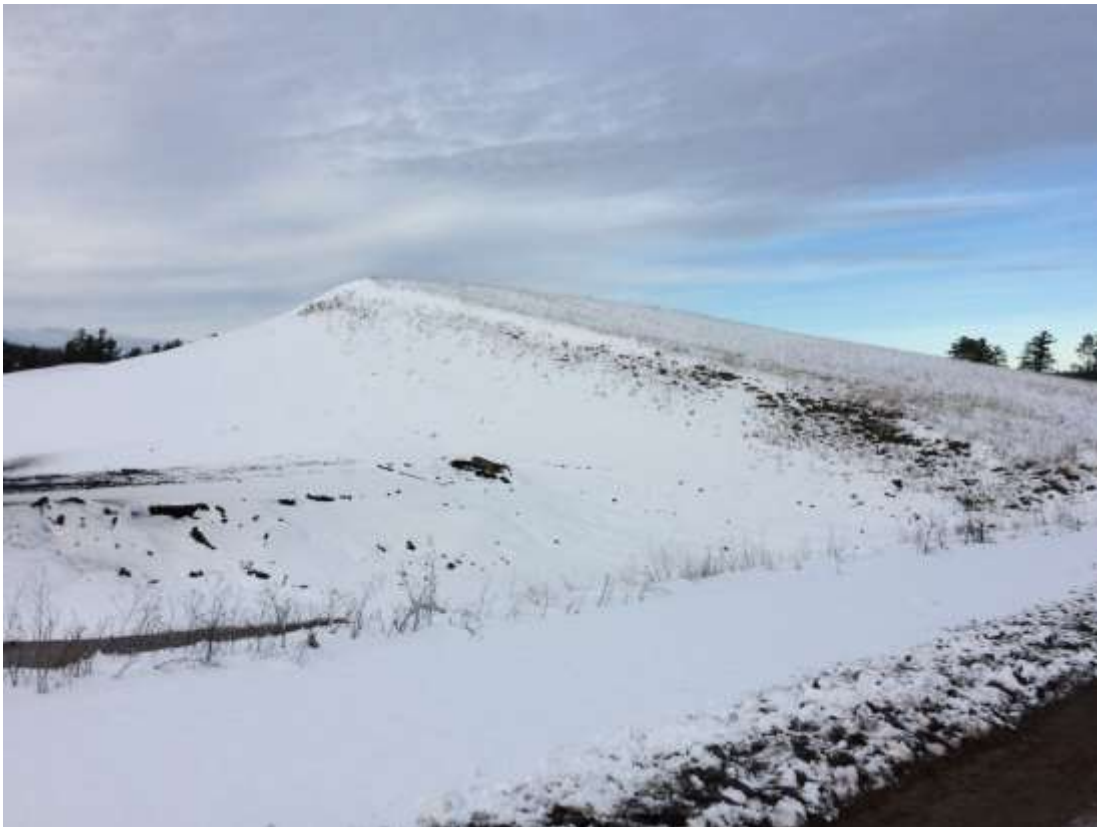
Photo 6- East slope of Cell 1 which was closed in 2014. Slope appears to be in very good condition, well vegetated, no signs of instability or erosion, no woody vegetation, and no observed animal burrows.

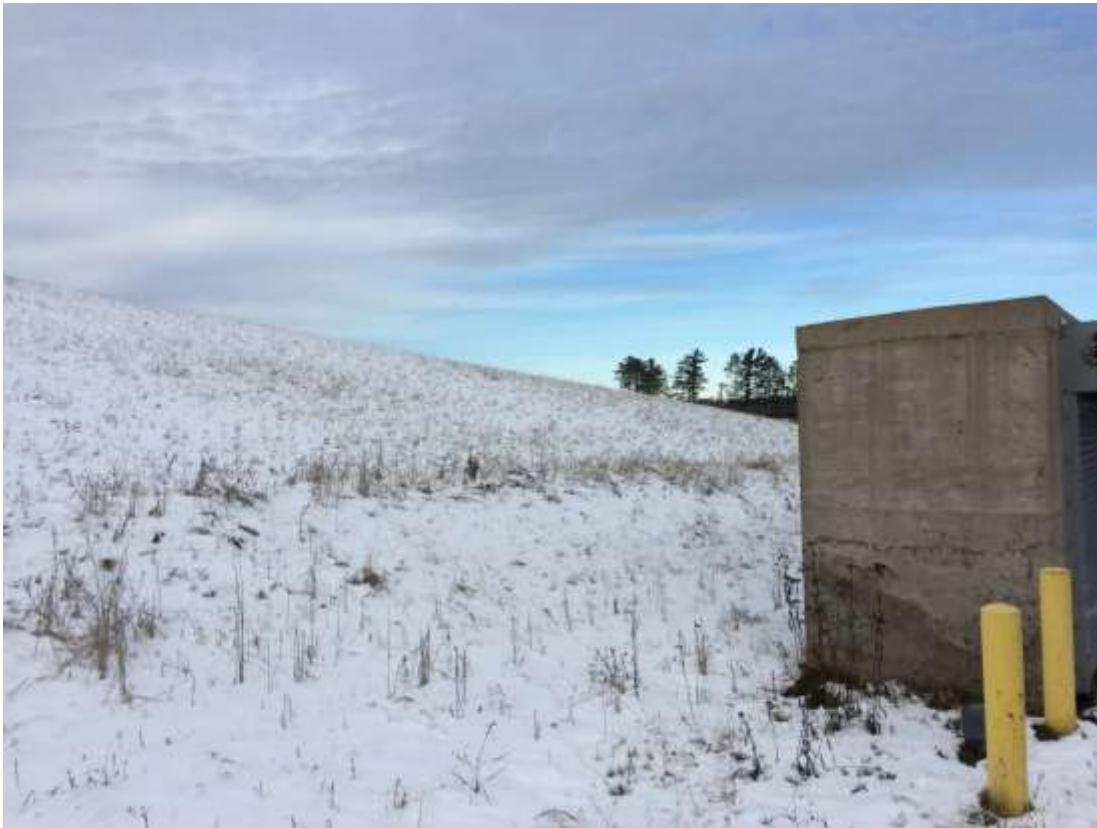
Photo 7- East slope of Cell 1. Slope appears to be in very good condition, well vegetated, no signs of instability or erosion, no woody vegetation, and no observed animal burrows.

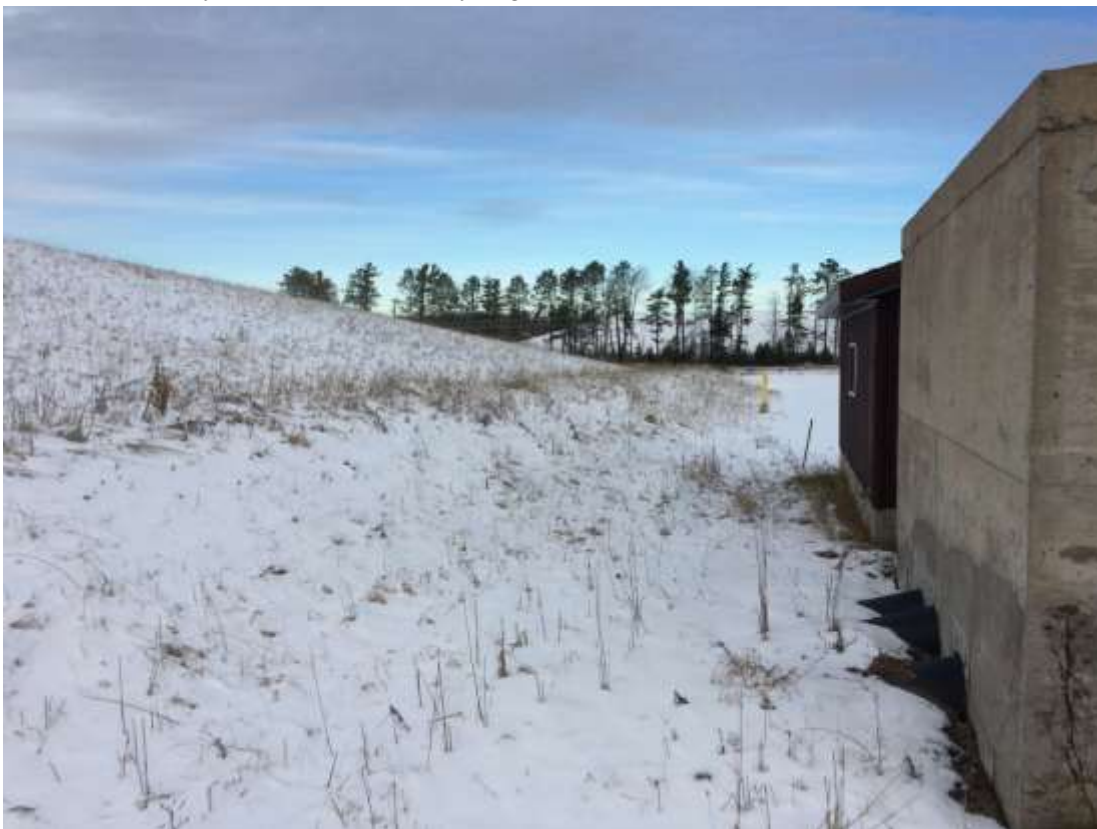
Photo 8- East slope of Cell 1. Slope appears to be in very good condition, well vegetated, no signs of instability or erosion, no woody vegetation, and no observed animal burrows.

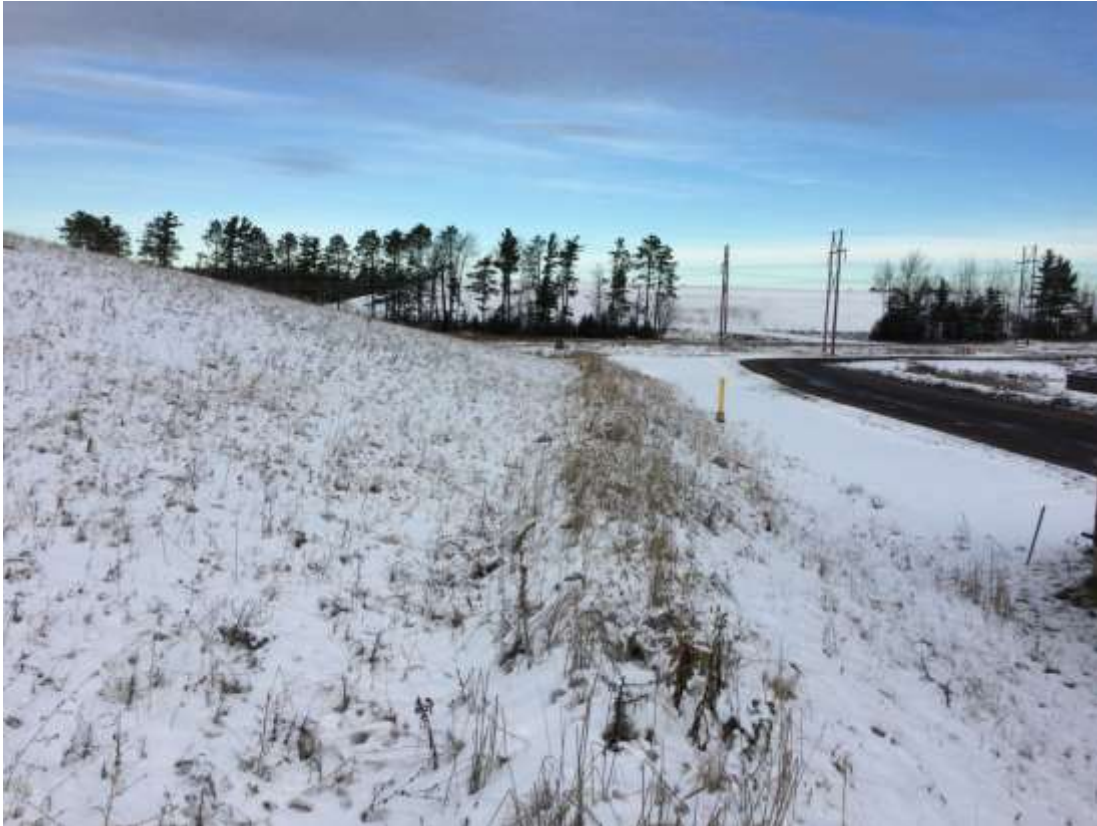
Photo 9- East slope of Cell 1. Slope appears to be in very good condition, well vegetated, no signs of instability or erosion, no woody vegetation, and no observed animal burrows.

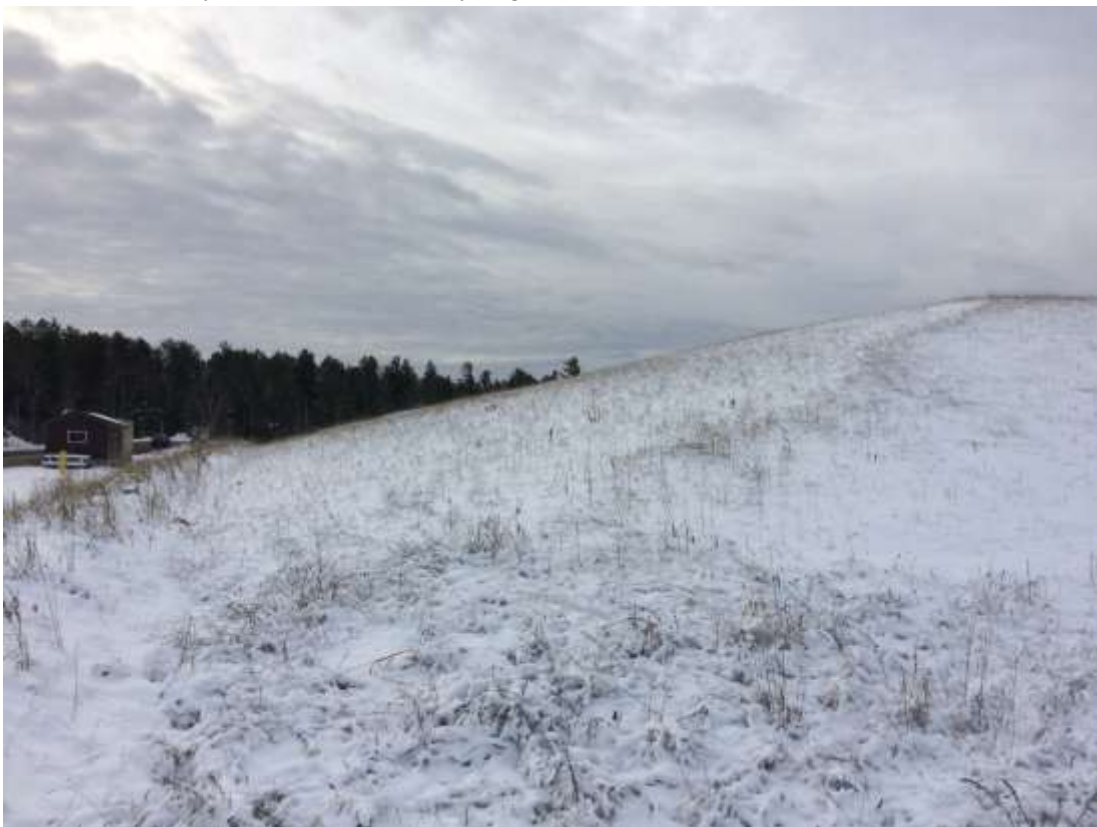
Photo 11- East slope of Cell 1. Slope appears to be in very good condition, well vegetated, no signs of instability or erosion, no woody vegetation, and no observed animal burrows.

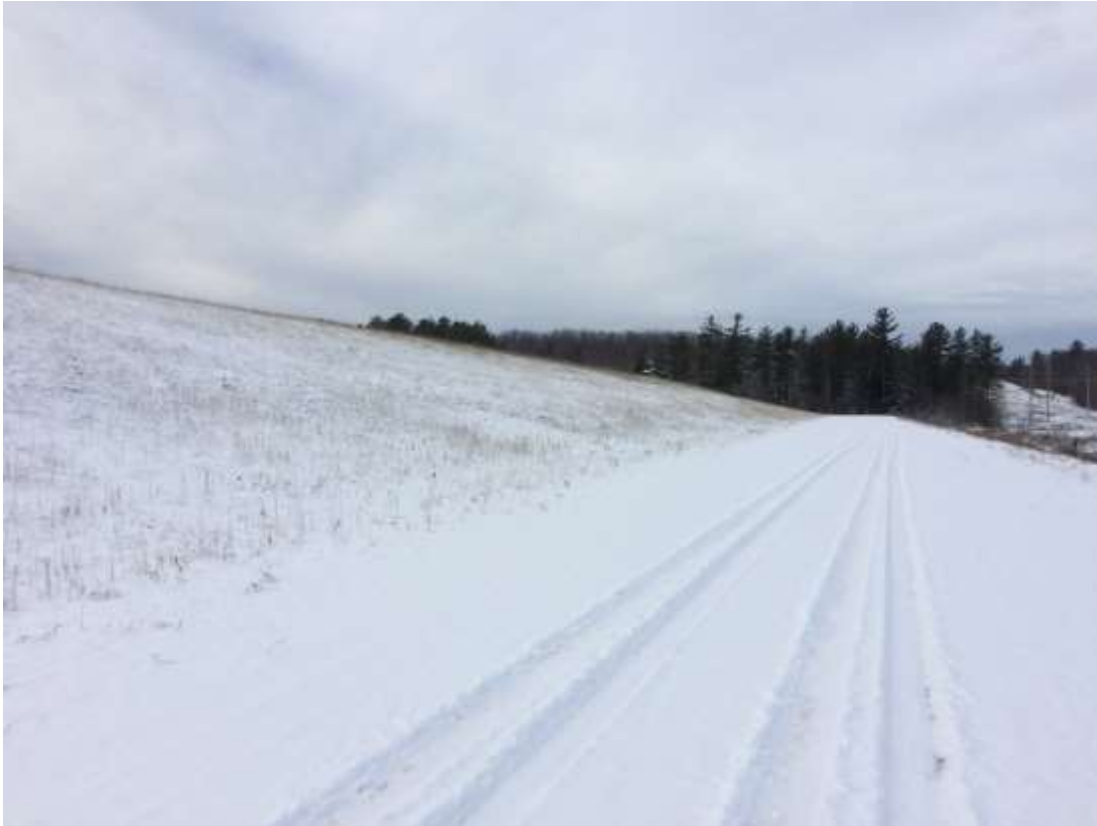
Photo 10- North slope of Cell 1. Slope appears to be in very good condition, well vegetated, no signs of instability or erosion, no woody vegetation, and no observed animal burrows.

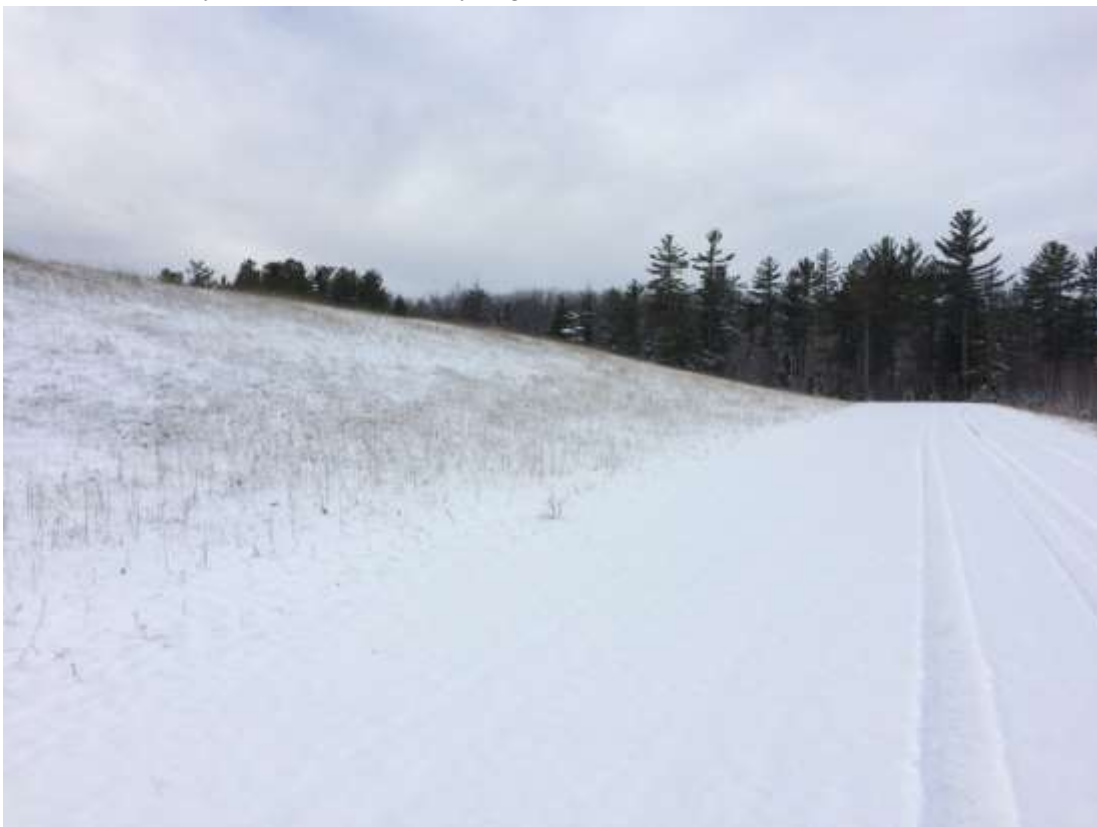
Photo 12- - North slope of Cell 1. Slope appears to be in very good condition, well vegetated, no signs of instability or erosion, no woody vegetation, and no observed animal burrows.

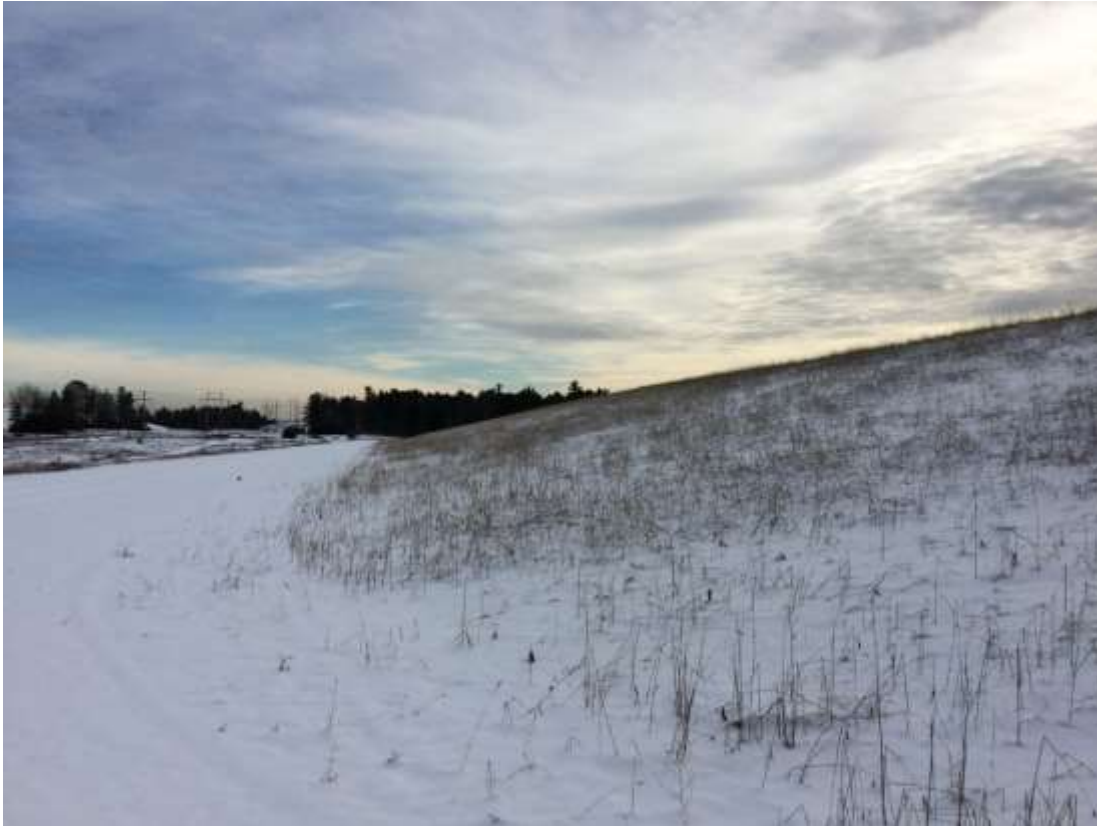
Photo 13- - North slope of Cell 1. Slope appears to be in very good condition, well vegetated, no signs of instability or erosion, no woody vegetation, and no observed animal burrows.

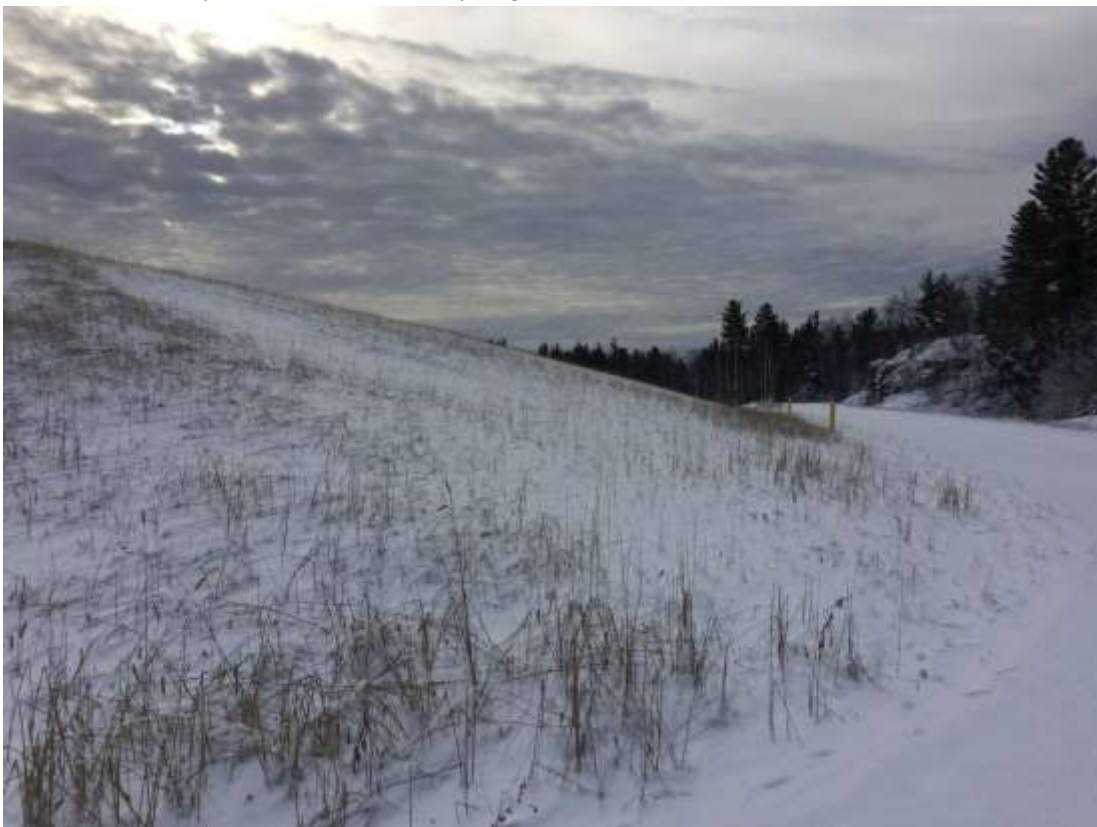
Photo 14 - West slope of Cell 1. Slope appears to be in very good condition, well vegetated, no signs of instability or erosion, no woody vegetation, and no observed animal burrows.

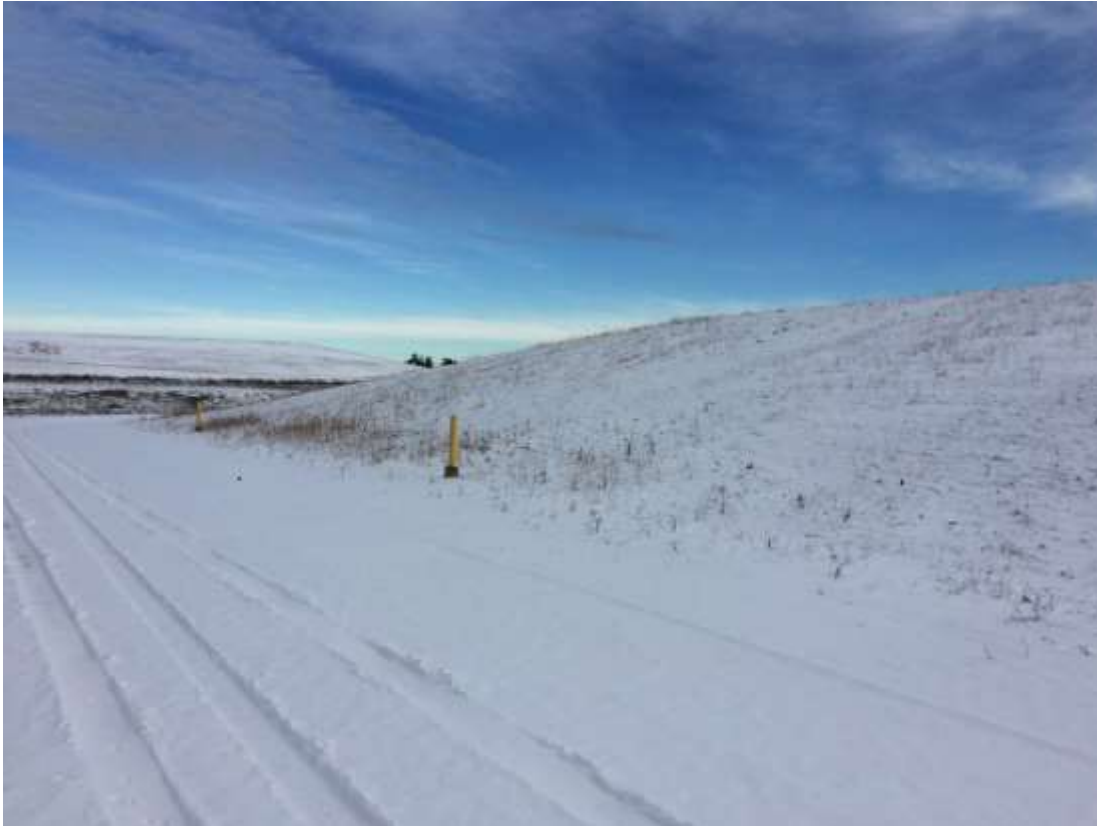
Photo 15- West slope of Cell 1. Slope appears to be in very good condition, well vegetated, no signs of instability or erosion, no woody vegetation, and no observed animal burrows.

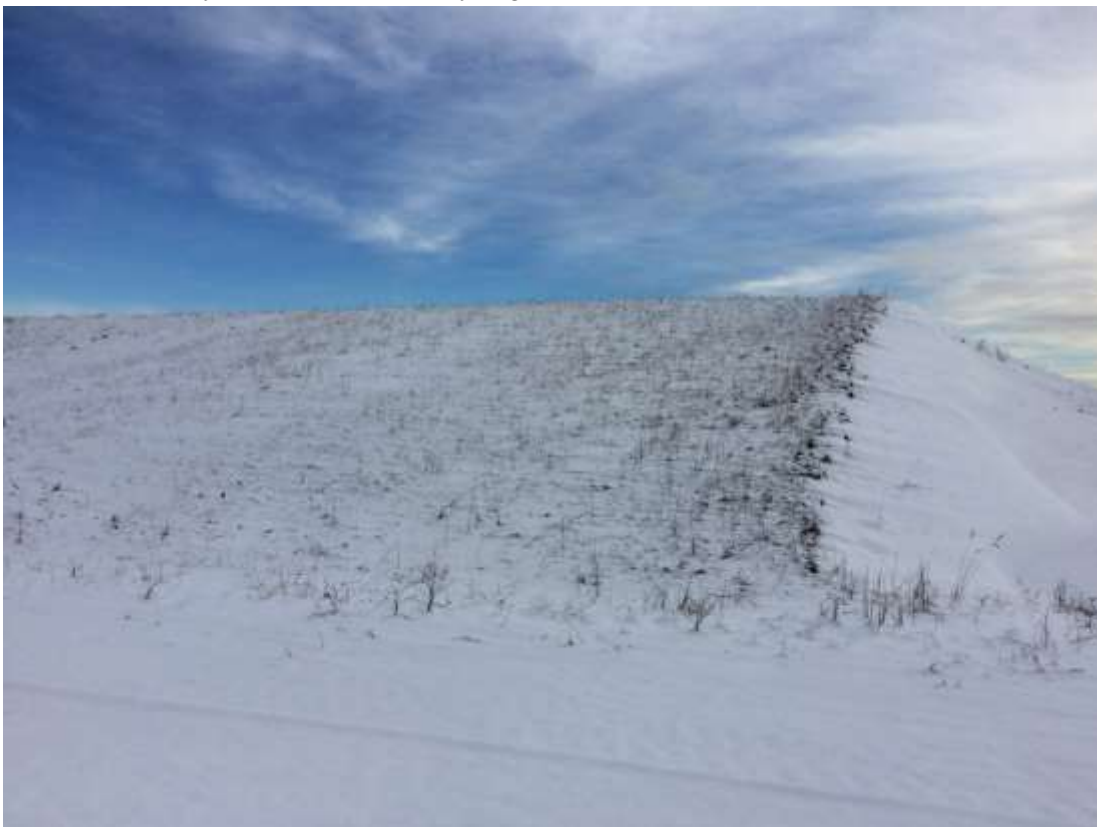
Photo 16 - West slope of Cell 1. Slope appears to be in very good condition, well vegetated, no signs of instability or erosion, no woody vegetation, and no observed animal burrows.

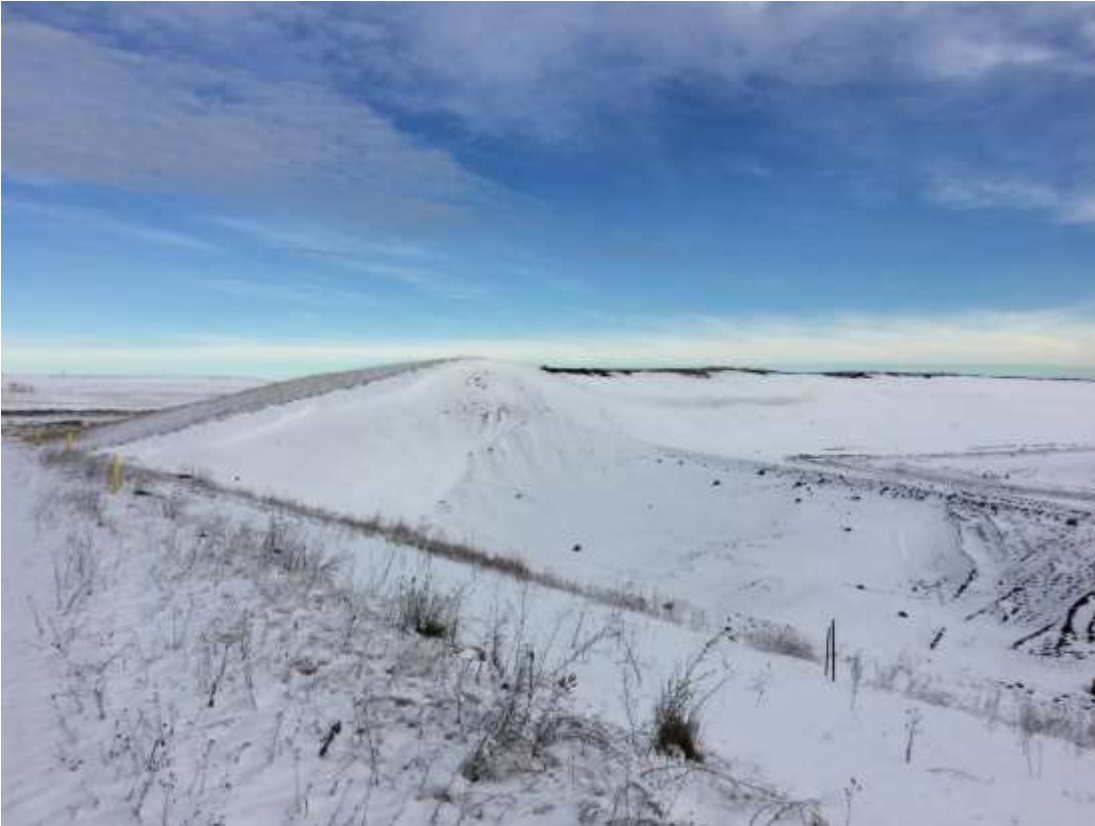
Photo 17- West slope and operational storm water containment ditch. The ditch is in very good condition and prepared for winter and eventual spring runoff

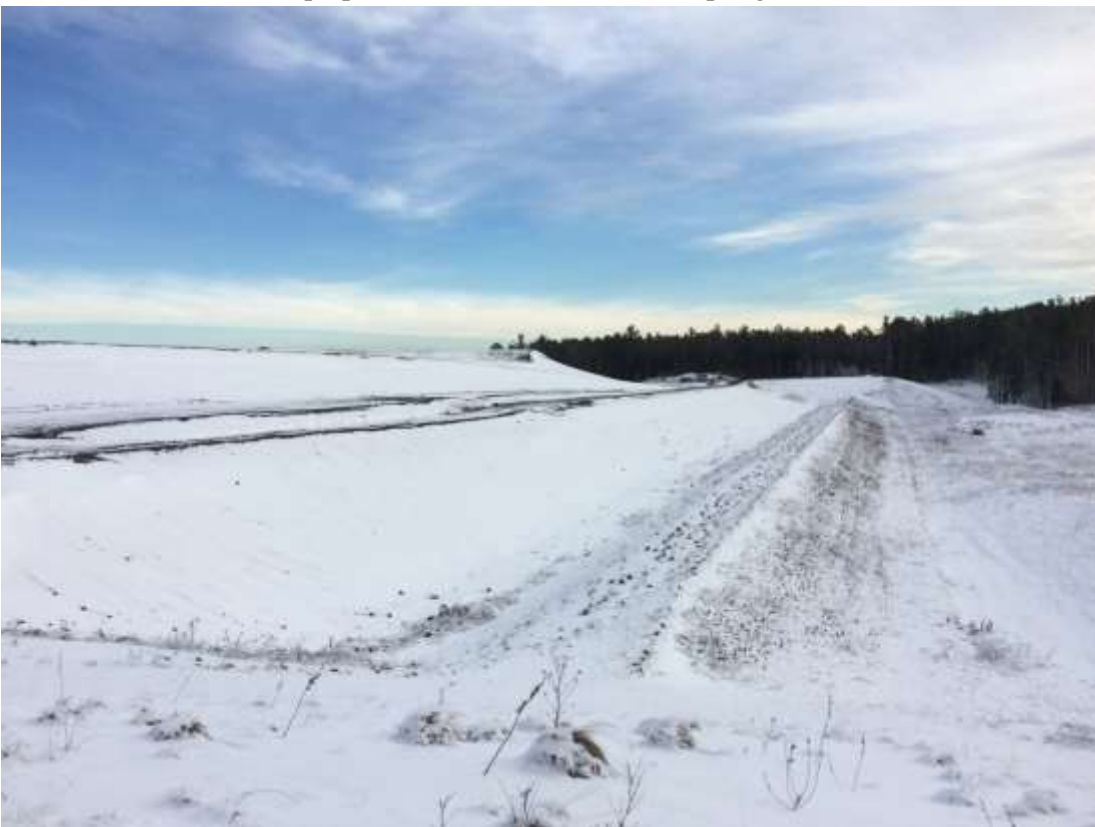
Photo 18- Looking east at the south containment berm and operational storm water containment area. The operational storm water containment area is graded as required by the design.
