Consulting December 19, 2020 Engineers and Scientists GEI Project No. 1610530

#### Re: Caledonia Ash Landfill Inspection Report We Energies Town of Caledonia, Racine County Wisconsin

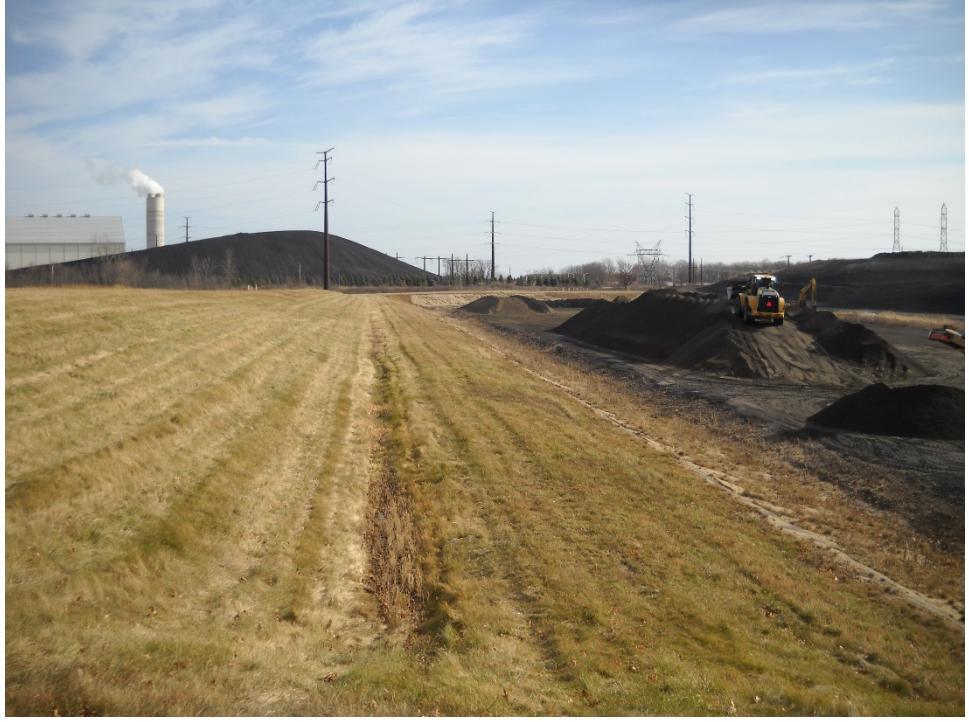
Photo No. 1: North perimeter limit of Cell 10 looking east on 11/19/2020

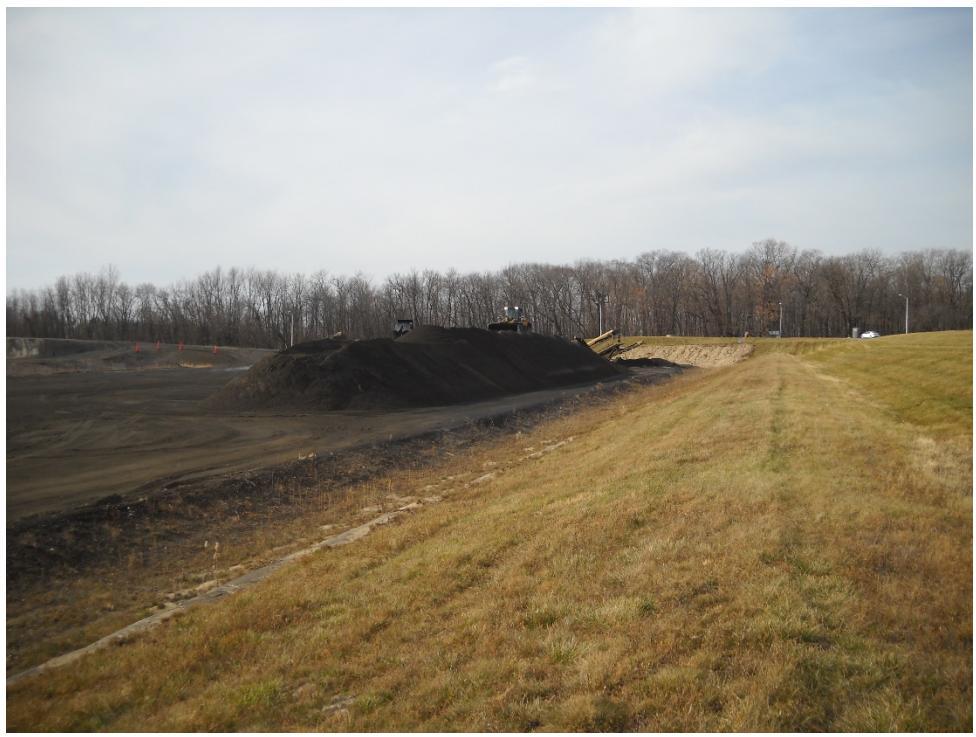
Photo No. 2: North perimeter limit of Cell 10 looking west on 11/19/2020

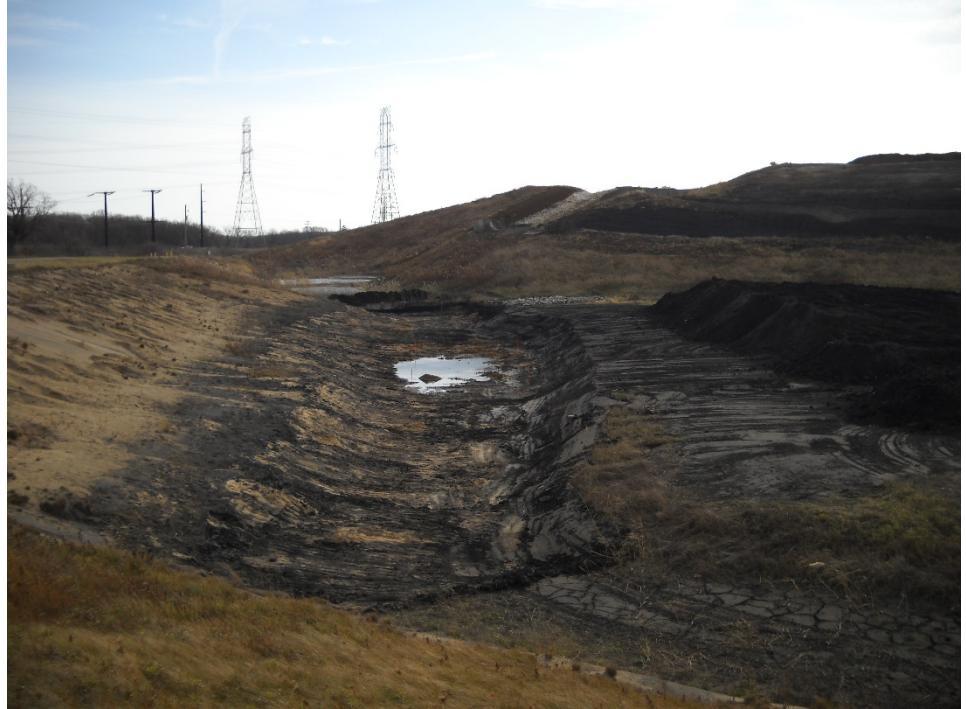
Photo No. 3: Contact water collection area along east end of Cell 10 looking south. 11/19/2020

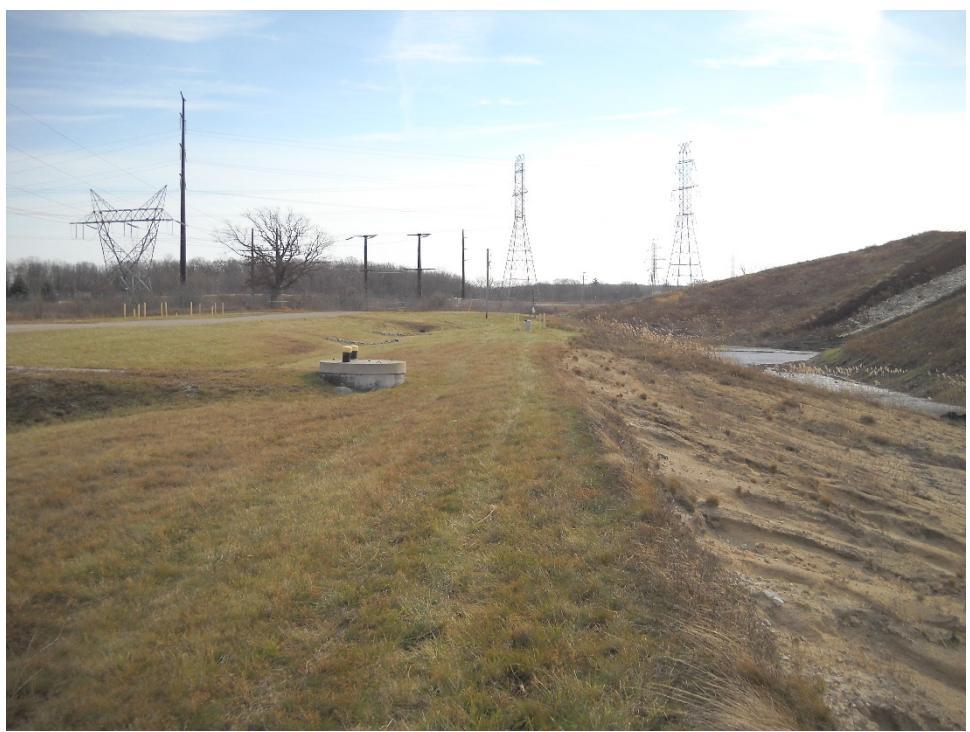
Photo No. 4: East perimeter berm looking south 11/19/2020

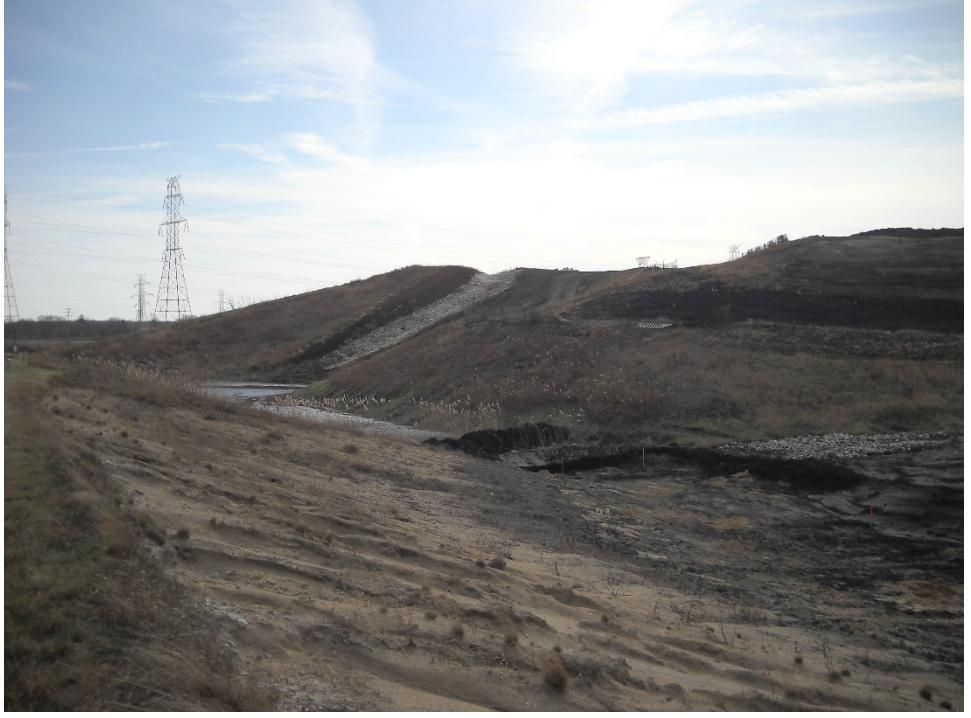
Photo No. 5: Contact water collection area along east slope 11/19/2020

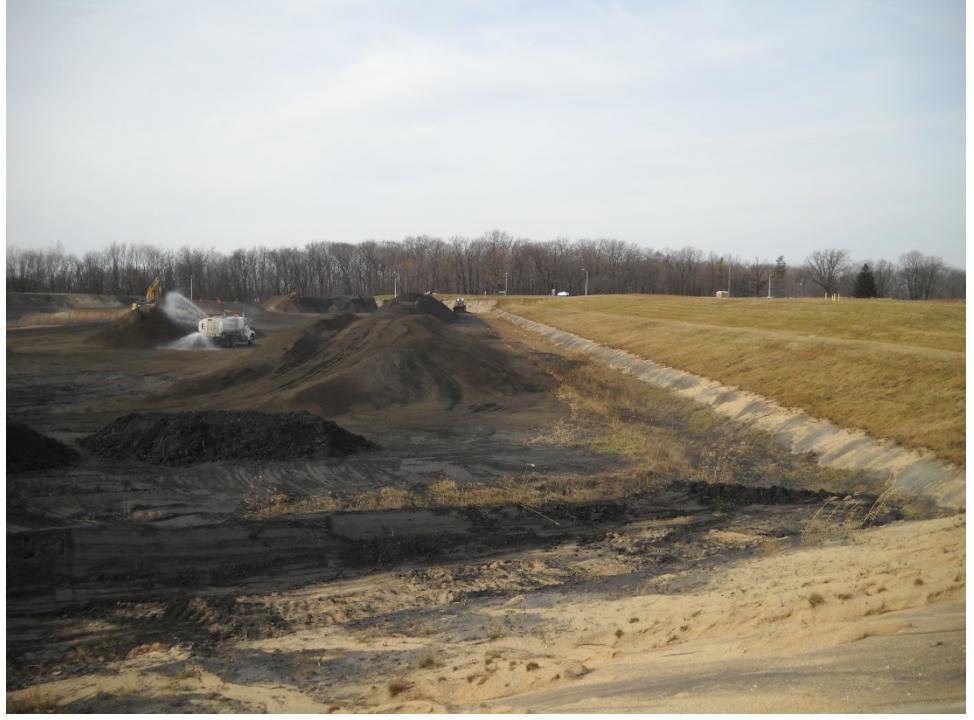
Photo No. 7: North interor slope of Cell 10 looking west on 11/19/2020

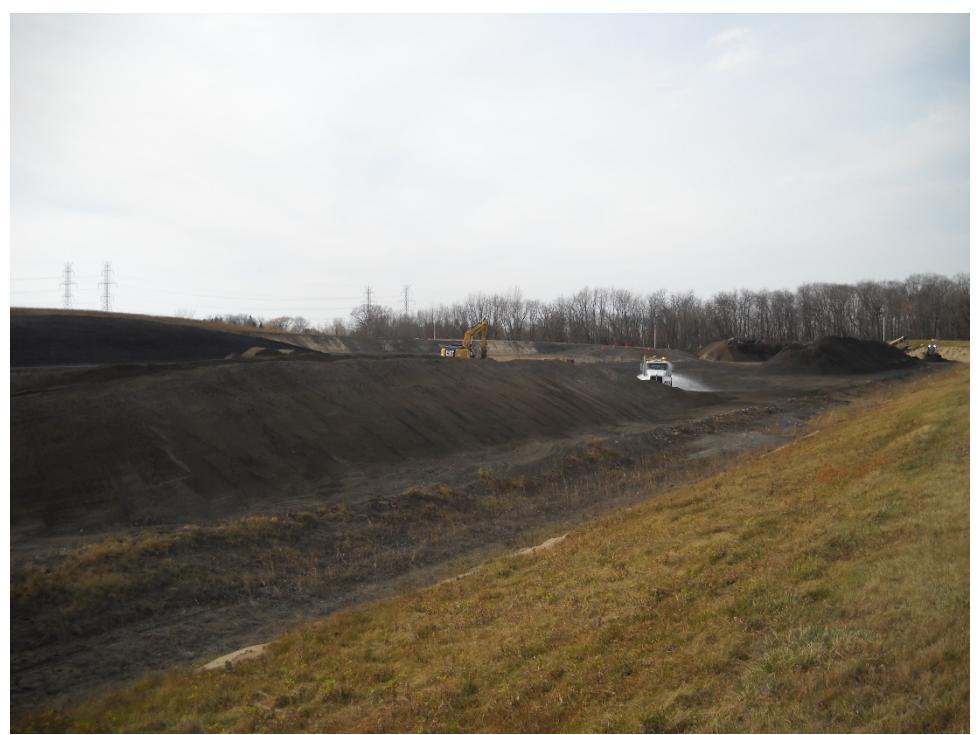
Photo No. 8: Screened ash stockpiling operation in Cell 10 for beneficial use 11/19/2020

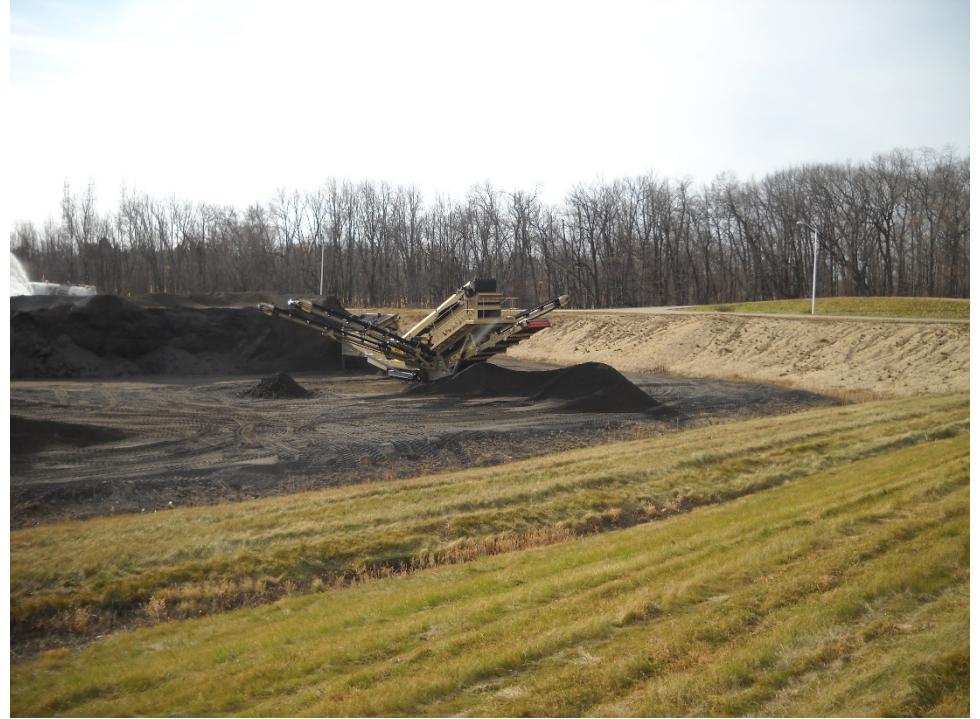
Photo No. 9: Ash screening operation in Cell 10 11/19/2020

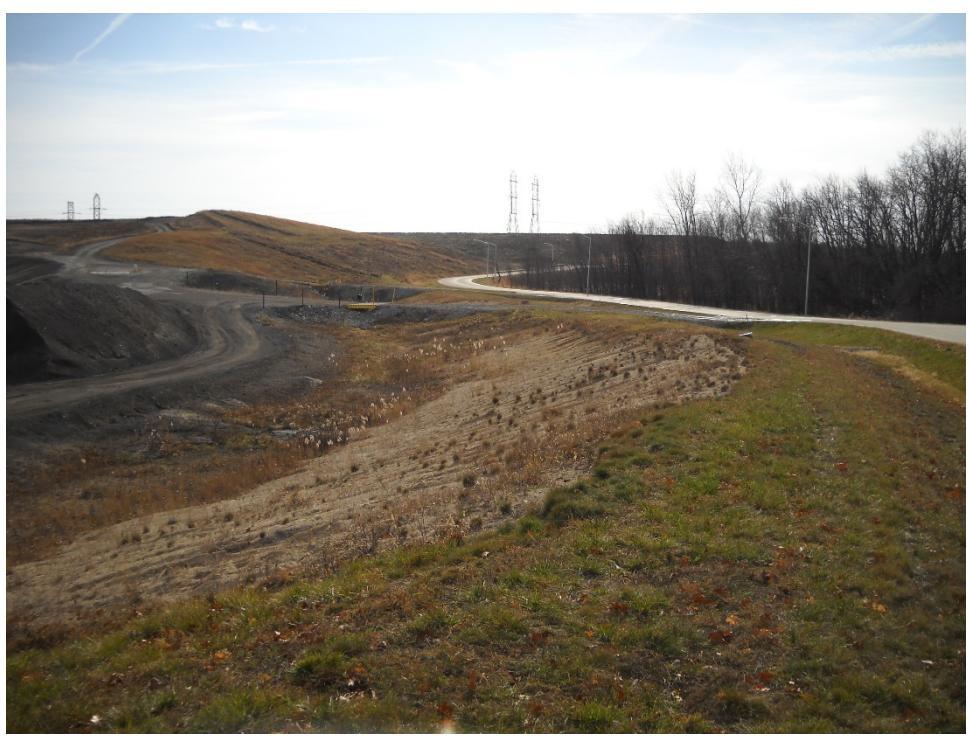
Photo No. 10: West interior slope looking south 11/19/2020

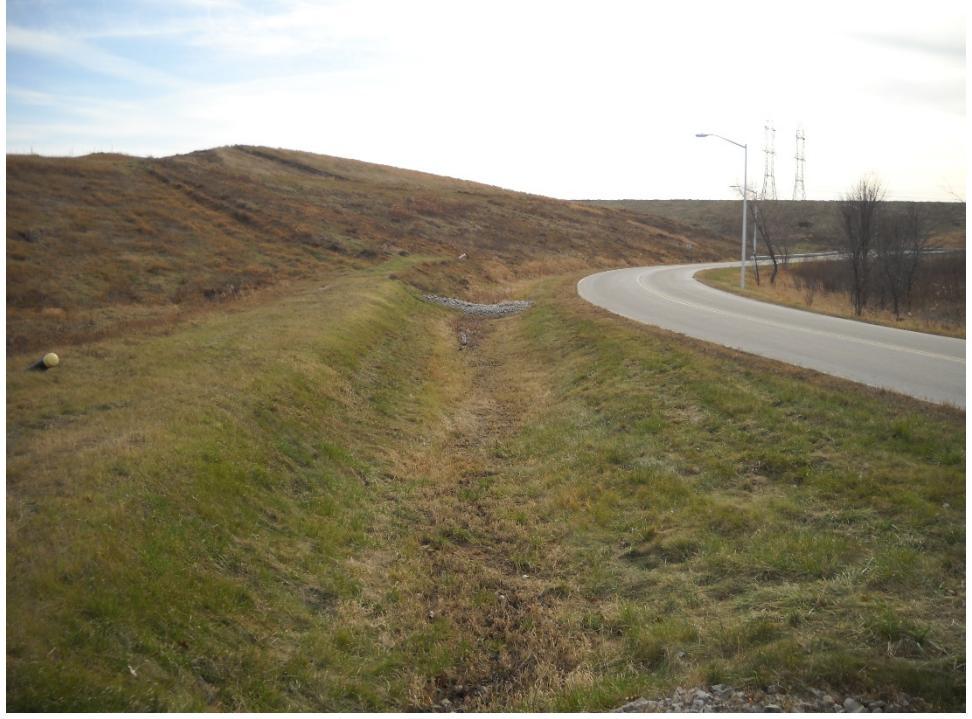
Photo No. 11: West perimeter slope and stormwater ditch looking south 11/19/2020

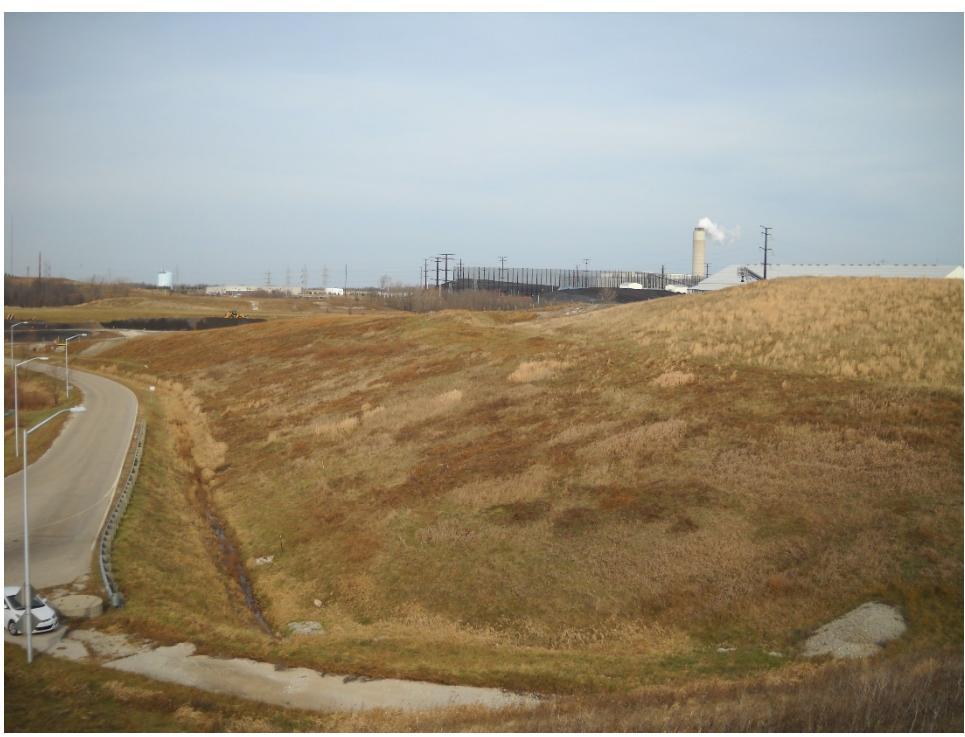
Photo No. 12: West perimeter slope looking north 11/19/2020

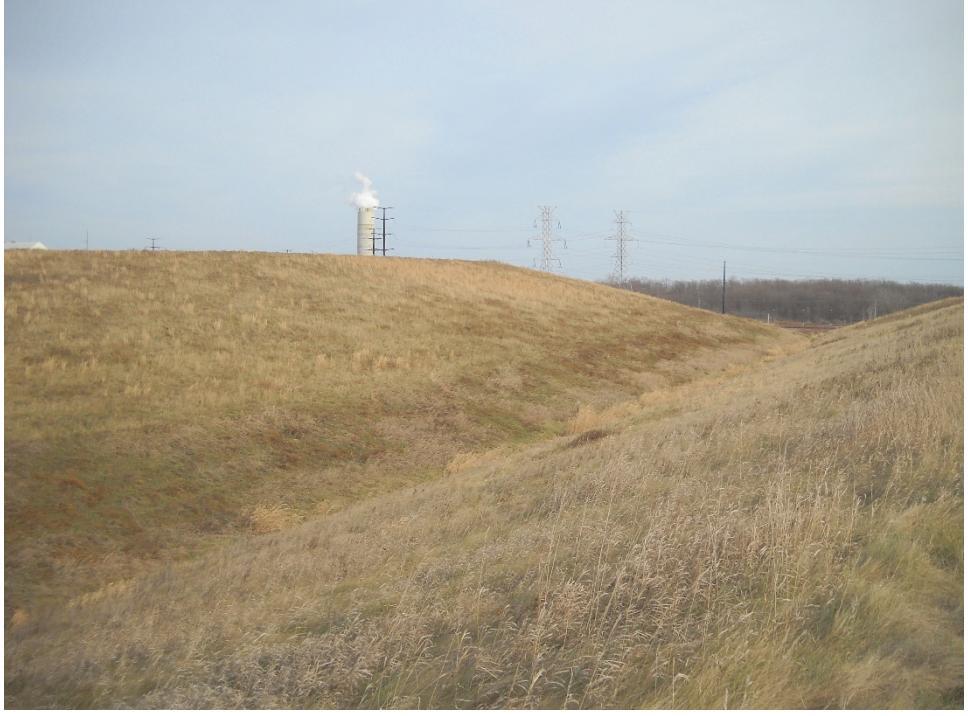
Photo No. 13: South slope of the Caledonia Landfill looking northeast 11/19/2020

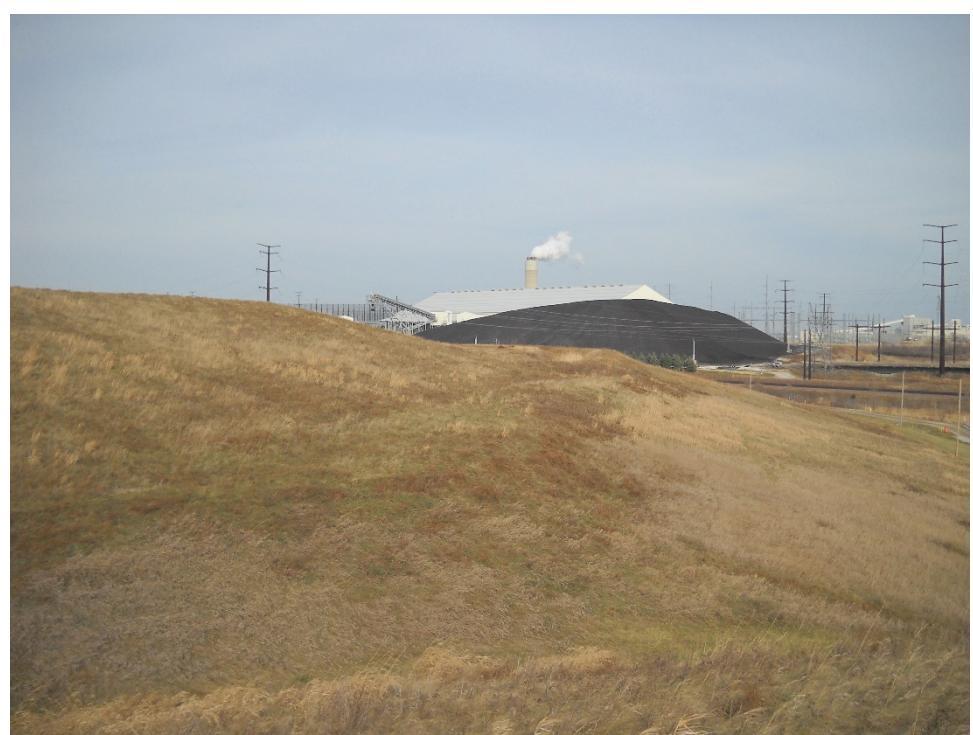
Photo No. 14: East slope of the Caledonia Landfill looking north-northeast 11/19/2020
