GEI Project No. 1610536

### Re: Landfill Inspection Report We Energies Presque Isle Power Plant Landfill No. 3 Marquette Township, Michigan

2019 Landfill No. 3 Inspection Presque Isle Power Plant Landfill We Energies

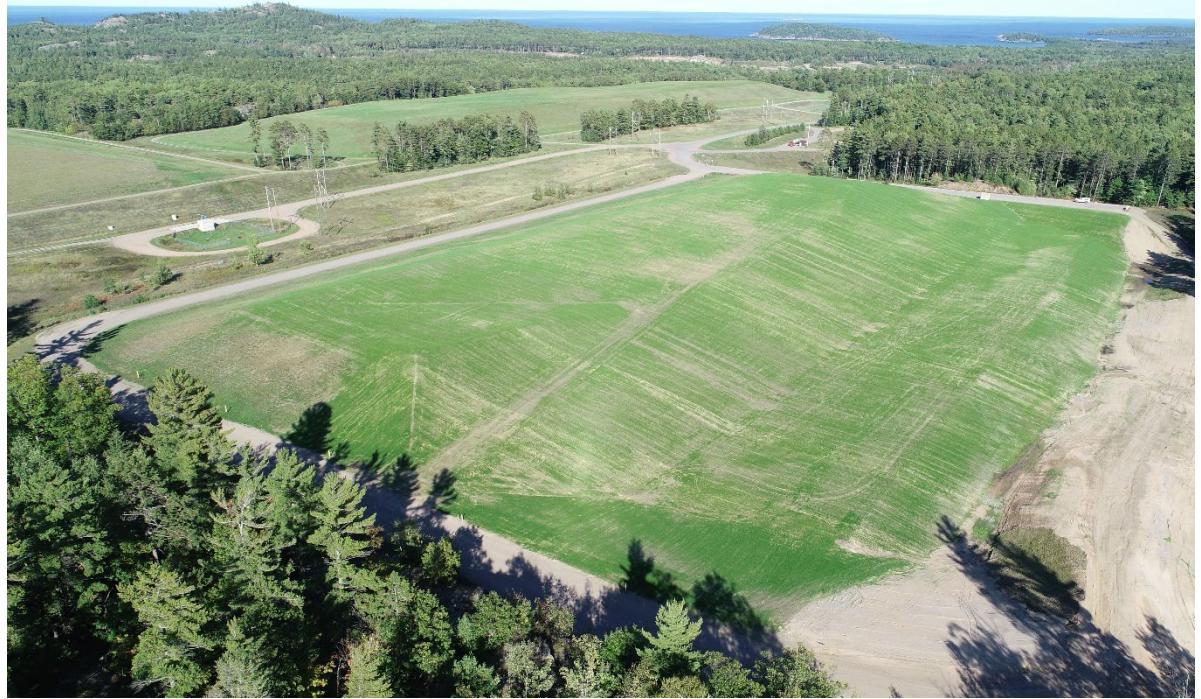
Photo No. 1: Aerial photo of PIPP Landfill No. 3 looking northeast 09/26/2019

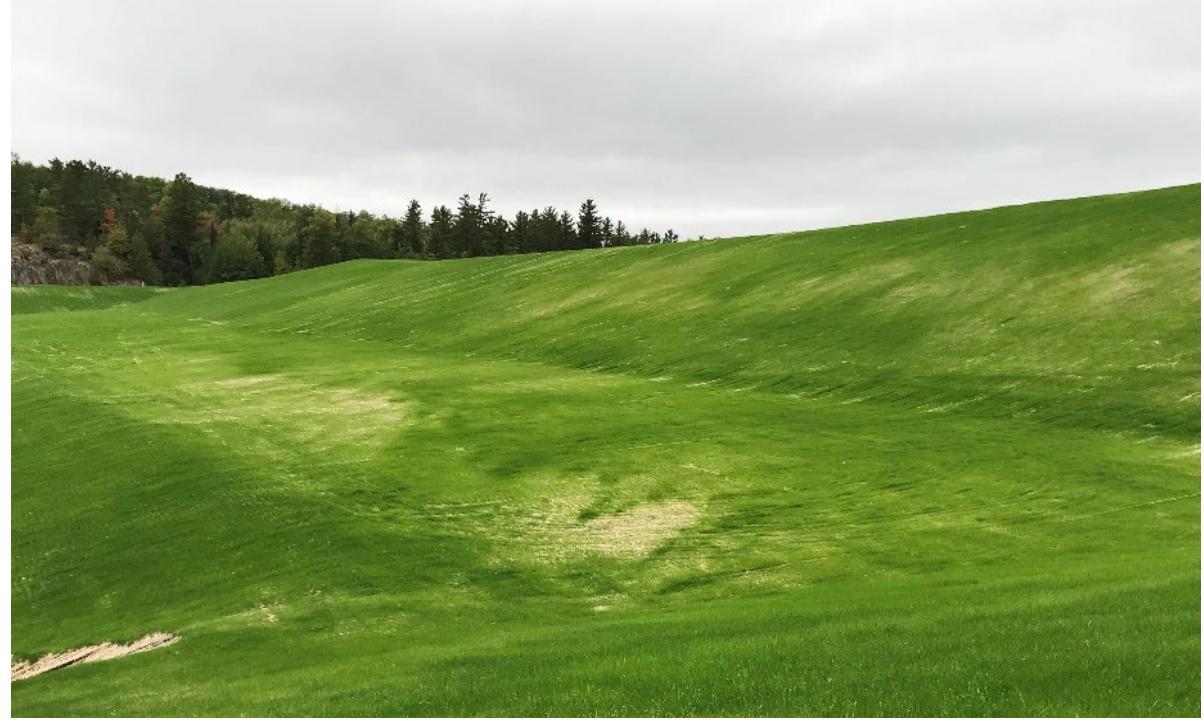
Photo No. 2: South slope of the PIPP Landfill No. 3 looking northwest 10/1/2019

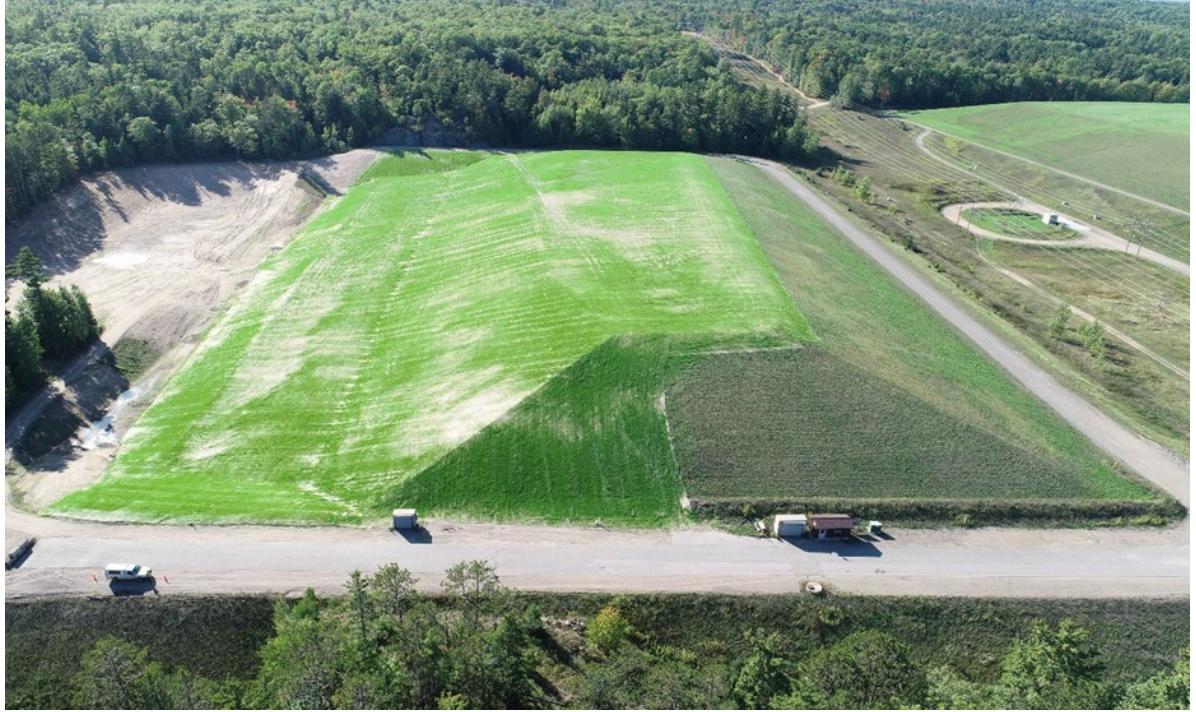
Photo No. 3: East slope of the PIPP Landfill No. 3 looking west 09/26/2019

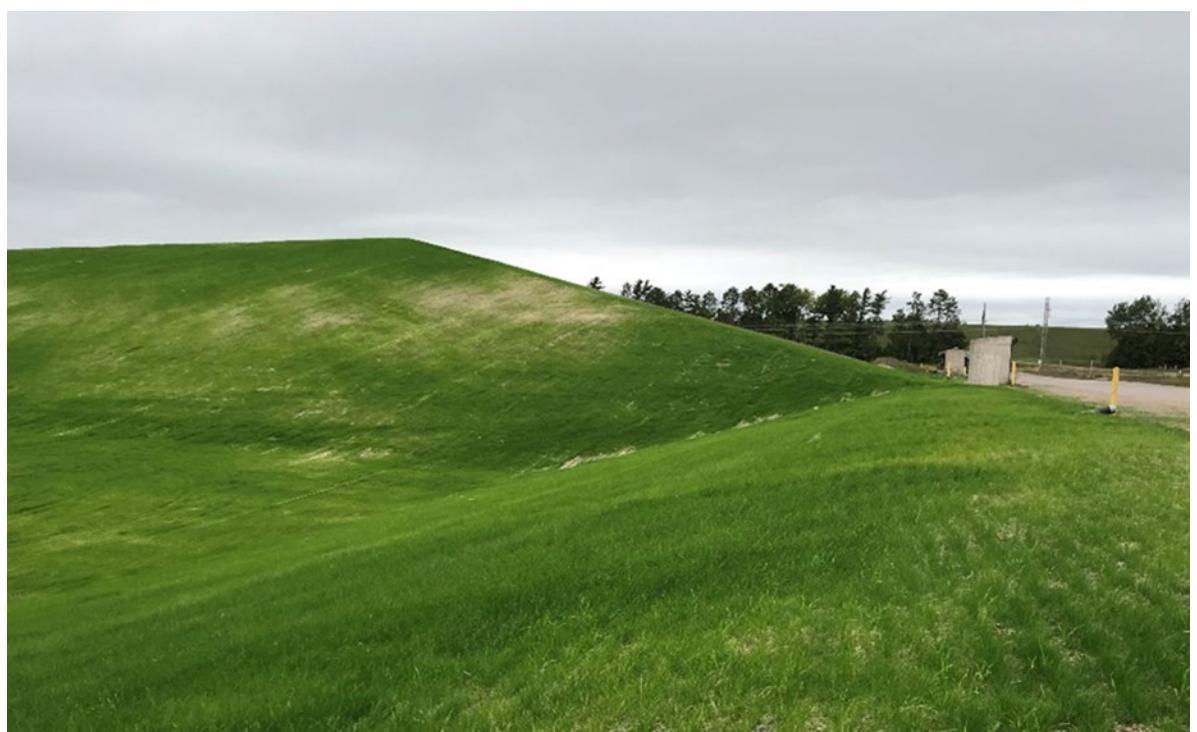
Photo No. 4: East slope of the PIPP Landfill No. 3 looking north 10/01/2019

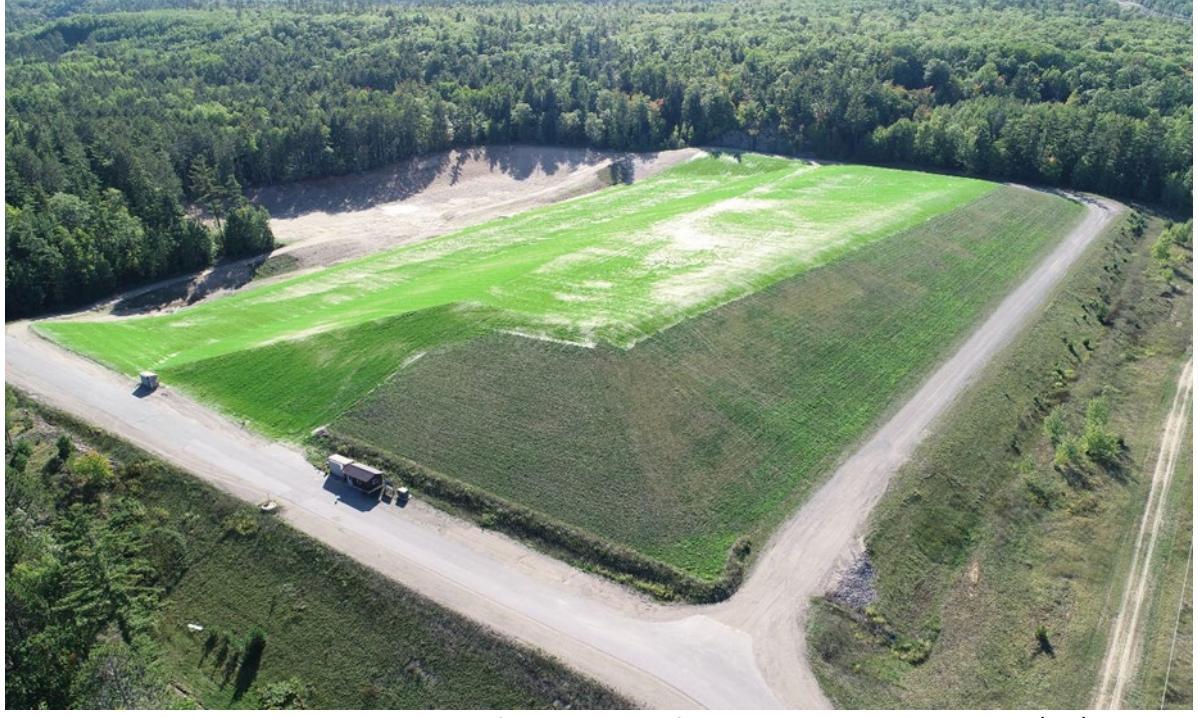
Photo No. 5: East and north slopes of the PIPP Landfill No. 3 looking southwest 09/26/2019

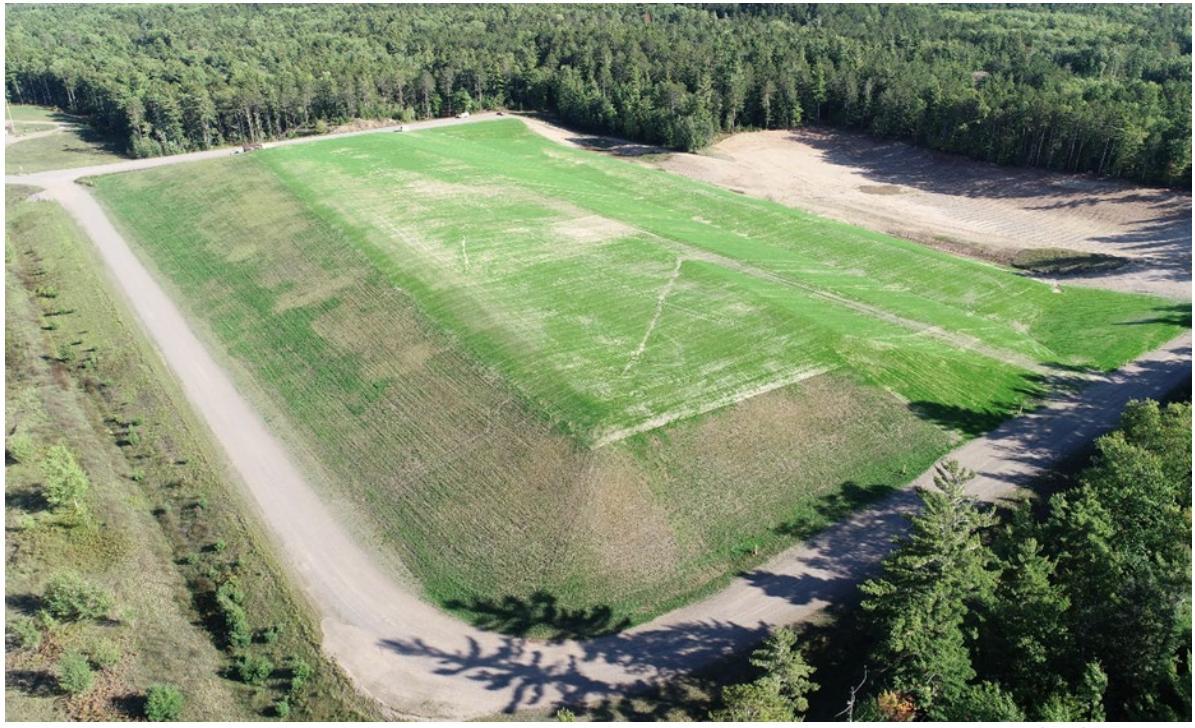
Photo No. 6: East and north slopes of the PIPP Landfill No. 3 looking southwest 09/26/2019

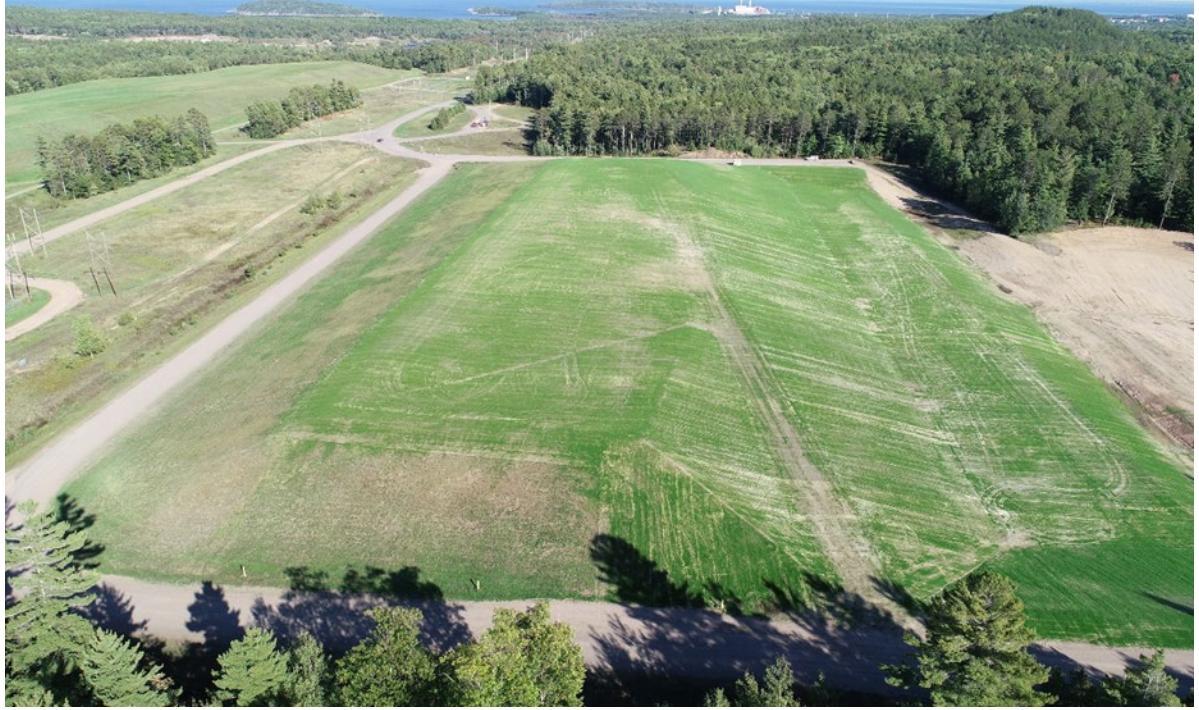
Photo No. 7: West slope of the PIPP Landfill No. 3 looking east 09/26/2019

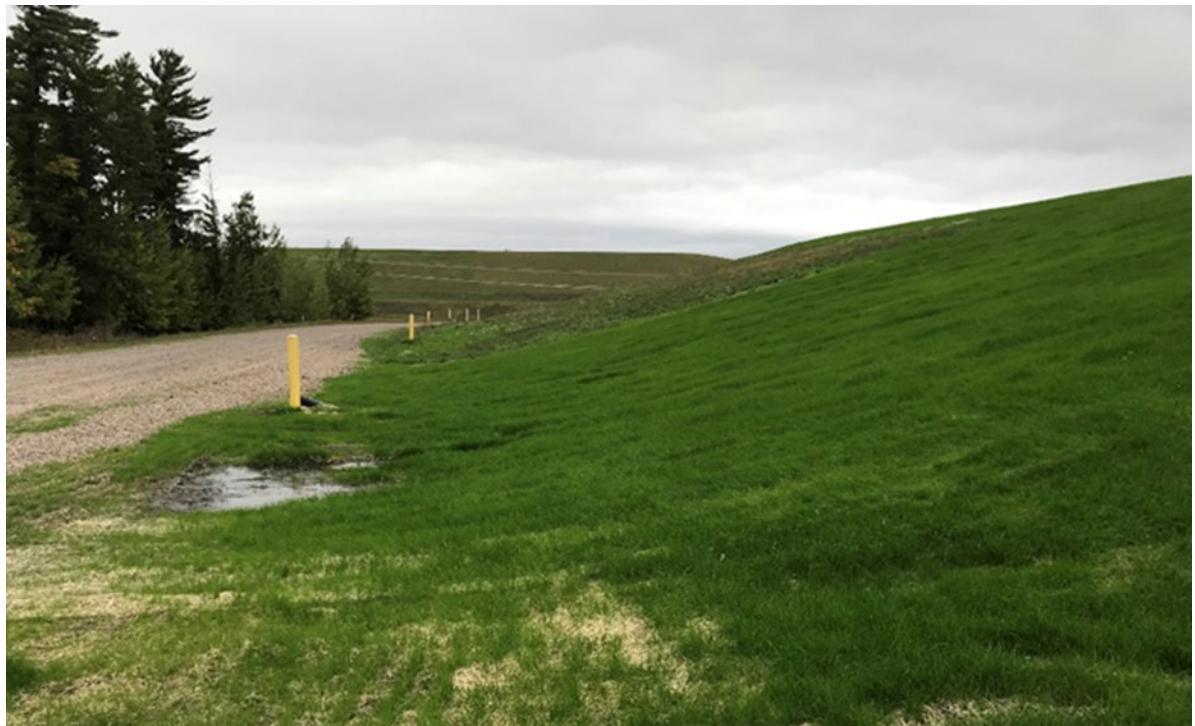
Photo No. 8: West slope of the PIPP Landfill No. 3 looking north 10/1/2019
